CHISEL POINT DEV 995/1069 PR – EUTECTOID TO HYPEREUTECTOID STEEL – EARLY MEDIEVAL TIMES – SWITZERLAND

Artefact name	Chisel point DEV 995/1069 PR
Authors	Marianne. Senn (EMPA, Dübendorf, Zurich, Switzerland) & Christian. Degrieny (HE-Arc CR, Neuchâtel, Neuchâtel, Switzerland)
Url	/artefacts/530/

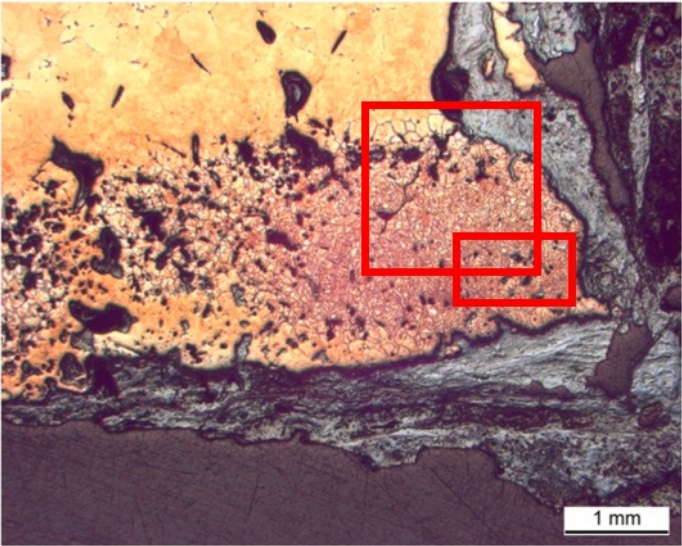
The remaining metal is a eutectoid to hypereutectoid steel (C 0.8-1 mass%) with cracks and porosity (Figs. 5 and 6). Its composition is given in Table 1 (except Fe). Of the trace elements, only Ni reaches a medium concentration (Ni 0.07 mass%). The composition and the high Ni/Co ratio are atypical for iron worked in smithies of the settlement at Develier-Courtételle JU, CH. The few slag inclusions and their chemical composition confirm this (Table 2). The slag is rich in CaO whereas the pisolithic or bean ore worked in the Central Jura smelting district is rich in Al₂O₃. The slag inclusions cannot be smithing slag because the artefact is formed from one piece of metal. The slag probably incorporated while refining the bloom or during the bloom smelting process. The ore from which this metal was smelted cannot yet be identified. Intergranular corrosion has developed, penetrating into the metal structure (Fig. 6). The etched metal shows a dominant martensitic structure, typical of quench hardened steel (Figs. 5, 7, 8 and 9). The characteristic forms of the martensite are non-organised needles (Fig. 8). In restricted areas bainite nodules occur (Figs. 7 and 8). In the centre of the point, hypereutectoid steel is composed of cementite in the grain boundaries and in needle like shapes within the grains (Fig. 10). Hypereutectoid regions also occur in the centre of the shaft and on its left surface (Fig. 5). Here the hypereutectoid steel is composed of martensite and cementite in the grain boundaries and in needle form within the grains (Figs. 6 and 9). Nevertheless, most of the chisel is dominated by eutectoid steel. The average hardness of the quench hardened eutectoid steel is about HV1 690. In the bainite nodules the average hardness drops to about HV1 350, the martensite has an average hardness of HV1 750.

Fig. 5: Micrograph of the metal sample from Fig. 3 (inverted picture, detail), etched, bright field. The metal contains porosity and cracks (in black). The micrographs of Figs. 6 and 9 are marked by the top and bottom rectangles respectively,

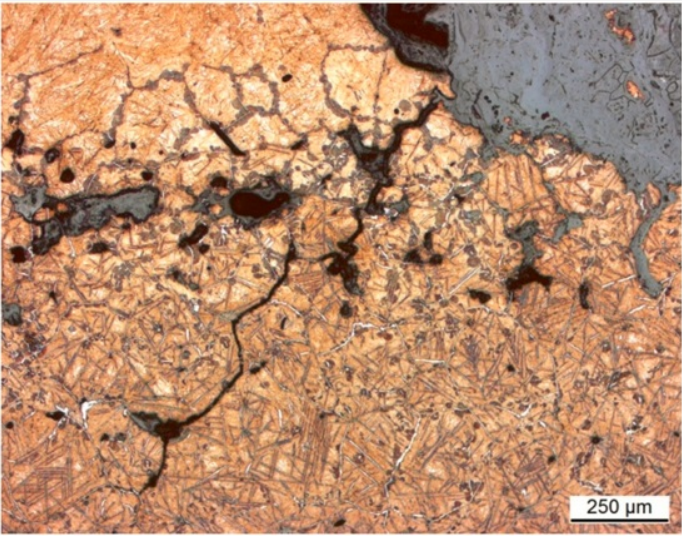
Fig. 6: Micrograph of the metal sample, detail from Fig. 5, etched, bright field. We observe martensite (in orange), cementite (in grey), porosity and intergranular cracks (in black) and corrosion,

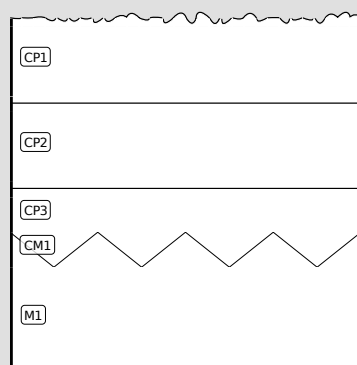
Fig. 4: Stratigraphic representation of the chisel point in cross-section using the MiCorr application. The characteristics of the strata are only accessible by clicking on the drawing that redirects you to the search tool by stratigraphy representation. This representation can be compared to Fig. 11, Credit HE-Arc CR.
