# MILITARY ID TAG 5668-MXX-1008-1 - ZN PB ALLOY - MODERN TIMES - FRANCE

<b>Artefact name</b>	Military ID tag 5668-MXX-1008-1
<b>Authors</b>	Christian. Degryny (HE-Arc CR, Neuchâtel, Neuchâtel, Switzerland) & Marie-Jeanne. Scholl (HE-Arc CR, Neuchâtel, Neuchâtel, Switzerland) & Valentin. Boissonnas (HE-Arc CR, Neuchâtel, Neuchâtel, Switzerland)
<b>Url</b>	/artefacts/537/

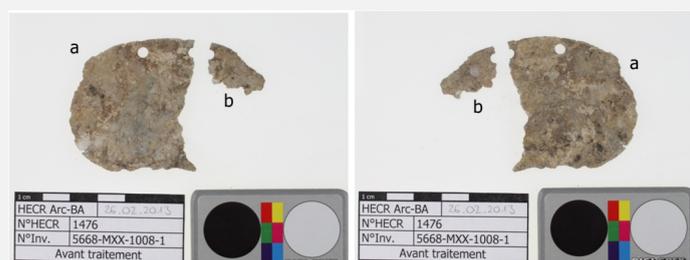
Fig. 1: German military ID tag from First World War, recto and verso, 2013,

<b>Description of the artefact</b>	Fragments from an oval shaped German military plate with two circular holes at the central upper edge (Fig. 1). Information concerning the soldier were given in the centre of the plate. The plate is covered with sediments. Dimensions (70 x 50 mm initially): L = 65mm; W = 50mm; T = 1 mm; WT = 6.3g.
<b>Type of artefact</b>	Military object
<b>Origin</b>	German army, 94th Infantry Regiment, 1918, Carspach, Alsace, France
<b>Recovering date</b>	Recovered in 2011
<b>Chronology category</b>	Modern Times
<b>chronology tpg</b>	<input type="text" value="1915"/> A.D. ▾
<b>chronology taq</b>	<input type="text" value="1915"/> A.D. ▾
<b>Chronology comment</b>	First World War
<b>Burial conditions / environment</b>	Soil
<b>Artefact location</b>	Pôle d'Archéologie Interdépartemental Rhénan, Sélestat, Alsace
<b>Owner</b>	Pôle d'Archéologie Interdépartemental Rhénan, Sélestat, Alsace

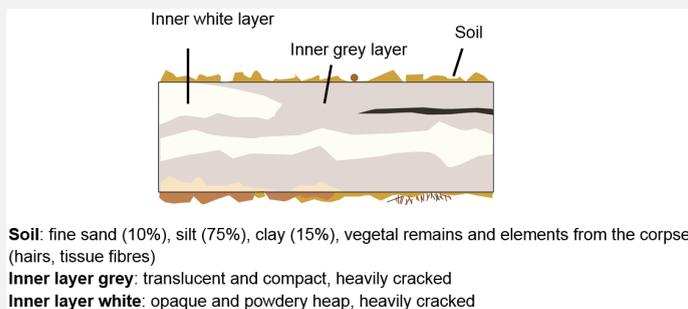
Fig. 3: Stratigraphic representation of fragment b of the military tag in cross-section by macroscopic observation,

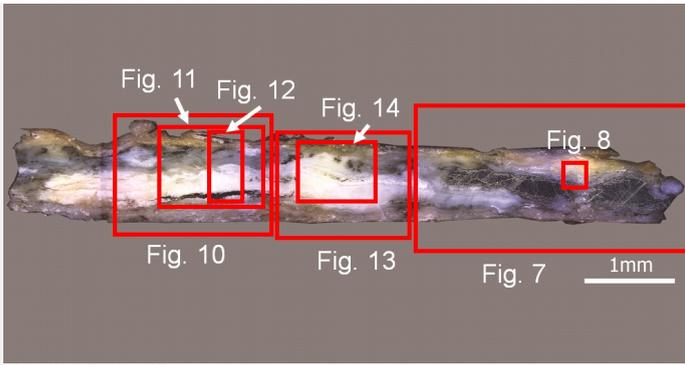
Fig. 4: Micrograph of the cross-section of fragment b of the military tag showing the location of Figs. 7, 8 and 10 to 14. Unetched, dark field, 50x,

<b>Description of sample</b>	This sample was cut out of fragment b in Fig. 1. The cross-section shows the entire thickness of the plate (L = 8 mm, W= 1 mm). The corrosion goes through the whole metal thickness but a metallic core remains (Figs. 4 and 7).
<b>Alloy</b>	Zn Pb Alloy
<b>Technology</b>	Cold worked (laminated)
<b>Lab number of sample</b>	None
<b>Sample location</b>	HE-Arc CR, Neuchâtel, Neuchâtel
<b>Responsible institution</b>	Pôle d'Archéologie Interdépartemental Rhénan, Sélestat, Alsace
<b>Date and aim of sampling</b>	2013, metallography and chemical analyses

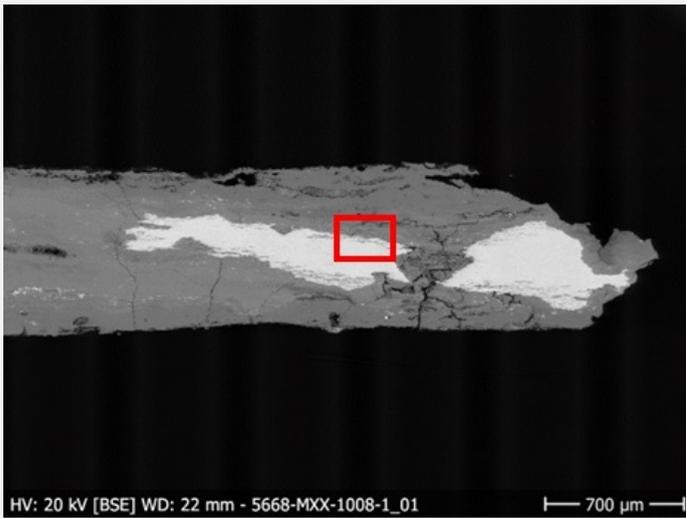
Fig. 7: SEM image of the cross-section, from Fig. 4 (detail), BSE-mode. Note the presence of Pb inclusions all through the thickness of the heavily cracked corrosion layers. The SEM image of Fig. 8 is marked by a rectangle,

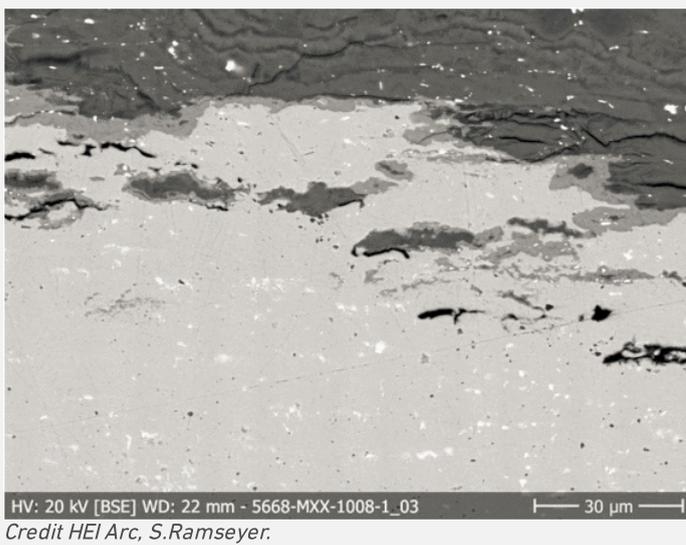
The remaining metal is a zinc alloy (Table 1) containing 1.8% in weight lead. Lead appears in the metal in the form of small flattened white Pb inclusions (Fig. 8), confirming the manufacturing technique, namely lamination. The etched metal does not show any specific microstructure (Fig. 9).

Fig. 8: SEM image of the cross-section, from Fig. 7 (detail), BSE-mode,

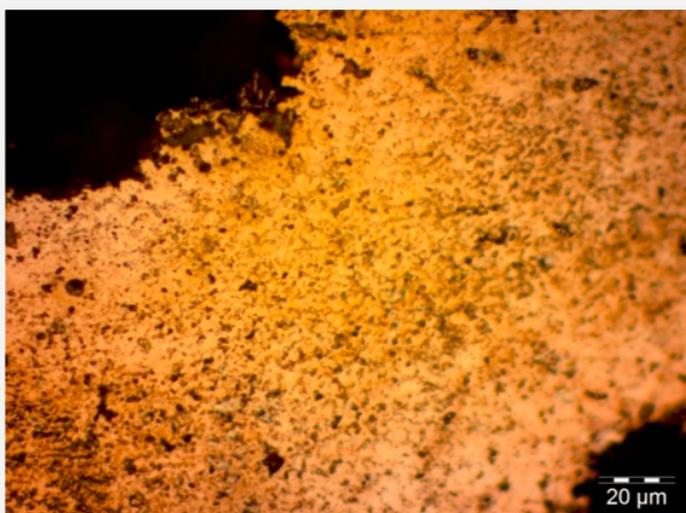
Fig. 9: Micrograph of the cross-section, etched, bright field, 500x,

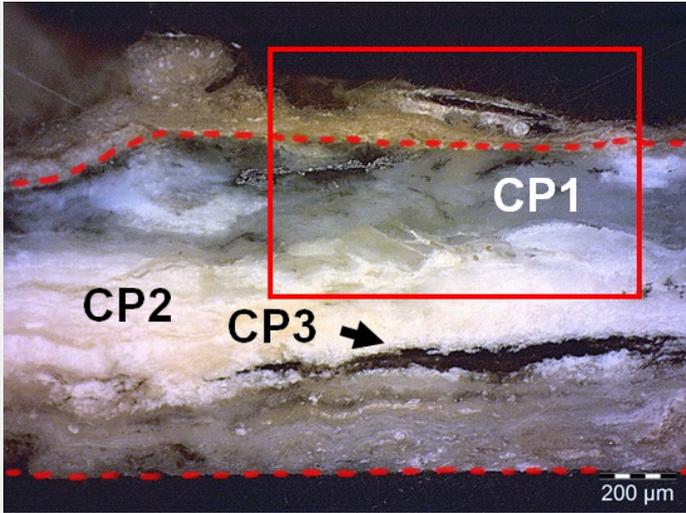
The inner grey layer (CP1, Figs. 5 and 10) has been identified by FTIR as a zinc carbonate (smithsonite), mixed with other unidentified corrosion products. Raman spectra seems to confirm it (Fig. 15). The exact composition of the inner white layer (CP2) is unknown. It shows a bluish fluorescence under UV light and has been identified by FTIR as a mixture of zinc oxides and carbonates, that could be zinc hydroxycarbonates (hydrozincite). Raman spectroscopy shows also a mixture of carbonates and other corrosion products (Fig. 16). The inner black layer (CP3) is a zinc carbonate as well, identified by FTIR and Raman spectroscopy (Fig. 17) appearing as a vein between layers of grey and white (Fig. 10).

Fig. 10: Micrograph of the cross-section, from Fig. 4 (detail) and corresponding to the stratigraphy of Fig. 5, unetched, dark field, 50x. View of the inner layers and the limit of the original surface (red line). We can see that the interfaces between the different layers are not well defined: some of the white corrosion product is found inside the inner grey layer. The micrograph of Fig. 11 is marked by a rectangle,

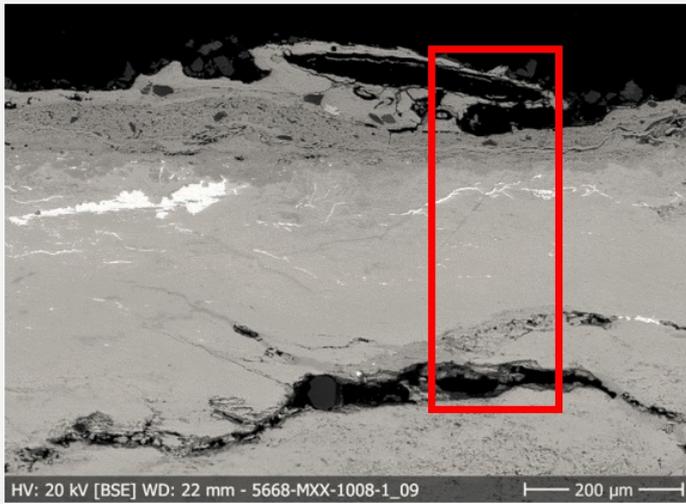
Fig. 11: SEM image of the cross-section from Fig. 10 (detail), BSE-mode. The area selected for elemental chemical distribution (Fig. 12) is marked by a rectangle,

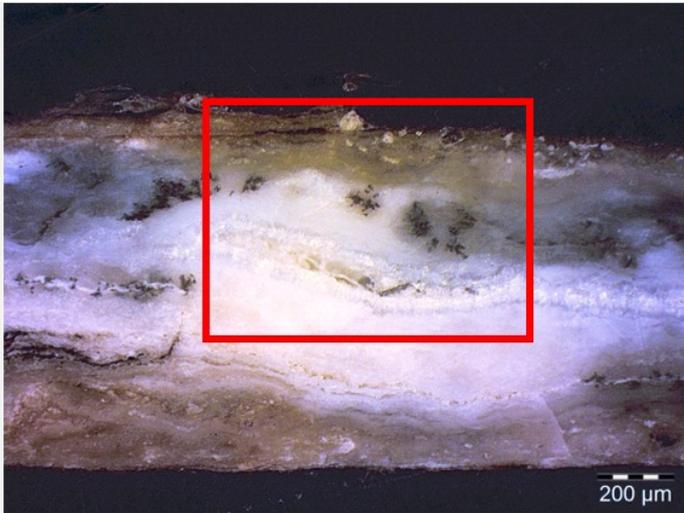
- **Inner grey layer – CP1** (up to 1 mm thick) is a translucent, compact layer and constitutes most part of the corrosion products. Corroded metal appears inside this layer as lead inclusions within a black corrosion product (Figs. 13 and 14). Sulphur has also been detected by SEM-EDS inside this layer, near the surface, where the colour turns into grey-orange (zinc sulfide or sulphates but to be confirmed, table 2).

Fig. 13: Micrograph of the cross-section, from Fig. 4 (detail), unetched, dark field, 50x. The micrograph of Fig. 14 is marked by a rectangular,

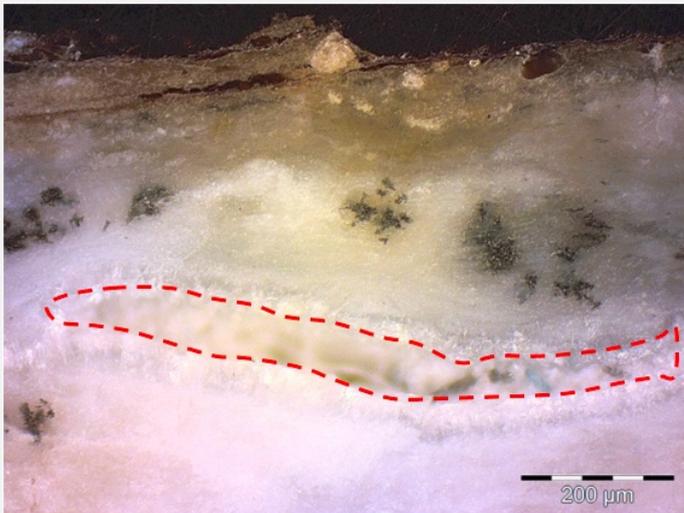
- **Inner white layer – CP2** (up to 0.6 mm thick) is an opaque and powdery heap, occurring in different places inside inner grey layer and sometimes near the surface, as pitting corrosion. The interface between inner layers grey and white is diffuse. Localized aggregates showing a crystalline microstructure of thickness of 50 µm are located against the walls of a structural void, inside the white corrosion product (Fig. 14).

Fig. 14: Micrograph of the cross-section, from Fig. 11 (detail) unetched, dark field, 100x. Structural void (dotted red line) with aggregates,

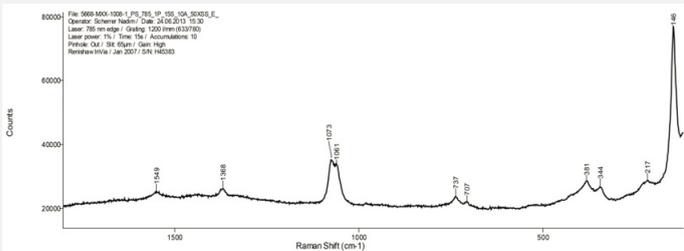
Fig. 15: Raman spectrum of the inner grey layer (CP1, ZnCO<sub>3</sub> – smithsonite?). Settings: laser wavelength 532nm, acquisition time 10s, one accumulation, filter D2 (0.75-0.8mW), hole 500, slit 80, grating 600. Method of analysis: Raman spectroscopy, Art Technological Laboratory, Departement Conservation HKB,

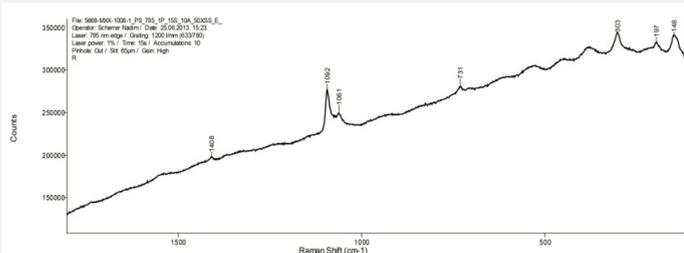
Fig. 16: Raman spectrum of the inner white layer (CP2, zinc hydroxycarbonate?). Settings: laser wavelength 532nm, acquisition time 10s, one accumulation, filter D2 (0.75-0.8mW), hole 500, slit 80, grating 600. Method of analysis: Raman spectroscopy, Art Technological Laboratory, Departement Conservation HKB,

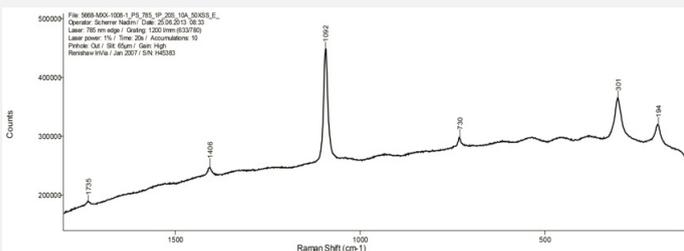
Fig. 17: Raman spectrum of the inner black layer (zinc carbonate?). Settings: laser wavelength 532nm, acquisition time 10s, one accumulation, filter D2 (0.75-0.8mW), hole 500, slit 80, grating 600. Method of analysis: Raman spectroscopy, Art Technological Laboratory, Departement Conservation HKB,

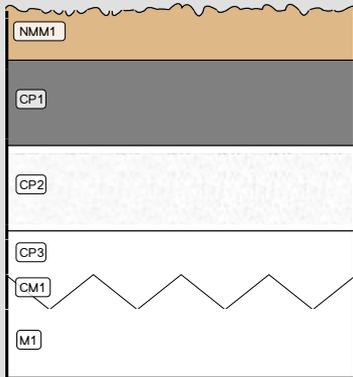
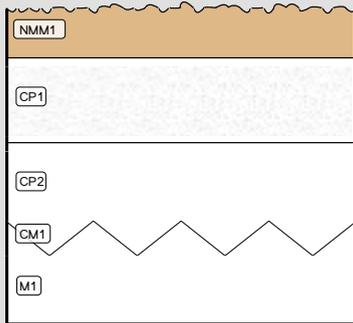
Fig. 5: Stratigraphic representation of fragment b of the military tag in cross-section using the MiCorr application. The characteristics of the strata are only accessible by clicking on the drawing that redirects you to the search tool by stratigraphy representation. This representation can be compared to Fig. 10, Credit HE-Arc CR, M-J.Scholl.

Fig. 6: Stratigraphic representation of fragment b of the military tag in cross-section using the MiCorr application. The characteristics of the strata are only accessible by clicking on the drawing that redirects you to the search tool by stratigraphy representation. This representation is different from Fig. 10 due to the inversion of CP1 and CP2. Furthermore, CP3 is not represented, Credit HE-Arc CR, M-J.Scholl.

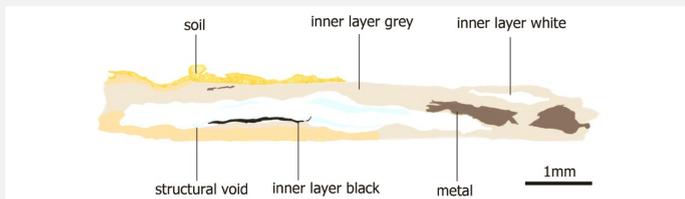
Fig. 16: Improved representation of the stratigraphy of corrosion layers of the military tag from visual observations and analyses,

The military tag is made of a laminated sheet of zinc-lead alloy. The corrosion has entirely penetrated the objet leaving though some spots of remaining original metal inside the corrosion products. Lead particles are not affected by the corrosion process. The main corrosion products are zinc carbonates (smithsonite) and hydroxycarbonates (hydrozincite) but mixtures of different corrosion products can occur. These corrosion products are intermixed and heavily cracked.
