# MILITARY ID TAG 5668-MXX-1008-1 - ZN PB ALLOY - MODERN TIMES - FRANCE

**Artefact name** Military ID tag 5668-MXX-1008-1

**Authors** Christian. Degrygn (HE-Arc CR, Neuchâtel, Neuchâtel, Switzerland) & Marie-Jeanne. Scholl (HE-Arc CR, Neuchâtel, Neuchâtel, Switzerland) & Valentin. Boissonnas (HE-Arc CR, Neuchâtel, Neuchâtel, Switzerland)

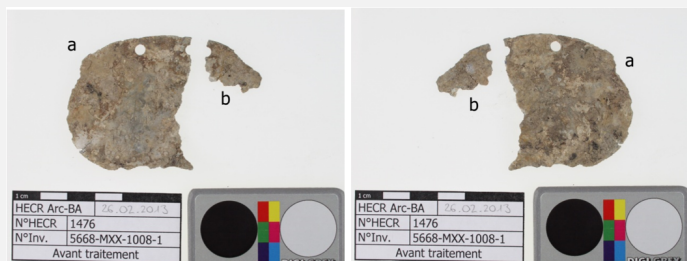
Fig. 1: German military ID tag from First World War, recto and verso, 2013,

**Description of the artefact** Fragments from an oval shaped German military plate with two circular holes at the central upper edge (Fig. 1). Information concerning the soldier were given in the centre of the plate. The plate is covered with sediments. Dimensions (70 x 50 mm initially): L = 65mm; W = 50mm; T = 1 mm; WT = 6.3g.

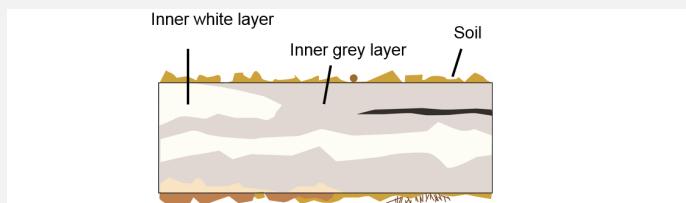
**Soil:** fine sand (10%), silt (75%), clay (15%), vegetal remains and elements from the corpse (hairs, tissue fibres)

**Inner layer grey:** translucent and compact, heavily cracked

**Inner layer white:** opaque and powdery heap, heavily cracked

Fig. 3: Stratigraphic representation of fragment b of the military tag in cross-section by macroscopic observation,

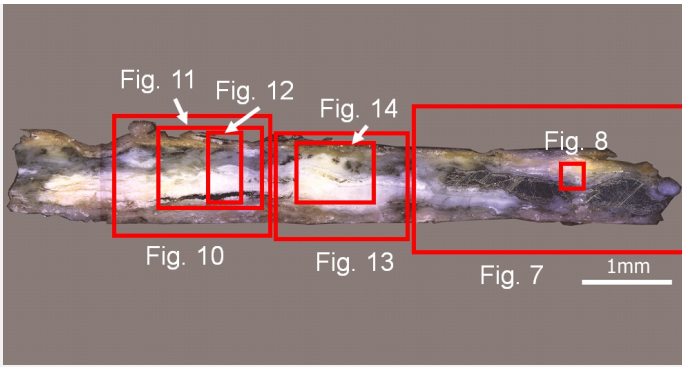
Fig. 4: Micrograph of the cross-section of fragment b of the military tag showing the location of Figs. 7, 8 and 10 to 14. Unetched, dark field, 50x,

This sample was cut out of fragment b in Fig. 1. The cross-section shows the entire thickness of the plate (L = 8 mm, W= 1 mm). The corrosion goes through the whole metal thickness but a metallic core remains (Figs. 4 and 7).

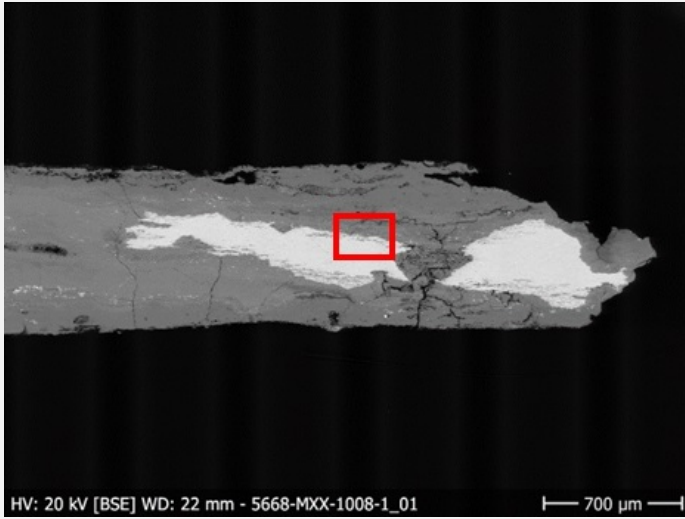
Fig. 7: SEM image of the cross-section, from Fig. 4 (detail), BSE-mode. Note the presence of Pb inclusions all through the thickness of the heavily cracked corrosion layers. The SEM image of Fig. 8 is marked by a rectangle,

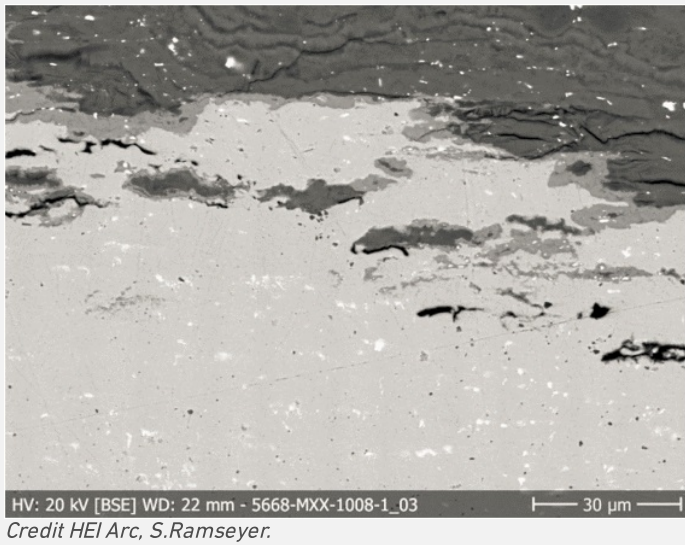
The remaining metal is a zinc alloy (Table 1) containing 1.8% in weight lead. Lead appears in the metal in the form of small flattened white Pb inclusions (Fig. 8), confirming the manufacturing technique, namely lamination. The etched metal does not show any specific microstructure (Fig. 9).

Fig. 8: SEM image of the cross-section, from Fig. 7 (detail), BSE-mode,

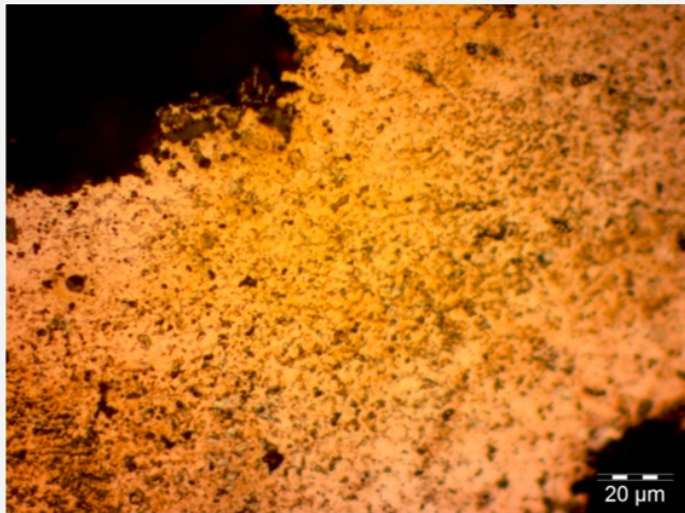
Fig. 9: Micrograph of the cross-section, etched, bright field, 500x,

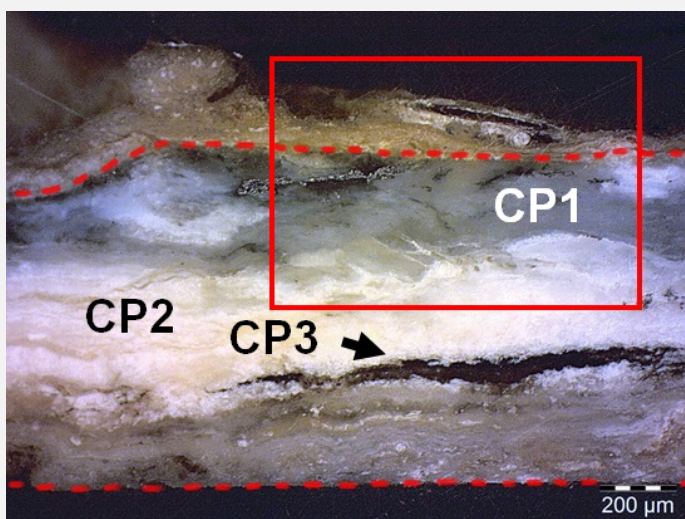
The inner grey layer (CP1, Figs. 5 and 10) has been identified by FTIR as a zinc carbonate (smithsonite), mixed with other unidentified corrosion products. Raman spectra seems to confirm it (Fig. 15). The exact composition of the inner white layer (CP2) is unknown. It shows a bluish fluorescence under UV light and has been identified by FTIR as a mixture of zinc oxides and carbonates, that could be zinc hydroxycarbonates (hydrozincite). Raman spectroscopy shows also a mixture of carbonates and other corrosion products (Fig. 16). The inner black layer (CP3) is a zinc carbonate as well, identified by FTIR and Raman spectroscopy (Fig. 17) appearing as a vein between layers of grey and white (Fig. 10).

Fig. 10: Micrograph of the cross-section, from Fig. 4 (detail) and corresponding to the stratigraphy of Fig. 5, unetched, dark field, 50x. View of the inner layers and the limit of the original surface (red line). We can see that the interfaces between the different layers are not well defined: some of the white corrosion product is found inside the inner grey layer. The micrograph of Fig. 11 is marked by a rectangle,

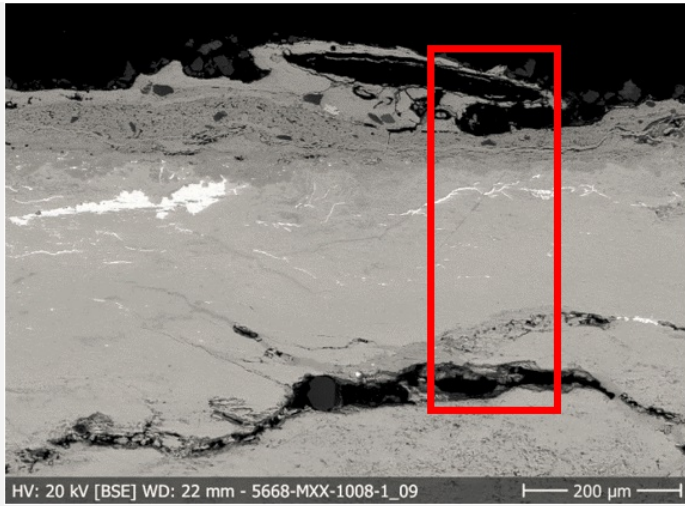
Fig. 11: SEM image of the cross-section from Fig. 10 (detail), BSE-mode. The area selected for elemental chemical distribution (Fig. 12)

is marked by a rectangle,

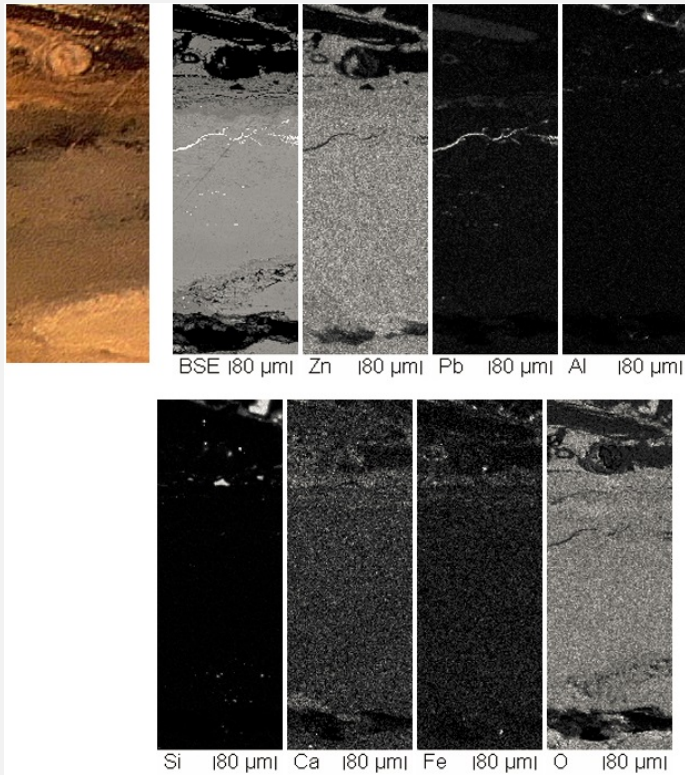
Fig. 12: SEM image of the cross-section from Fig. 11 (detail), SE-mode, and elemental chemical distribution. Method of examination: SEM/EDS, Lab of Electronic Microscopy and microanalysis, IMA (Néode), HEI Arc,

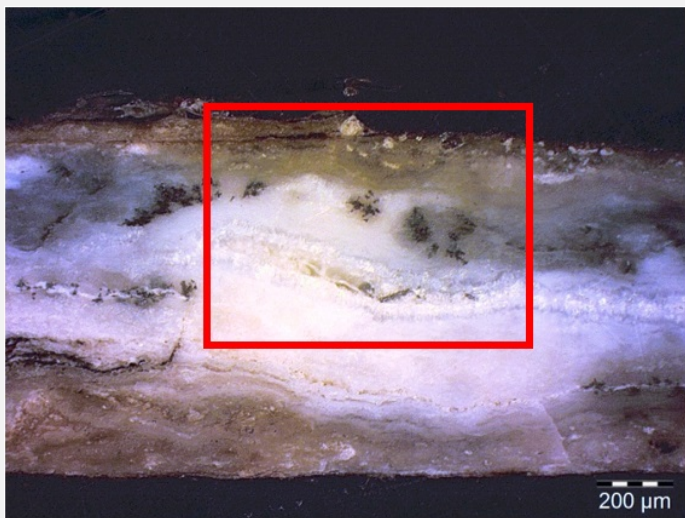
- **Inner grey layer – CP1** (up to 1 mm thick) is a translucent, compact layer and constitutes most part of the corrosion products. Corroded metal appears inside this layer as lead inclusions within a black corrosion product (Figs. 13 and 14). Sulphur has also been detected by SEM-EDS inside this layer, near the surface, where the colour turns into grey-orange (zinc sulfide or sulphates but to be confirmed, table 2).

Fig. 13: Micrograph of the cross-section, from Fig. 4 (detail), unetched, dark field, 50x. The micrograph of Fig. 14 is marked by a rectangular,

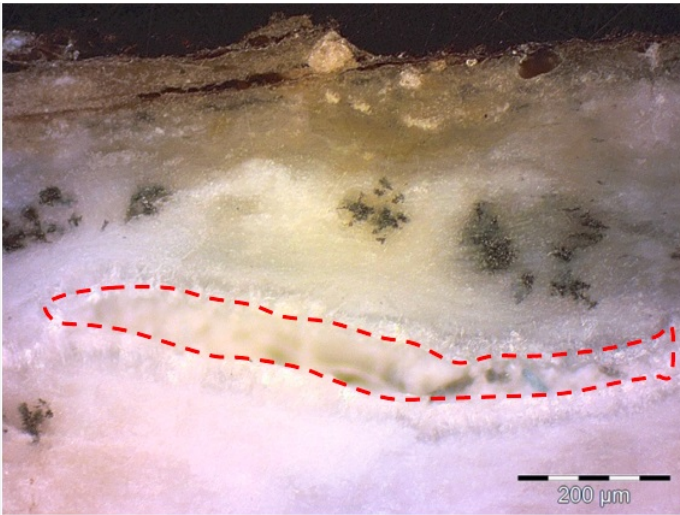
- **Inner white layer – CP2** (up to 0.6 mm thick) is an opaque and powdery heap, occurring in different places inside inner grey layer and sometimes near the surface, as pitting corrosion. The interface between inner layers grey and white is diffuse. Localized aggregates showing a crystalline microstructure of thickness of 50 µm are located against the walls of a structural void, inside the white corrosion product (Fig. 14).

Fig. 14: Micrograph of the cross-section, from Fig. 11 (detail) unetched, dark field, 100x. Structural void (dotted red line) with aggregates,

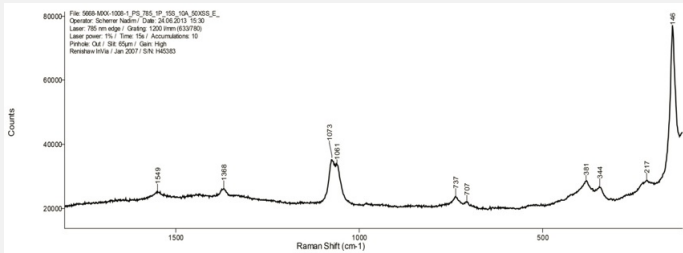
Fig. 15: Raman spectrum of the inner grey layer (CP1, ZnCO<sub>3</sub> – smithsonite?). Settings: laser wavelength 532nm, acquisition time 10s, one accumulation, filter D2 (0.75-0.8mW), hole 500, slit 80, grating 600. Method of analysis: Raman spectroscopy, Art Technological Laboratory, Departement Conservation HKB,

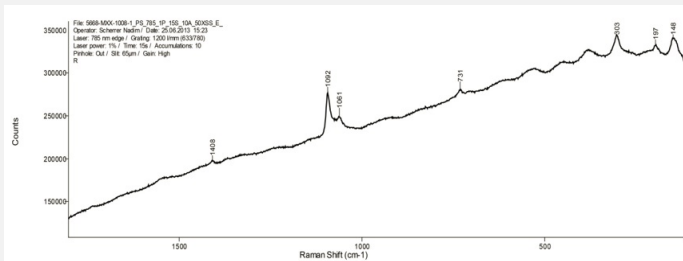
Fig. 16: Raman spectrum of the inner white layer (CP2, zinc hydroxycarbonate?). Settings: laser wavelength 532nm, acquisition time 10s, one accumulation, filter D2 (0.75-0.8mW), hole 500, slit 80, grating 600. Method of analysis: Raman spectroscopy, Art Technological Laboratory, Departement Conservation HKB,

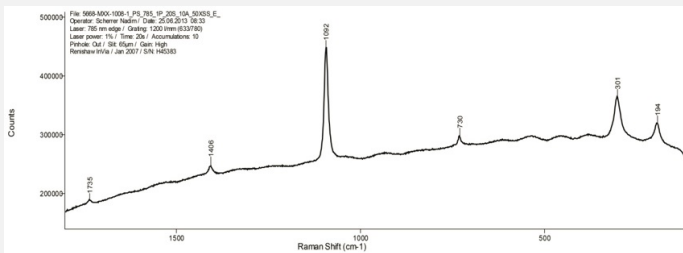
Fig. 17: Raman spectrum of the inner black layer (zinc carbonate?). Settings: laser wavelength 532nm, acquisition time 10s, one accumulation, filter D2 (0.75-0.8mW), hole 500, slit 80, grating 600. Method of analysis: Raman spectroscopy, Art Technological Laboratory, Departement Conservation HKB,

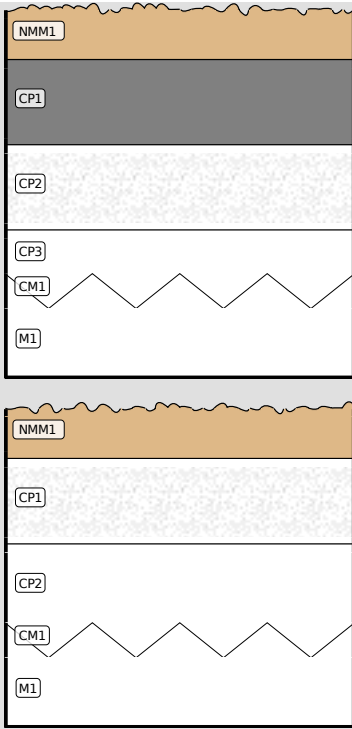
Fig. 6: Stratigraphic representation of fragment b of the military tag in cross-section using the MiCorr application. The characteristics of the strata are only accessible by clicking on the drawing that redirects you to the search tool by stratigraphy representation. This representation is different from Fig. 10 due to the inversion of CP1 and CP2. Furthermore, CP3 is not represented, Credit HE-Arc CR, M-J.Scholl.

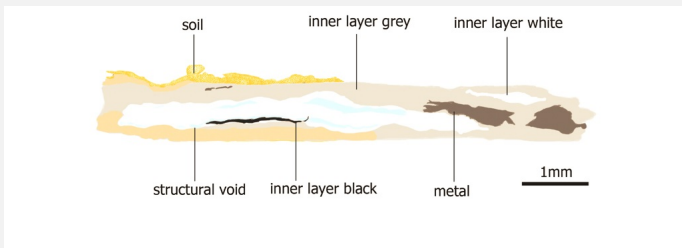
Fig. 16: Improved representation of the stratigraphy of corrosion layers of the military tag from visual observations and analyses,

Strate	Composition
Soil (S)	Elements from soil, organic elements
Grey corrosion product (CP1)	Zinc carbonate (smithsonite) + S
White corrosion product (CP2)	Zinc hydroxycarbonate + mixture of CP
Black corrosion product (CP3)	Zinc carbonate
Corroded metal (CM)	
Metal (M)	Zn-Pb
