MILITARY ID TAG 5668-MXX-1008-1 - ZN PB ALLOY - MODERN TIMES - FRANCE

Artefact name	Military ID tag 5668-MXX-1008-1
Authors	Christian. Degryny (HE-Arc CR, Neuchâtel, Neuchâtel, Switzerland) & Marie-Jeanne. Scholl (HE-Arc CR, Neuchâtel, Neuchâtel, Switzerland) & Valentin. Boissonnas (HE-Arc CR, Neuchâtel, Neuchâtel, Switzerland)
Url	/artefacts/537/

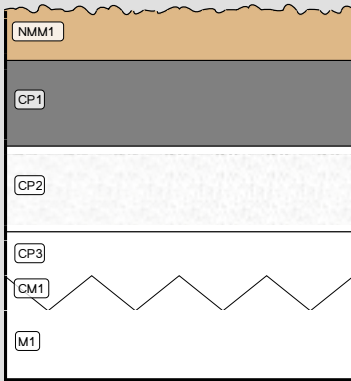
Fig. 5: Stratigraphic representation of fragment b of the military tag in cross-section using the MiCorr application. The characteristics of the strata are only accessible by clicking on the drawing that redirects you to the search tool by stratigraphy representation. This representation can be compared to Fig. 10, Credit HE-Arc CR, M-J.Scholl.

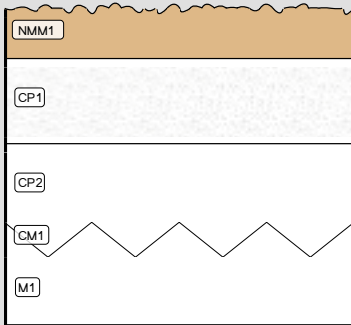
Fig. 6: Stratigraphic representation of fragment b of the military tag in cross-section using the MiCorr application. The characteristics of the strata are only accessible by clicking on the drawing that redirects you to the search tool by stratigraphy representation. This representation is different from Fig. 10 due to the inversion of CP1 and CP2. Furthermore, CP3 is not represented, Credit HE-Arc CR, M-J.Scholl.

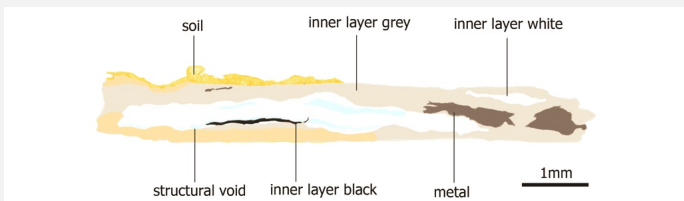
Fig. 16: Improved representation of the stratigraphy of corrosion layers of the military tag from visual observations and analyses,

Strate	Composition
Soil (S)	Elements from soil, organic elements
Grey corrosion product (CP1)	Zinc carbonate (smithsonite) + S
White corrosion product (CP2)	Zinc hydroxycarbonate + mixture of CP
Black corrosion product (CP3)	Zinc carbonate
Corroded metal (CM)	
Metal (M)	Zn-Pb
