MILITARY ID TAG 5668-MXX-1008-1 - ZN PB ALLOY - MODERN TIMES - FRANCE

Artefact name	Military ID tag 5668-MXX-1008-1
Authors	Christian. Degryny (HE-Arc CR, Neuchâtel, Neuchâtel, Switzerland) & Marie-Jeanne. Scholl (HE-Arc CR, Neuchâtel, Neuchâtel, Switzerland) & Valentin. Boissonnas (HE-Arc CR, Neuchâtel, Neuchâtel, Switzerland)
Url	/artefacts/537/

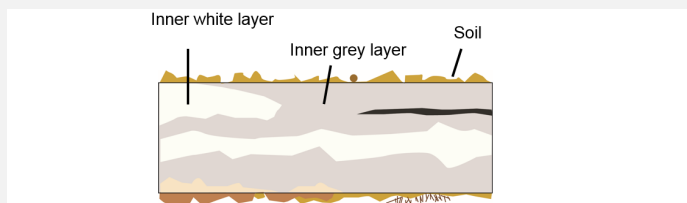
Fig. 3: Stratigraphic representation of fragment b of the military tag in cross-section by macroscopic observation,

Soil: fine sand (10%), silt (75%), clay (15%), vegetal remains and elements from the corpse (hairs, tissue fibres)

Inner layer grey: translucent and compact, heavily cracked

Inner layer white: opaque and powdery heap, heavily cracked

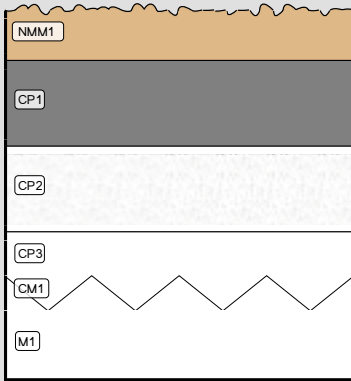
Fig. 5: Stratigraphic representation of fragment b of the military tag in cross-section using the MiCorr application. The characteristics of the strata are only accessible by clicking on the drawing that redirects you to the search tool by stratigraphy representation. This representation can be compared to Fig. 10, Credit HE-Arc CR, M-J.Scholl.

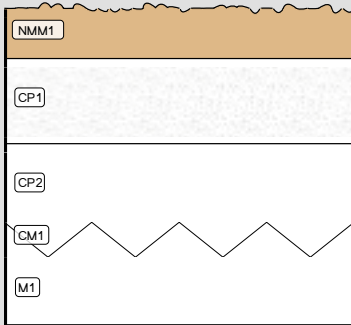
Fig. 6: Stratigraphic representation of fragment b of the military tag in cross-section using the MiCorr application. The characteristics of the strata are only accessible by clicking on the drawing that redirects you to the search tool by stratigraphy representation. This representation is different from Fig. 10 due to the inversion of CP1 and CP2. Furthermore, CP3 is not represented, Credit HE-Arc CR, M-J.Scholl.
