SITULA EMT09-554.665 – TIN BRONZE – IRON AGE – SWITZERLAND

Artefact name	Situla EMT09-554.665
Authors	Christian. Degriigny (HE-Arc CR, Neuchâtel, Neuchâtel, Switzerland) & Marie-Jeanne. Scholl (HE-Arc CR, Neuchâtel, Neuchâtel, Switzerland) & Valentin. Boissonnas (HE-Arc CR, Neuchâtel, Neuchâtel, Switzerland)
Url	/artefacts/538/

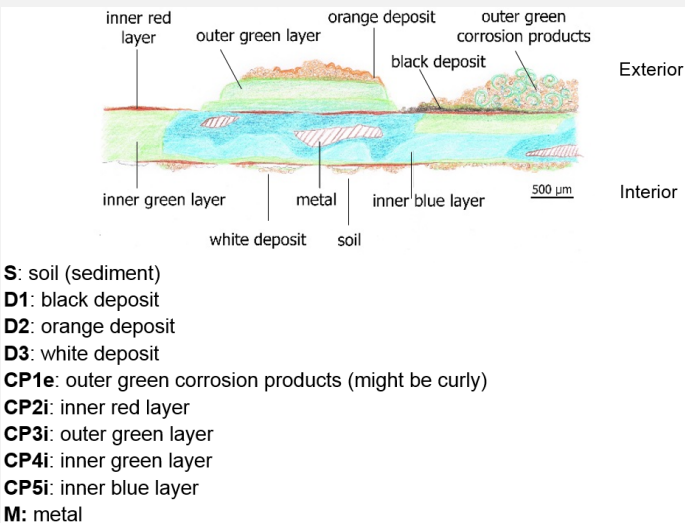
Fig. 3: Stratigraphic representation of the situla in cross-section by macroscopic observation,

The sample was cut from a detached fragment of the upper part of the main body of the situla in Fig. 2. The cross-section is representative of the entire thickness (0.5 mm) of the object's body where on the outside there is a thicker accumulation of corrosion including curly malachite clusters (Fig. 3). A metallic core is still present inside the corrosion products layers (Fig. 4).

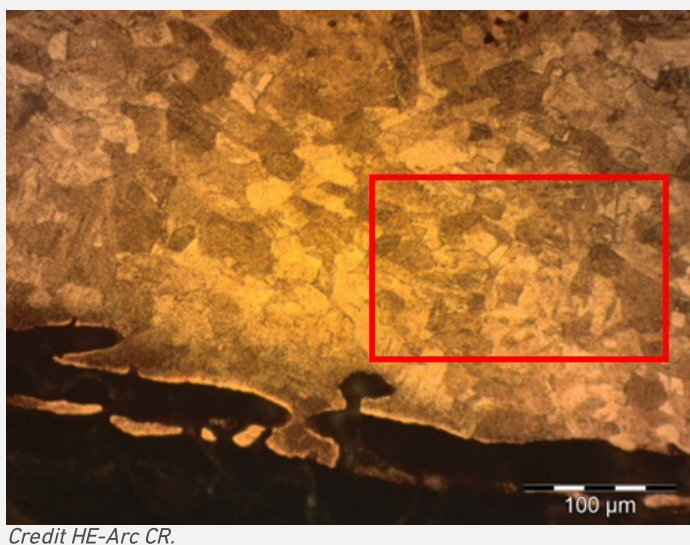
Fig. 8: Micrograph of the etched metal structure from Fig. 7 (detail), etched, bright field, 50x. The alpha phase of the alloy shows polygonal grains. Area of Fig. 9 is marked by a red rectangle,
