## SITULA EMT09-554.665 – TIN BRONZE – IRON AGE – SWITZERLAND

<b>Artefact name</b>	Situla EMT09-554.665
<b>Authors</b>	Christian. Degriigny (HE-Arc CR, Neuchâtel, Neuchâtel, Switzerland) & Marie-Jeanne. Scholl (HE-Arc CR, Neuchâtel, Neuchâtel, Switzerland) & Valentin. Boissonnas (HE-Arc CR, Neuchâtel, Neuchâtel, Switzerland)
<b>Url</b>	/artefacts/538/

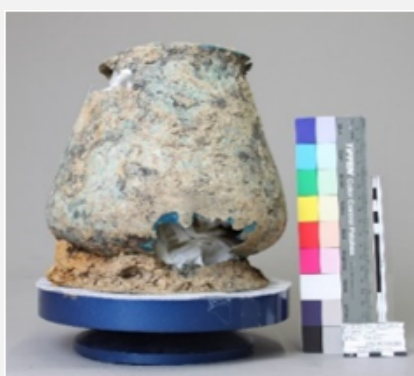
Fig. 1: Situla (Archeodunum (Gollion), 2009) inverted as found in situ,

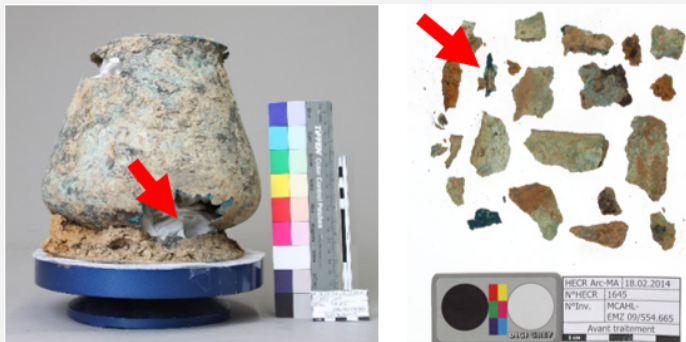
Fig. 2: Location of sampling area and sample selected from detached fragments,

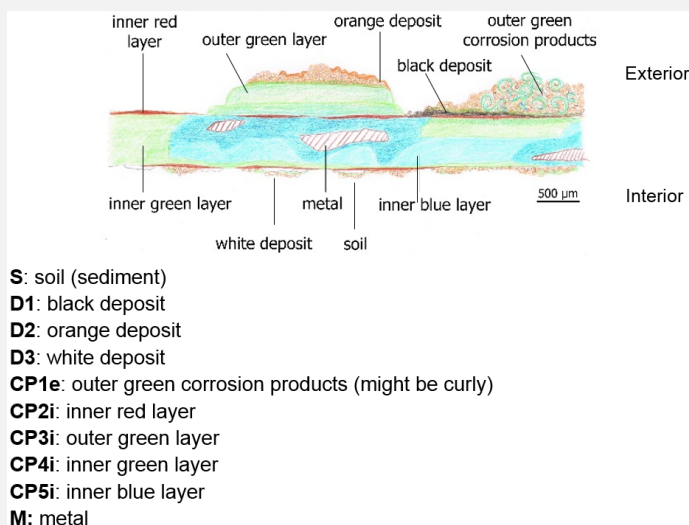
Fig. 3: Stratigraphic representation of the situla in cross-section by macroscopic observation,

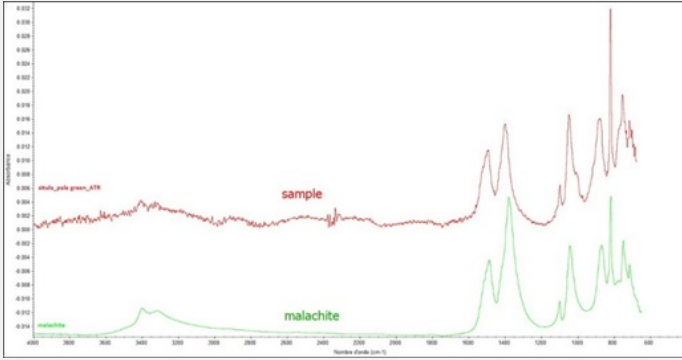
Fig. 15: FTIR spectrum (ATR mode) of the outer green layer compared to the malachite standard spectrum. Method of analysis: FTIR spectroscopy, HE-Arc CR.,

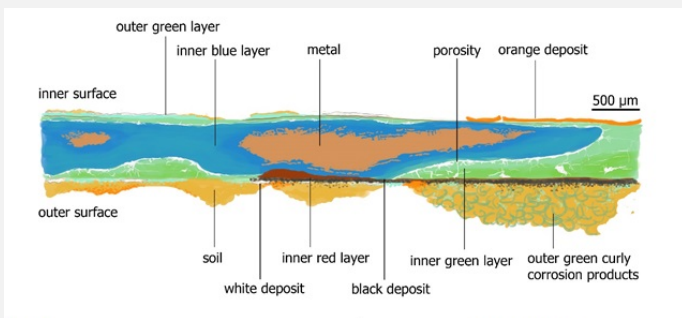
Fig. 16: Improved stratigraphic representation of the situla from visual observations and analyses,

Strata	Composition
Soil (S)	Ca, Si, Al, Fe
Black deposit (D1)	C
Orange deposit (D2)	Ferrous oxides
White deposit (D3)	Ca
Outer green curly corrosion product (CP1e)	Copper carbonates (curly malachite)
Inner red (CP2i)	Copper oxide (cuprite ?)
Outer green layer (CP3i)	Copper carbonates (malachite)
Inner green layer (CP4i)	Copper carbonates (?) + Sn
Inner blue layer (CP5i)	Copper carbonates (?) + Sn
Remnant metal phase (M)	Bronze (90%Cu, 10% Sn)
