# SITULA EMT09-554.665 – TIN BRONZE – IRON AGE – SWITZERLAND

**Artefact name** Situla EMT09-554.665

**Authors** Christian. Degrigny (HE-Arc CR, Neuchâtel, Neuchâtel, Switzerland) & Marie-Jeanne. Scholl (HE-Arc CR, Neuchâtel, Neuchâtel, Switzerland) & Valentin. Boissonnas (HE-Arc CR, Neuchâtel, Neuchâtel, Switzerland)

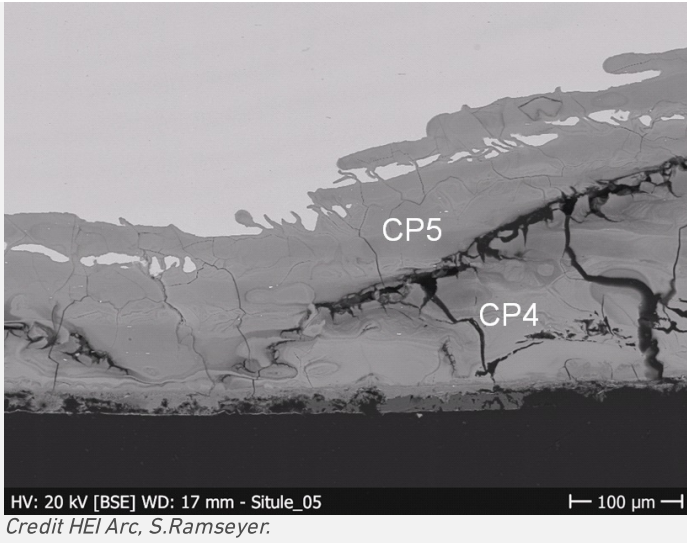
The corrosion crust is heterogeneous and has in places completely replaced the metal. The metal – corrosion products interface is irregular due to transgranular corrosion (Figs 7-8). In most cases, the corrosion crust can be divided in three main layers: an inner compact blue layer directly on the metal core (CP5, Figs. 6, 10 and 11 and CP3, Fig. 5). In areas of extensive corrosion this blue layer coexists with a friable green layer (CP4, Figs. 6, 10 and 11 and CP2, Fig. 5). Depending on the area either a very fine dark green (CP3, Fig. 6 and Fig. 10) or red corrosion layer (CP2, Fig. 6 and Fig. 10) marks the limit of the original surface. It is followed by an external fourth layer, consisting of friable and sometimes curly pale green corrosion products intermingled with soil products (CP1, Fig. 6 and Fig. 10 and 13). In heavily worked and fragile parts of the object a cleavage between the inner layers of blue and green corrosion is present, rendering the green corrosion vulnerable to loss (Fig. 11).

Fig. 11: SEM image, BSE-mode of the metal sample from Fig. 10 (detail) showing cleavage between the inner blue (CP5) and green (CP4) layers of Fig. 6,

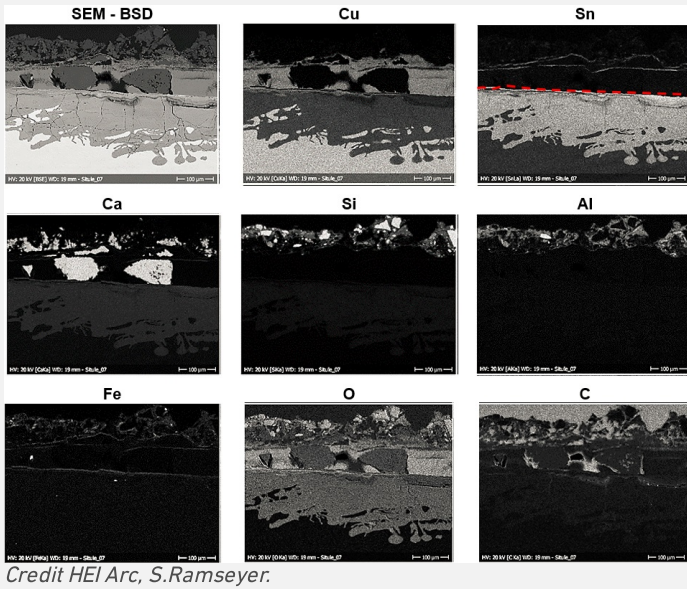
The inner layers (CP3-CP5) are Sn and O-rich and depleted in Cu (Table 2). The outer layers (CP1 and CP2) are Cu and O-rich, contain no Sn, and are contaminated with Ca, Si, Al and Fe coming from the soil (Fig. 12). The colour of the corrosion crust varies according to the content of Sn (the more Sn, the darker green or blue the corrosion). FTIR on the inner blue (CP5 and Fig. 14) and outer green (CP1 and Fig. 15) layers were difficult to interpret. Only malachite could be identified in both cases. XRD spectra could not be interpreted because of the deficiency of peaks.

The limit of the original surface is well defined (interface of CP1 and CP2) but due to the fragility of the inner corrosion layers it was difficult to uncover.

Fig. 12: SEM image, SE-mode, and elemental chemical distribution of the selected area of Fig. 10. In red: the limit of the original surface highlighted by the enriched tin layer. Method of examination: SEM-EDS, Lab of Electronic Microscopy and Microanalysis, IMA (Néode), HEI Arc,

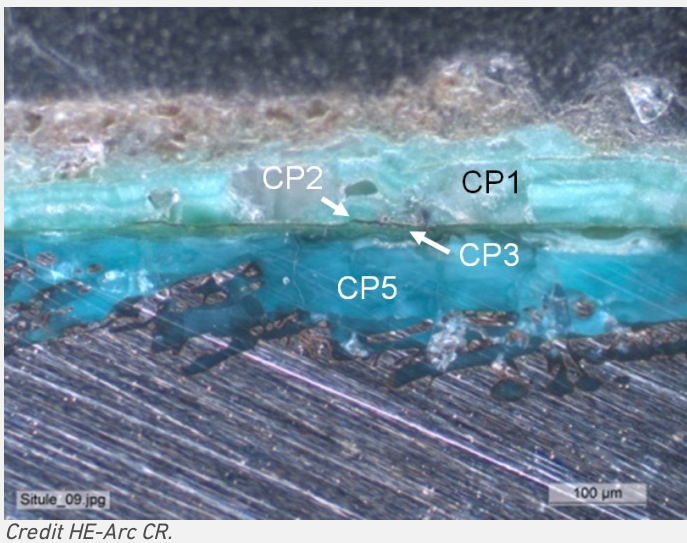
Fig. 13: Micrograph of the metal / corrosion interface (detail of Fig. 10) unetched, dark field, 100x. The outer layer (CP1 of Fig. 6) incorporates soil material and the thin dark layer (CP2 of Fig. 6) highlights the limit of the original surface,

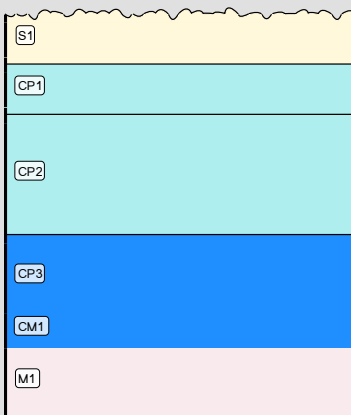
There are 2 stratigraphies (Fig. 5 corresponding to the interior face of the situla and Fig. 6 to its exterior face). The strata are similar in composition but their coding is different: CP1 to CP3 in Fig. 5 correspond to CP3 to CP5 in Fig. 6. Since the stratigraphy of Fig. 6 is more complete, the composition of each of its strata is given below.

Fig. 5: Stratigraphic representation of the sample taken from the detached fragment of the situla in cross-section using the MiCorr application. The characteristics of the strata are only accessible by clicking on the drawing that redirects you to the search tool by stratigraphy representation. This representation shows the exterior face and can be compared to Fig. 10 (bottom red rectangle), Credit HE-Arc CR, M-J.Scholl.

Fig. 6: Stratigraphic representation of the sample taken from the detached fragment of the situla in cross-section using the MiCorr application. The characteristics of the strata are only accessible by clicking on the drawing that redirects you to the search tool by stratigraphy representation. This representation shows the interior face and can be compared to Fig. 10 (top red rectangle), Credit HE-Arc CR, M-J.Scholl.
