SITULA EMT09/554.665 – TIN BRONZE – IRON AGE – SWITZERLAND

Artefact name	Situla EMT09/554.665
Authors	Christian. Degriigny (HE-Arc CR, Neuchâtel, Neuchâtel, Switzerland) & Marie-Jeanne. Scholl (HE-Arc CR, Neuchâtel, Neuchâtel, Switzerland) & Valentin. Boissonnas (HE-Arc CR, Neuchâtel, Neuchâtel, Switzerland)
Url	/artefacts/538/

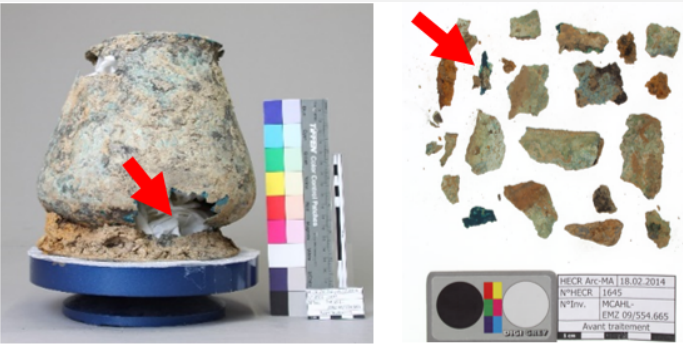
Fig. 2: Location of sampling area and sample selected from detached fragments,

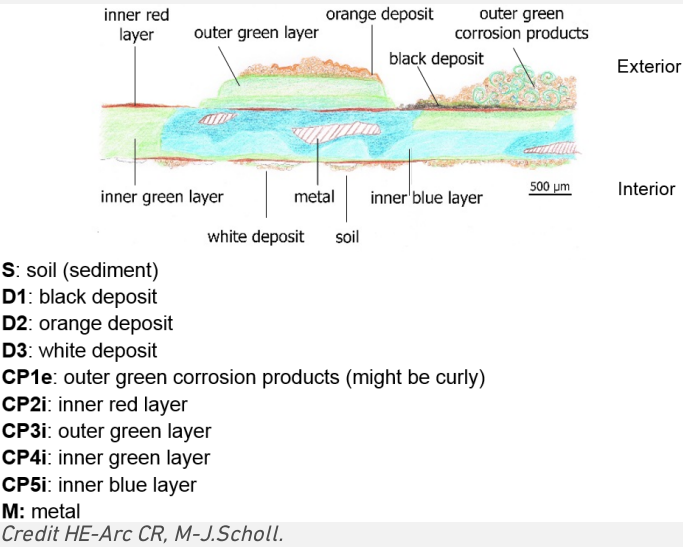
Fig. 3: Stratigraphic representation of the situla in cross-section by macroscopic observation,

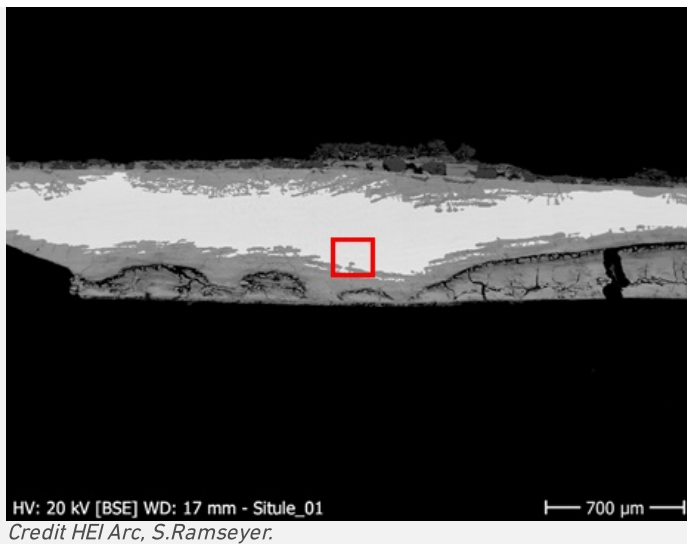
The remaining metal is a dense tin bronze (Fig. 7, Table 1), showing no inclusion. In bright field, the etched alloy shows a structure principally consisting of polygonal alpha phase grains (Fig. 8). Some of the grains include twin lines (Fig. 9). The presence of strain lines (slip lines) indicates a final cold work without annealing (Fig. 9).

Fig. 8: Micrograph of the etched metal structure from Fig. 7 (detail), etched, bright field, 50x. The alpha phase of the alloy shows polygonal grains. Area of Fig. 9 is marked by a red rectangle,

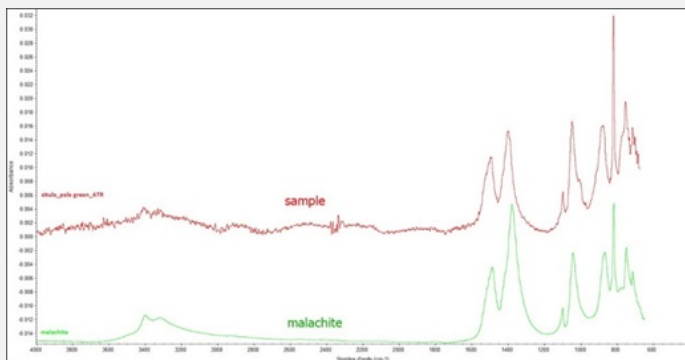
Fig. 15: FTIR spectrum (ATR mode) of the outer green layer compared to the malachite standard spectrum. Method of analysis: FTIR spectroscopy, HE-Arc CR.,

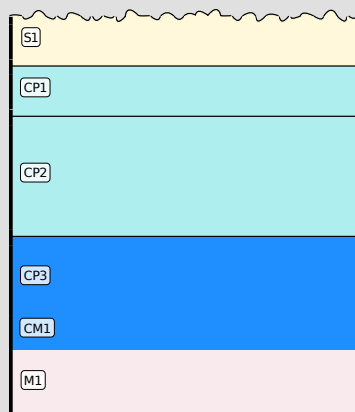
Fig. 5: Stratigraphic representation of the sample taken from the detached fragment of the situla in cross-section using the MiCorr application. The characteristics of the strata are only accessible by clicking on the drawing that redirects you to the search tool by stratigraphy representation. This representation shows the exterior face and can be compared to Fig. 10 (bottom red rectangle), Credit HE-Arc CR, M-J.Scholl.

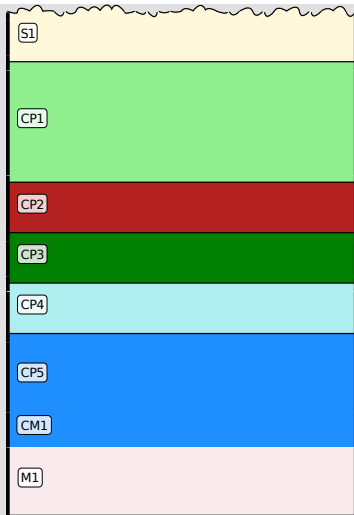
Fig. 6: Stratigraphic representation of the sample taken from the detached fragment of the situla in cross-section using the MiCorr application. The characteristics of the strata are only accessible by clicking on the drawing that redirects you to the search tool by stratigraphy representation. This representation shows the interior face and can be compared to Fig. 10 (top red rectangle), Credit HE-Arc CR, M-J.Scholl.

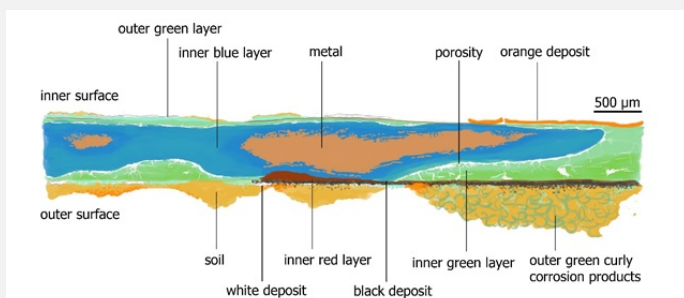
Fig. 16: Improved stratigraphic representation of the situla from visual observations and analyses,

Strata	Composition
Soil (S)	Ca, Si, Al, Fe
Black deposit (D1)	C
Orange deposit (D2)	Ferrous oxides
White deposit (D3)	Ca
Outer green curly corrosion product (CP1e)	Copper carbonates (curly malachite)
Inner red (CP2i)	Copper oxide (cuprite ?)
Outer green layer (CP3i)	Copper carbonates (malachite)
Inner green layer (CP4i)	Copper carbonates (?) + Sn
Inner blue layer (CP5i)	Copper carbonates (?) + Sn
Remnant metal phase (M)	Bronze (90%Cu, 10% Sn)
