SITULA EMT09-554.665 – TIN BRONZE – IRON AGE – SWITZERLAND

Artefact name	Situla EMT09-554.665
Authors	Christian. Degriigny (HE-Arc CR, Neuchâtel, Neuchâtel, Switzerland) & Marie-Jeanne. Scholl (HE-Arc CR, Neuchâtel, Neuchâtel, Switzerland) & Valentin. Boissonnas (HE-Arc CR, Neuchâtel, Neuchâtel, Switzerland)
Url	/artefacts/538/

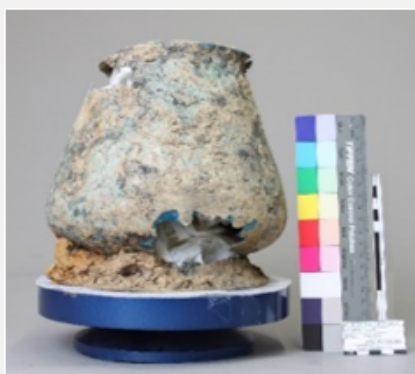
Fig. 1: Situla (Archeodunum (Gollion), 2009) inverted as found in situ,

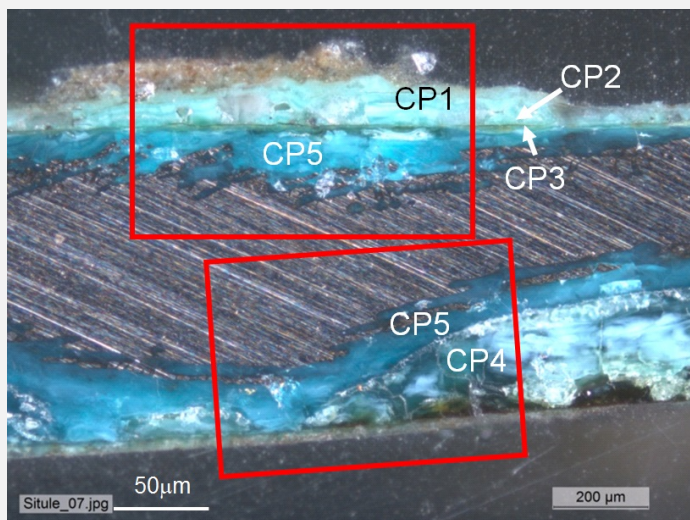
The corrosion crust is heterogeneous and has in places completely replaced the metal. The metal – corrosion products interface is irregular due to transgranular corrosion (Figs 7-8). In most cases, the corrosion crust can be divided in three main layers: an inner compact blue layer directly on the metal core (CP5, Figs. 6, 10 and 11 and CP3, Fig. 5). In areas of extensive corrosion this blue layer coexists with a friable green layer (CP4, Figs. 6, 10 and 11 and CP2, Fig. 5). Depending on the area either a very fine dark green (CP3, Fig. 6 and Fig. 10) or red corrosion layer (CP2, Fig. 6 and Fig. 10) marks the limit of the original surface. It is followed by an external fourth layer, consisting of friable and sometimes curly pale green corrosion products intermingled with soil products (CP1, Fig. 6 and Fig. 10 and 13). In heavily worked and fragile parts of the object a cleavage between the inner layers of blue and green corrosion is present, rendering the green corrosion vulnerable to loss (Fig. 11).

Fig. 10: Micrograph of the metal sample from Fig. 4, unetched, dark field, 50x. Areas of Fig. 11 (bottom, corresponding to the stratigraphy of Fig. 5) and Figs. 12 and 13 (top, corresponding to the stratigraphy of Fig. 6) are marked by a rectangle. Codes are those of Fig. 6.
