SITULA EMT09-554.665 – TIN BRONZE – IRON AGE – SWITZERLAND

Artefact name	Situla EMT09-554.665
Authors	Christian. Degrigny (HE-Arc CR, Neuchâtel, Neuchâtel, Switzerland) & Marie-Jeanne. Scholl (HE-Arc CR, Neuchâtel, Neuchâtel, Switzerland) & Valentin. Boissonnas (HE-Arc CR, Neuchâtel, Neuchâtel, Switzerland)
Url	/artefacts/538/

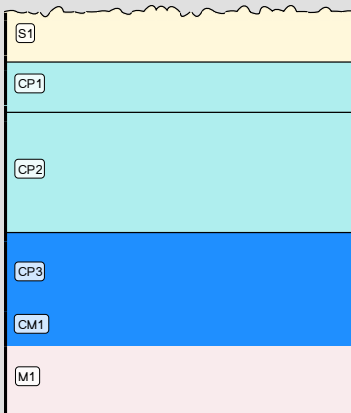
There are 2 stratigraphies (Fig. 5 corresponding to the interior face of the situla and Fig. 6 to its exterior face). The strata are similar in composition but their coding is different: CP1 to CP3 in Fig. 5 correspond to CP3 to CP5 in Fig. 6. Since the stratigraphy of Fig. 6 is more complete, the composition of each of its strata is given below.

Fig. 5: Stratigraphic representation of the sample taken from the detached fragment of the situla in cross-section using the MiCorr application. The characteristics of the strata are only accessible by clicking on the drawing that redirects you to the search tool by stratigraphy representation. This representation shows the exterior face and can be compared to Fig. 10 (bottom red rectangle), Credit HE-Arc CR, M-J.Scholl.

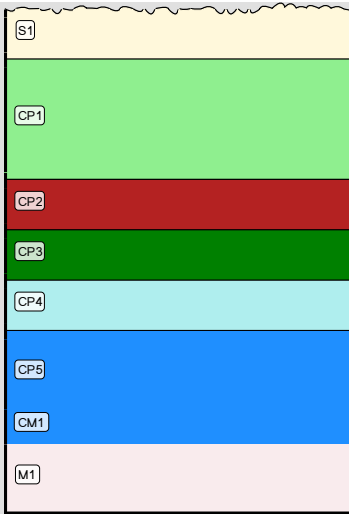
Fig. 6: Stratigraphic representation of the sample taken from the detached fragment of the situla in cross-section using the MiCorr application. The characteristics of the strata are only accessible by clicking on the drawing that redirects you to the search tool by stratigraphy representation. This representation shows the interior face and can be compared to Fig. 10 (top red rectangle), Credit HE-Arc CR, M-J.Scholl.

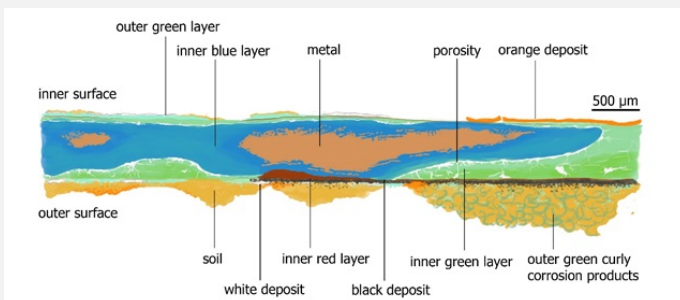
Fig. 16: Improved stratigraphic representation of the situla from visual observations and analyses,

Strata	Composition
Soil (S)	Ca, Si, Al, Fe
Black deposit (D1)	C
Orange deposit (D2)	Ferrous oxides
White deposit (D3)	Ca
Outer green curly corrosion product (CP1e)	Copper carbonates (curly malachite)
Inner red (CP2i)	Copper oxide (cuprite ?)
Outer green layer (CP3i)	Copper carbonates (malachite)
Inner green layer (CP4i)	Copper carbonates (?) + Sn
Inner blue layer (CP5i)	Copper carbonates (?) + Sn
Remnant metal phase (M)	Bronze (90%Cu, 10% Sn)
