## SHINGLE OF A ROOF - CU ALLOY - MODERN TIMES - SWITZERLAND

**Artefact name** Shingle of a roof

**Authors** Marianne. Senn (EMPA, Dübendorf, Zurich, Switzerland) & Christian. Degrigny (HE-Arc CR, Neuchâtel, Neuchâtel, Switzerland)

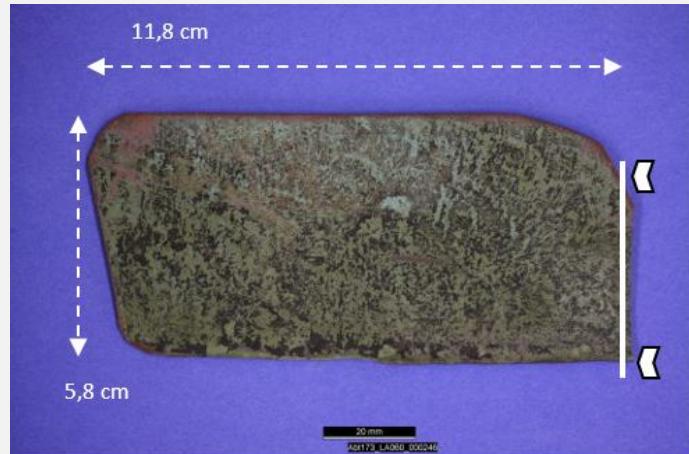
Fig. 2: showing the location of sampling area,

Two samples were taken (Fig. 2). The polished samples show a well-preserved metal surface with a thin corrosion crust (Fig. 3). T = 0.5mm.

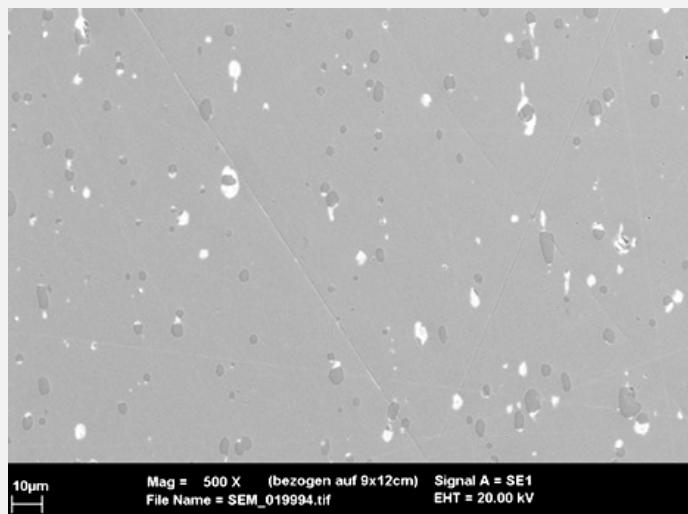
The remaining metal is a copper alloy (Table 1). The evenly distributed inclusions observed under SEM, SE-mode, are either light-grey or white (Fig. 5). The oval shape of the light-grey inclusions is due to deformation, probably by hot rolling (a common technique in the 18th century). Under polarised light they look red (Fig. 7) and their analysis reveals a composition similar to cuprite/Cu<sub>2</sub>O (Table 2). The white inclusions are rich in Pb and are remnants of the refining process (Table 2). The etched copper shows a structure of polygonal and twinned grains (Fig. 6). The grain size is variable. The average hardness of the metal is about HV1 70.

Table 2: Chemical composition (mass %) of the inclusions in the metal (from Fig. 5). Method of analysis: SEM/EDS, Laboratory of Analytical Chemistry, Empa.

Fig. 5: SEM image, SE-mode, of the metal sample from Fig. 3 (detail). Light-grey and white inclusions are distributed evenly,

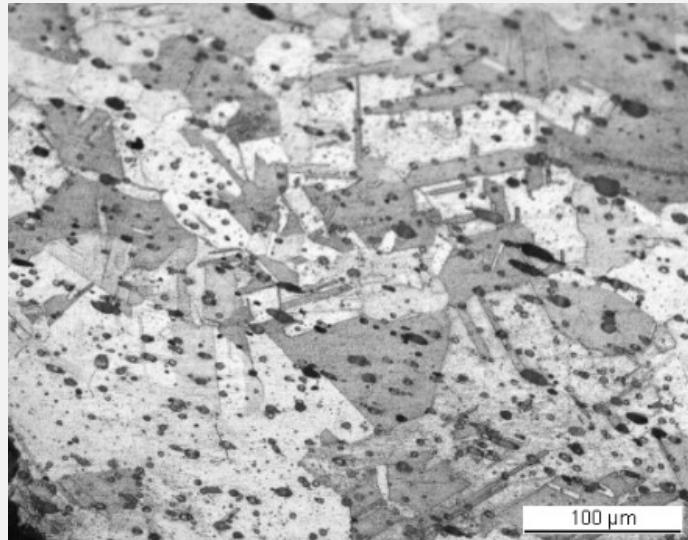
Fig. 6: Micrograph of the metal sample from Fig. 3 (detail), etched, bright field. The metal shows a structure of polygonal and twinned grains. Cuprite inclusions appear as dark spots,

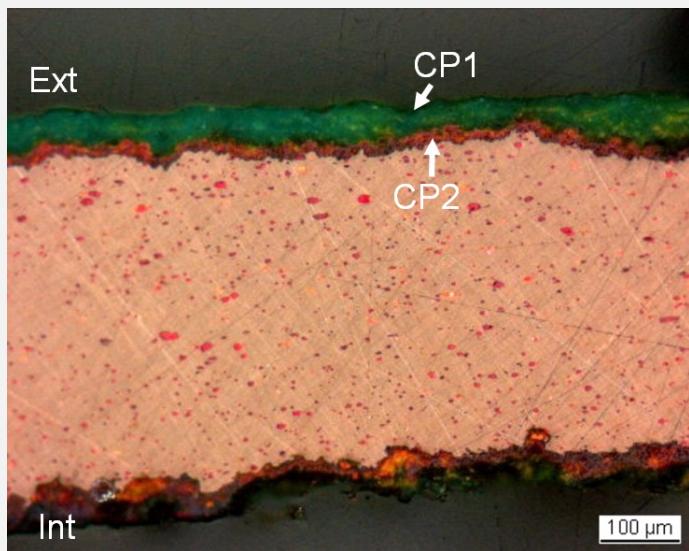
The corrosion crusts of the external and internal sides are distinctively different (Fig. 7). On the internal side an irregular red-orange corrosion layer has developed, and pitting corrosion has occurred. The more uniform corrosion layers on the external side are composed of a red-orange layer, followed by a thicker green outer layer. In some areas, dark-red corrosion products can be observed between the green and red-orange sub-layers. The same dark-red sub-layer can be seen in areas on the internal side covering the red-orange corrosion products. The red-orange corrosion layer on both sides (CP2) has a chemical composition similar to cuprite/Cu<sub>2</sub>O, while the green layer on the external side (CP1) contains Cu, S and O and is enriched on its upper surface with Si (Table 3 and Fig. 8). XRD analysis of the corrosion products on the external side of another shingle fragment from the same roof identified brochantite/Cu<sub>4</sub>SO<sub>4</sub>(OH)<sub>6</sub> and cuprite as corrosion products (Rapport d'analyse no. MAH 98-257). These results are confirmed by Raman spectroscopy of the external side of this sample where the same compounds were clearly identified (Figs. 9 and 10).

Fig. 7: Micrograph of the metal sample from Fig. 3 and corresponding to the stratigraphy of Fig. 4, polarised light. External side: the regular corrosion crust with outer green, inner red-orange corrosion products and intermediate dark-red corrosion products. Internal side: the irregular corrosion crust with inner red-orange and outer dark-red corrosion products,

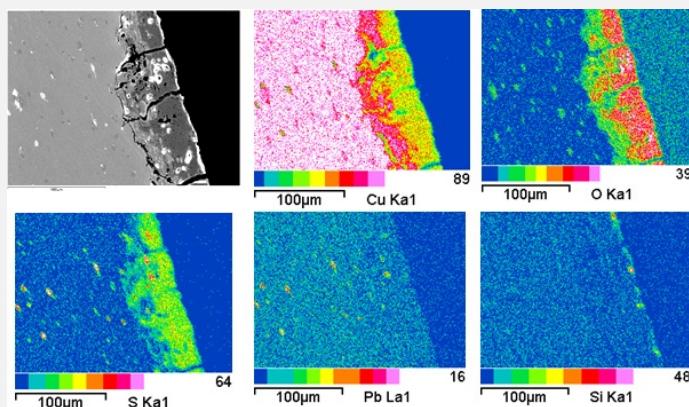
Fig. 8: SEM image, SE-mode, and elemental chemical distribution of the selected area of Fig. 3 (rotated image, detail). Method of examination: SEM/EDS, Laboratory of Analytical Chemistry, Empa,

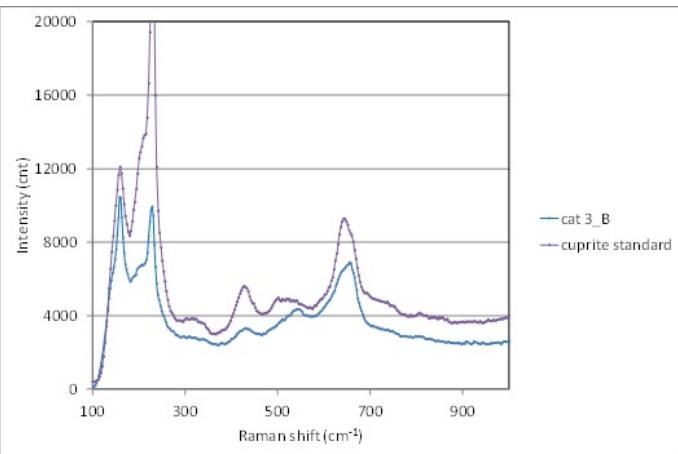
Fig. 9: Raman spectrum of the red-orange inner corrosion layer (CP2) of the external side (cat3\_B) compared to a cuprite standard spectrum. Settings: laser wavelength 532nm, acquisition time 100s, one accumulation, filter D2 (0.75–0.8 mW), hole 500, slit 80, grating 600. Method of analysis: Raman spectroscopy, Lab Swiss National Museum, Affoltern a. Albis ZH,

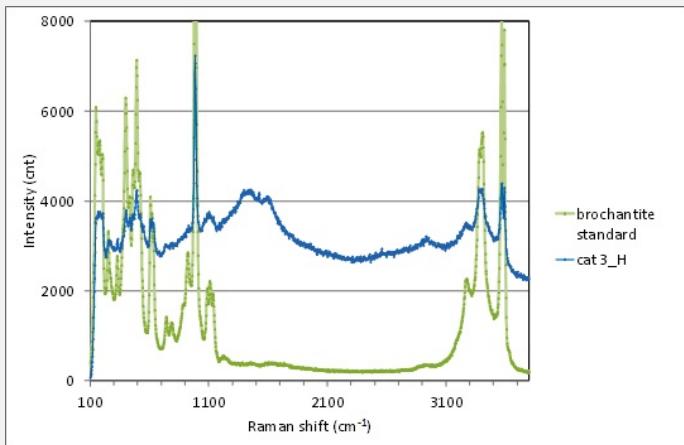
Fig. 10: Raman spectrum of the green outer corrosion layer (CP1) of the external side (cat3\_H) compared to a brochantite standard spectrum. Settings: laser wavelength 532nm, acquisition time 100s, one accumulation, filter D2 (0.75–0.8 mW), hole 500, slit 80, grating 600. The peak indicated with an arrow on the cat3\_H spectrum is due to fluorescence. Method of analysis: Raman spectroscopy, Lab Swiss National Museum, Affoltern a. Albis ZH,

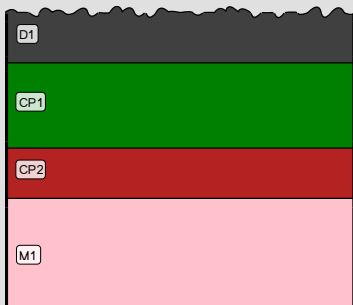
Fig. 4: Stratigraphic representation of the sample taken from the shingle in cross-section using the MiCorr application. The characteristics of the strata are only accessible by clicking on the drawing that redirects you to the search tool by stratigraphy representation. This representation can be compared to Fig. 7, Credit HE-Arc CR.
