SHINGLE OF A ROOF – CU ALLOY – MODERN TIMES – SWITZERLAND

Artefact name	Shingle of a roof
Authors	Marianne. Senn (EMPA, Dübendorf, Zurich, Switzerland) & Christian. Degriany (HE-Arc CR, Neuchâtel, Neuchâtel, Switzerland)
Url	/artefacts/540/

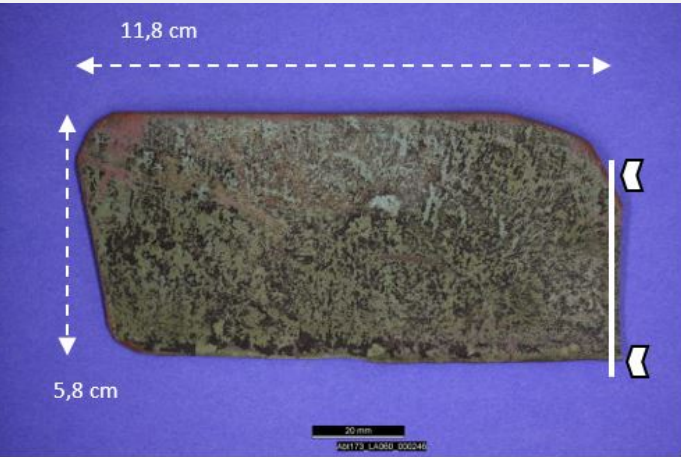
Fig. 2: showing the location of sampling area,

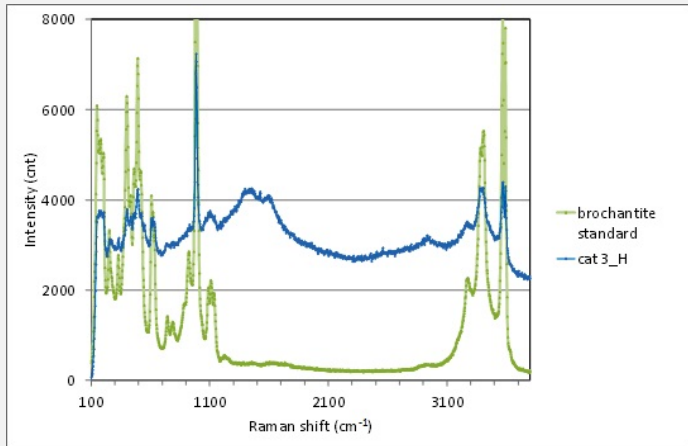
Fig. 10: Raman spectrum of the green outer corrosion layer (CP1) of the external side (cat3_H) compared to a brochantite standard spectrum. Settings: laser wavelength 532nm, acquisition time 100s, one accumulation, filter D2 (0.75-0.8 mW), hole 500, slit 80, grating 600. The peak indicated with an arrow on the cat3_H spectrum is due to fluorescence. Method of analysis: Raman spectroscopy, Lab Swiss National Museum, Affoltern a. Albis ZH,

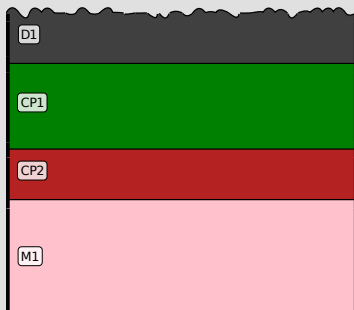
Fig. 4: Stratigraphic representation of the sample taken from the shingle in cross-section using the MiCorr application. The characteristics of the strata are only accessible by clicking on the drawing that redirects you to the search tool by stratigraphy representation. This representation can be compared to Fig. 7, Credit HE-Arc CR.
