# FITTING ON BACK PANEL OF A MILITARY CARRIAGE – THOMAS STEEL – MODERN TIMES – SWITZERLAND

Artefact name Fitting on back panel of a military carriage

Authors Marianne. Senn (EMPA, Dübendorf, Zurich, Switzerland) & Christian. Degrigny (HE-Arc CR, Neuchâtel, Neuchâtel,

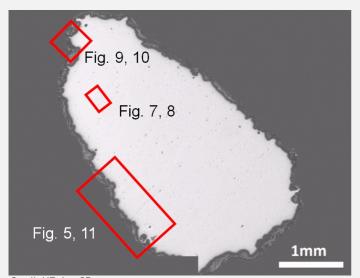
Fig. 3: Micrograph of the cross-section of the sample taken from the fitting showing the location of Figs. 5 and 7 to 11,  $\,$

covered by a thin corrosion layer (Fig. 3).

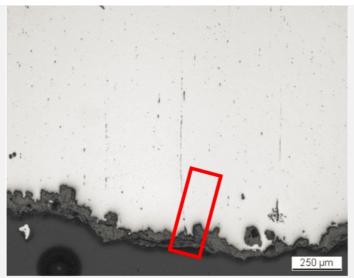
The remaining metal is a Mn-rich soft steel (C content around 0.1 mass%) containing manganese sulphide inclusions with a varying Fe content (Tables 1 and 2). The numerous inclusions form parallel rows (Fig. 5). This orientation is typical for hot rolled metal. After etching with Oberhoffer's reagent, three main welding seams (P-rich) become visible (Fig. 6). Near the surface they are also outlined by corrosion (Figs. 5 and 11). After nital etching, the metal shows a ferritic structure with tertiary cementite and lamellar pearlite at the grain boundaries (Figs. 7 and 8). The grains are small with an ASTM grain size of 10 and are recrystallized due to annealing after hot rolling. The average hardness of the metal is HV1 165. The hardness is slightly high for such a structure and this is due to the Mn content of the metal. The chemical composition, especially the Mn content and the presence of carbo-nitrides (not analysed here), is typical for Thomas steel.

Fig. 5: Micrograph of the metal sample from Fig. 3 (rotated by 270°, detail), unetched, bright field. We observe the metal including welding seams outlined by corrosion products and MnS inclusions. The area selected for elemental chemical distribution (Fig. 11) is marked by a red rectangle,

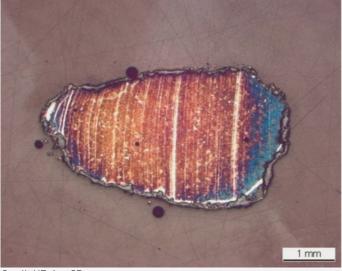
Fig. 6: Micrograph of the metal sample from Fig. 3, etched with Oberhoffer's reagent, bright field. We observe three P-rich welding seams in white,

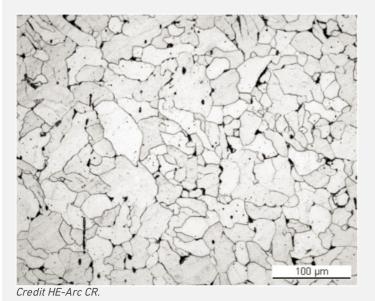
Fig. 7: Micrograph of the metal sample, nital etched, bright field. We observe tertiary cementite (black) on the grain boundaries,

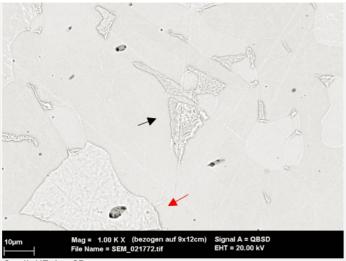
Fig. 8: SEM image of the metal sample from Fig. 3 (detail), BSE-mode, nital etched, bright field. The white ferrite grains contain lamellar pearlite (black arrow) and lenticular grey MnS inclusions (red arrow) in between the grain boundaries,

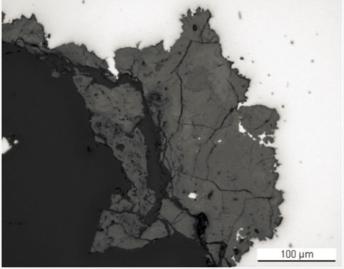
The average thickness of the corrosion products is about 80µm (Figs. 5 and 9). In bright field they appear grey, marbled and heavily cracked (Fig. 9). Under polarised light, the corrosion products appear orange to dark-brown (Fig. 10). At the metal - corrosion products interface they are dark-brown (CP3). The middle part (CP2) is red-orange and the outer part is bright orange (CP1). The elemental mapping of the corrosion layers shows no distinctive stratification, but areas near the metal - corrosion crust interface (CP3) as well as the top surface of the corrosion layer (CP1) seem to have a lower 0 content (Fig. 11). The 0 content indicates the presence of iron hydroxides (Table 3). Soil materials (such as rock fragments and dust) are found in the welding seams near the surface.

Fig. 9: Micrograph showing the metal - corrosion crust interface from Fig. 3 (rotated by  $270^{\circ}$ , detail), unetched, bright field. We observe in white the metal, in grey the corrosion products and in black the resin,

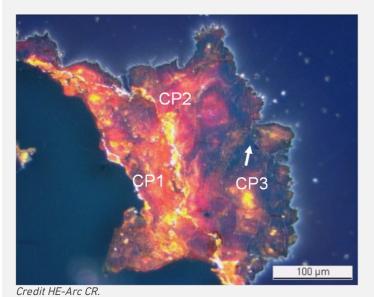
Fig. 10: Micrograph showing the metal - corrosion crust (same as Fig. 9) and corresponding to the stratigraphy of Fig. 4, unetched, polarised light. The corrosion products are dark-brown at the metal - corrosion crust interface and red-orange on the outside,

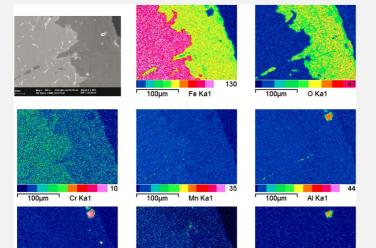
Table 3: Chemical composition (mass %) of the corrosion layer (from Fig. 11). Method of analysis: SEM/EDS, Laboratory of Analytical Chemistry, Empa.

Fig. 11: SEM image, BSE-mode, and elemental chemical distribution of the selected area from Fig. 5 (rotated by  $270^\circ$ , detail). Method of examination: SEM/EDS, Laboratory of Analytical Chemistry, Empa.
