# ROOF GUTTER ELEMENT – ZN ALLOY – MODERN TIMES – FRANCE

**Artefact name** Roof gutter element

**Authors** Christian. Degrigny (HE-Arc CR, Neuchâtel, Neuchâtel, Switzerland) & Mathea. Hovind (University of Oslo, Department of archaeology, conservation and history (IAKH-UiO), Oslo, Oslo, Norway)

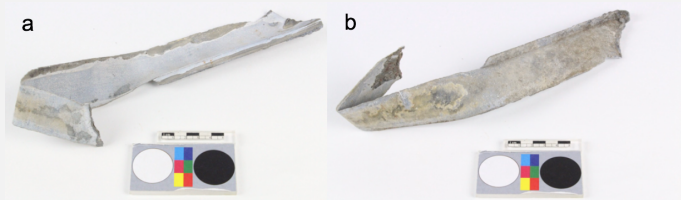
Fig. 1: Roof gutter element having different appearances on each of its surfaces: "a" on the left and "b" on the right,

<b>Description of the artefact</b>	A roof gutter element with remains of lead solder (Fig. 1). Its surfaces are covered by a white, strongly adherent oxide layer. Surface "b" is slightly darker in colour than surface "a" due to the presence of soil particles. Dimensions: L = 265mm; W = 47mm; T = 1mm; WT = 93g.
<b>Type of artefact</b>	Architectural element
<b>Origin</b>	Château de Germolles (14th century), Mellecey, Bourgogne, France
<b>Recovering date</b>	Unknown
<b>Chronology category</b>	Modern Times
<b>chronology tpq</b>	<input type="text" value="1900"/> A.D. ▼
<b>chronology taq</b>	<input type="text" value="2000"/> A.D. ▼
<b>Chronology comment</b>	19th-20th century
<b>Burial conditions / environment</b>	Outdoor atmosphere
<b>Artefact location</b>	Haute Ecole Arc Conservation-Restauration
<b>Owner</b>	Château de Germolles, Mellecey, Bourgogne
<b>Inv. number</b>	None
<b>Recorded conservation data</b>	Not conserved

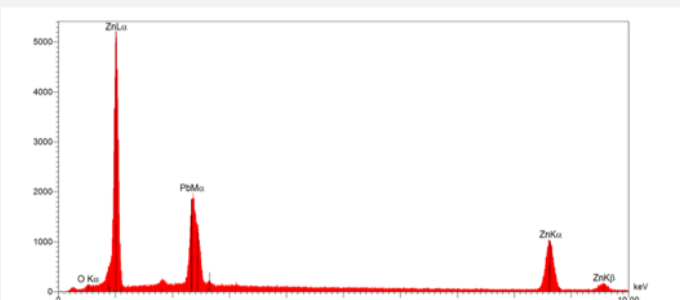
Fig. 10: SEM-EDS spectrum showing the composition of the elongated inclusions from Fig. 9. Method of analysis: SEM-EDS. Lab. of Electronic Microscopy and Microanalysis, Néode, HEI Arc,

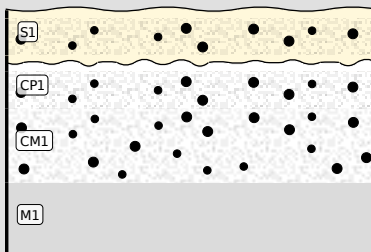
Fig. 5: Stratigraphic representation of the sample taken from the roof gutter (surface "b") in cross-section using the MiCorr application. The characteristics of the strata are only accessible by clicking on the drawing that redirects you to the search tool by stratigraphy representation. This representation can be compared to Figs. 11 and 12, Credit UiO-IAKH, M.Hovind.
