# ROOF GUTTER ELEMENT – ZN ALLOY – MODERN TIMES – FRANCE

Artefact name	Roof gutter element
Authors	Christian. Degrigny (HE-Arc CR, Neuchâtel, Neuchâtel, Switzerland) & Mathea. Hovind (University of Oslo, Department of archaeology, conservation and history (IAKH-UiO), Oslo, Oslo, Norway)
Url	/artefacts/543/

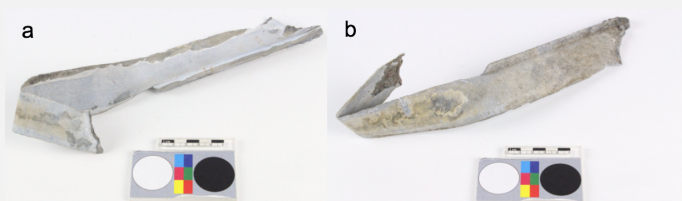
Fig. 1: Roof gutter element having different appearances on each of its surfaces: "a" on the left and "b" on the right,

Description of the artefact	A roof gutter element with remains of lead solder (Fig. 1). Its surfaces are covered by a white, strongly adherent oxide layer. Surface "b" is slightly darker in colour than surface "a" due to the presence of soil particles. Dimensions: L = 265mm; W = 47mm; T = 1mm; WT = 93g.		
Type of artefact	Architectural element		
Origin	Château de Germolles, Mellecey, Bourgogne, France		
Recovering date	Unknown		
Chronology category	Modern Times		
chronology tpq	1900	A.D.	▼
chronology taq	2000	A.D.	▼
Chronology comment	19th-20th century		
Burial conditions / environment	Outdoor atmosphere		
Artefact location	Haute Ecole Arc Conservation-Restauration		
Owner	Château de Germolles, Mellecey, Bourgogne		
Inv. number	None		
Recorded conservation data	Not conserved

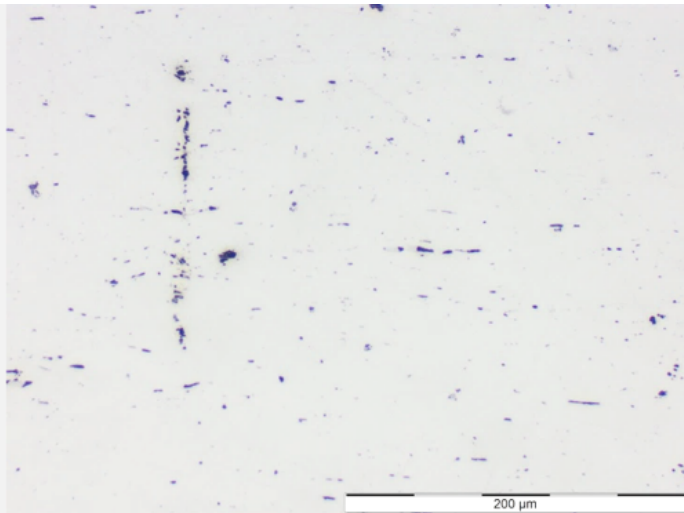
The metal appears white to light grey under bright field (Fig. 7). Under polarized light however (Fig. 8), the microstructure of the metal is visible as small polygonal grains appearing in various shades of brown, a coloured effect due to the anisotropic properties of the metal (Scott 1991: 49). In the SEM-image, white elongated inclusions are visible (Fig. 9) consisting mainly of Zn and Pb with some O (Fig. 10).

Fig. 7: Micrograph of the metal sample from Fig. 4 (detail). Unetched, bright field,

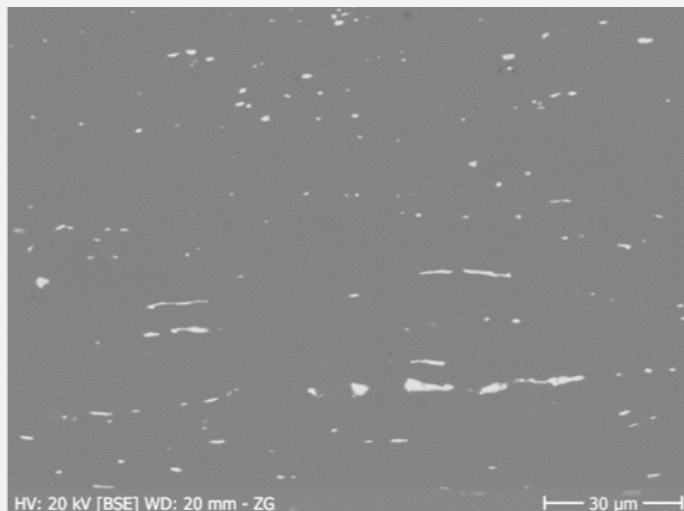
Fig. 9: SEM-image (BSE-mode) of the metal sample from Fig. 4 (detail) showing the white elongated inclusions,

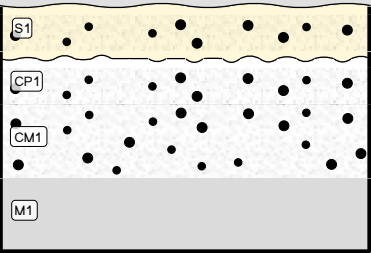
Fig. 5: Stratigraphic representation of the sample taken from the roof gutter (surface "b") in cross-section using the MiCorr application. The characteristics of the strata are only accessible by clicking on the drawing that redirects you to the search tool by stratigraphy representation. This representation can be compared to Figs. 11 and 12, Credit UiO-IAKH, M.Hovind.
