ROOF GUTTER ELEMENT – ZN ALLOY – MODERN TIMES – FRANCE

Artefact name	Roof gutter element
Authors	Christian. Degrigny (HE-Arc CR, Neuchâtel, Neuchâtel, Switzerland) & Mathea. Hovind (University of Oslo, Department of archaeology, conservation and history (IAKH-UiO), Oslo, Oslo, Norway)
Url	/artefacts/543/

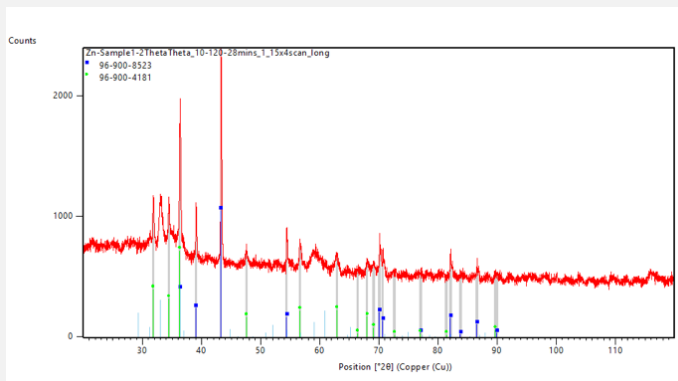
Table 2: Summary of the results from the crystallographic analysis of the white corrosion product (CP1). A representative spectrum is given in Fig. 13. Method of analysis: XRD. Center of X-ray Analytics, Empa-Swiss Federal Laboratories for Materials Science and Technology (Dübendorf), credit MiCorr_Empa, Z.Balogh-Michels. *The results are based on the analysis of two powder samples from different areas (see Fig. 2 for sample locations).

Fig. 13: XRD-spectrum for the analysis of powder sample 1. Ref. 96-900-8523 (in blue) corresponds to pure zinc and 96-900-4181 (in green) to zincite (ZnO),

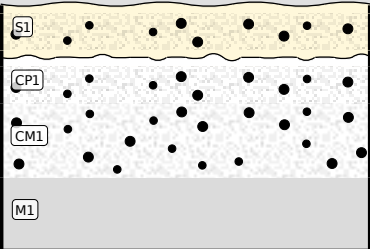
Fig. 5: Stratigraphic representation of the sample taken from the roof gutter (surface "b") in cross-section using the MiCorr application. The characteristics of the strata are only accessible by clicking on the drawing that redirects you to the search tool by stratigraphy representation. This representation can be compared to Figs. 11 and 12, Credit UiO-IAKH, M.Hovind.
