## ROOF GUTTER ELEMENT – ZN ALLOY – MODERN TIMES – FRANCE

<b>Artefact name</b>	Roof gutter element
<b>Authors</b>	Christian. Degrigny (HE-Arc CR, Neuchâtel, Neuchâtel, Switzerland) & Mathea. Hovind (University of Oslo, Department of archaeology, conservation and history (IAKH-UiO), Oslo, Oslo, Norway)
<b>Url</b>	/artefacts/543/

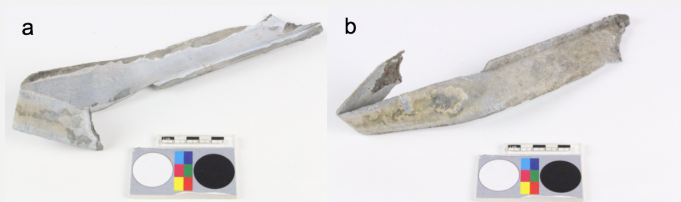
Fig. 1: Roof gutter element having different appearances on each of its surfaces: "a" on the left and "b" on the right,

<b>Description of the artefact</b>	A roof gutter element with remains of lead solder (Fig. 1). Its surfaces are covered by a white, strongly adherent oxide layer. Surface "b" is slightly darker in colour than surface "a" due to the presence of soil particles. Dimensions: L = 265mm; W = 47mm; T = 1mm; WT = 93g.
<b>Type of artefact</b>	Architectural element
<b>Origin</b>	Château de Germolles (14th century), Mellecey, Bourgogne, France
<b>Recovering date</b>	Unknown
<b>Chronology category</b>	Modern Times
<b>chronology tpq</b>	<input type="text" value="1900"/> A.D. ▾
<b>chronology taq</b>	<input type="text" value="2000"/> A.D. ▾
<b>Chronology comment</b>	19th-20th century
<b>Burial conditions / environment</b>	Outdoor atmosphere
<b>Artefact location</b>	Haute Ecole Arc Conservation-Restauration
<b>Owner</b>	Château de Germolles, Mellecey, Bourgogne
<b>Inv. number</b>	None
<b>Recorded conservation data</b>	Not conserved

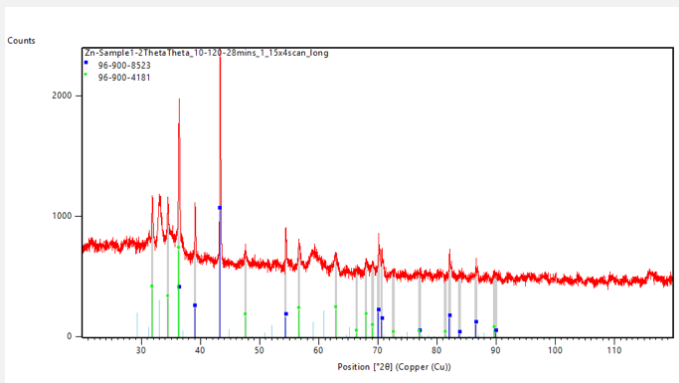
Table 2: Summary of the results from the crystallographic analysis of the white corrosion product (CP1). A representative spectrum is given in Fig. 13. Method of analysis: XRD. Center of X-ray Analytics, Empa-Swiss Federal Laboratories for Materials Science and Technology (Dübendorf), credit MiCorr\_Empa, Z.Balogh-Michels. \*The results are based on the analysis of two powder samples from different areas (see Fig. 2 for sample locations).

Fig. 13: XRD-spectrum for the analysis of powder sample 1. Ref. 96-900-8523 (in blue) corresponds to pure zinc and 96-900-4181 (in green) to zincite (ZnO),

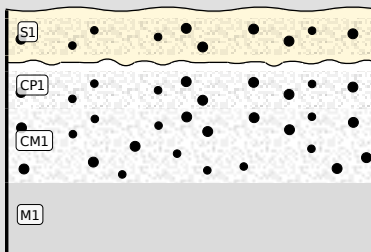
Fig. 5: Stratigraphic representation of the sample taken from the roof gutter (surface "b") in cross-section using the MiCorr application. The characteristics of the strata are only accessible by clicking on the drawing that redirects you to the search tool by stratigraphy representation. This representation can be compared to Figs. 11 and 12, Credit UiO-IAKH, M.Hovind.
