FRAGMENT OF AN AEGIS OF NEÏTH 1886.305.0096 – LEADED BRONZE

Artefact name Fragment of an Aegis of Neïth 1886.305.0096

Authors Line. Pedersen (HE-Arc, Neuchâtel, Neuchâtel, Switzerland) & Christian. Degrigny (HE-Arc CR, Neuchâtel, Neuchâtel, Switzerland) & Valentin. Boissonnas (HE-Arc CR, Neuchâtel, Neuchâtel, Switzerland)

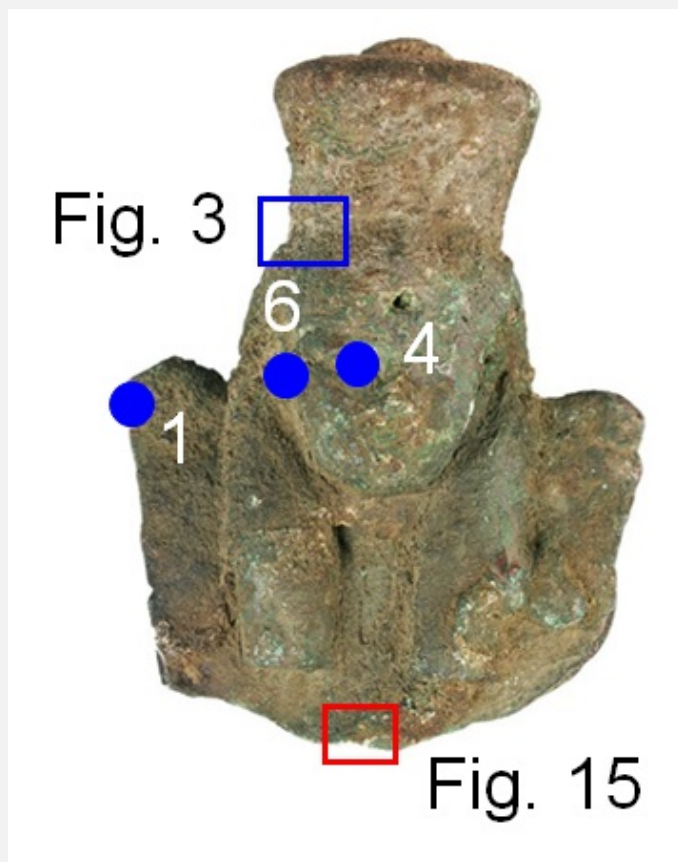
Fig. 2: Front face of the aegis with location of XRF measurements (blue spots), powder sample (red square) and gilding remains on the surface (blue square),

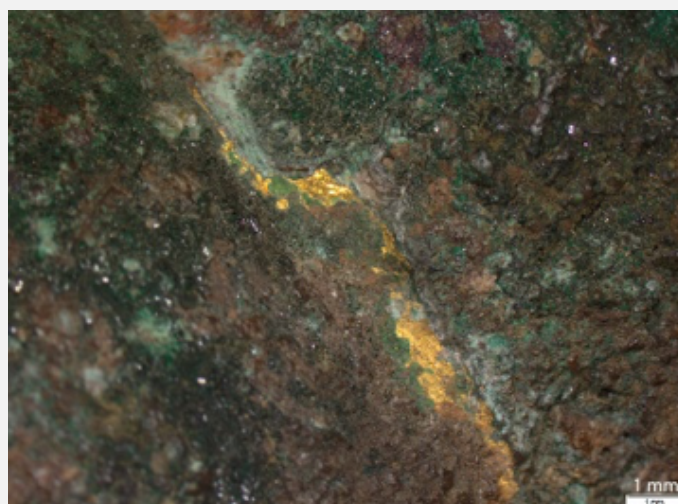
Fig. 3: Remains of foil-gilding on the corroded surface,

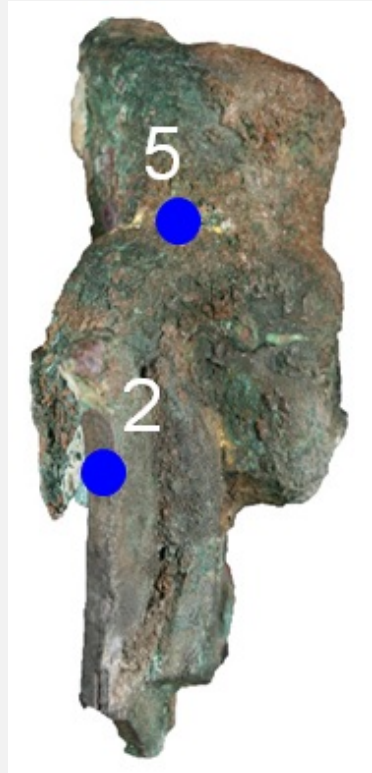
Fig. 4: Side view of the aegis with location of XRF measurements (blue spots),

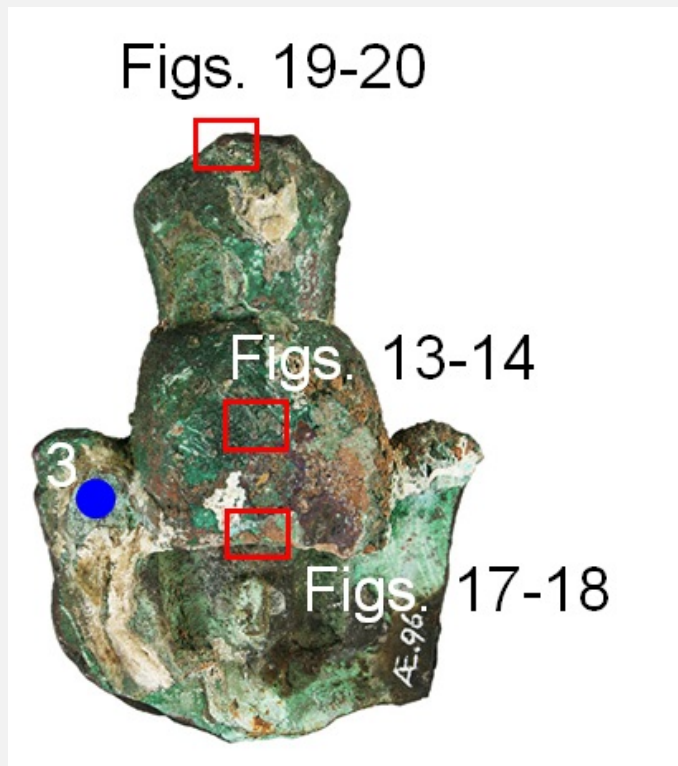
Fig. 5: Back face of the aegis with location of XRF measurement (blue spot) and powder samples (red squares),

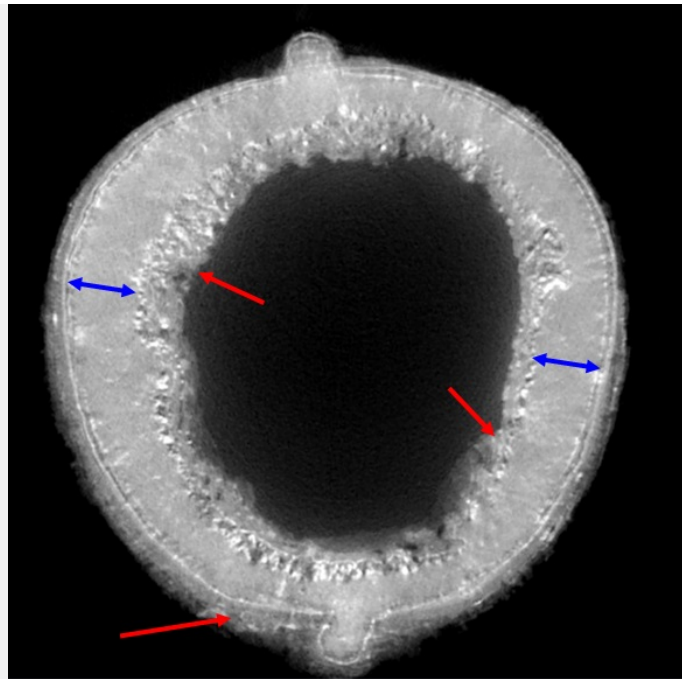
As indicated by the X-ray tomography, the metal of the aegis seems to be well preserved (Figs. 11-12). The metal (M2 in Fig.9 and M1 in Fig. 10) was analysed on the broken edge of the bottom of the artefact where despite a highly corroded surface, the metal seems to be the best preserved. The XRF analyses revealed that the metal is a leaded bronze with remains of gold leaf on the surface (Table 1, Au was detected in the measurement spots 4,5 and 6) (Scott 2002; Gouda 2012; Mohammed 2012).

Fig. 11: X-ray tomography by cross section of the crown showing a dense and non-porous metal core (blue arrows). The corrosion products however are porous (red arrows). The

external limitos is visible as a fine line preserved under corrosion layers,

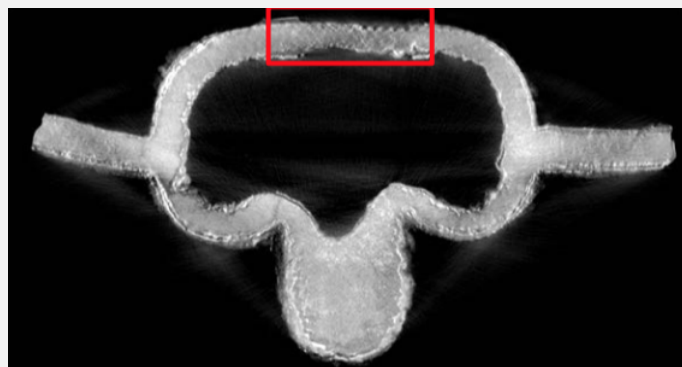
Fig. 12: X-ray tomography by cross section of the lower part showing that there are losses of the original surface (red square),

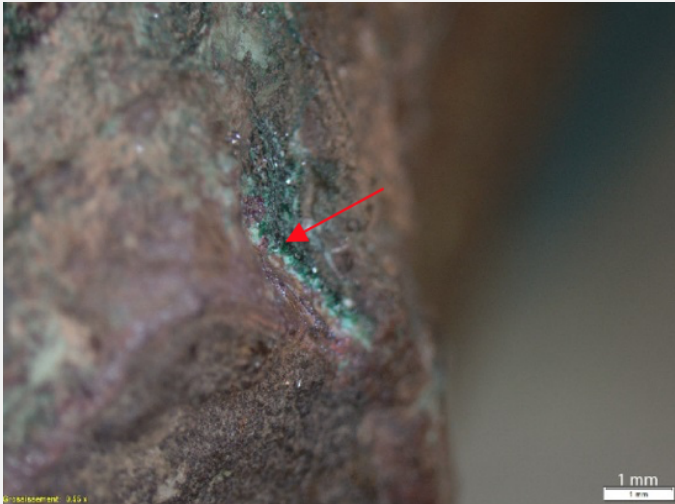
Fig. 13: Observation of the dark green corrosion product,

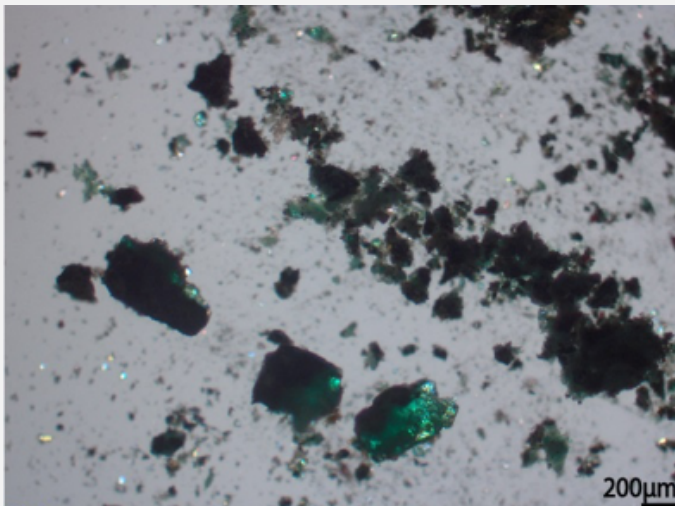
Fig. 14: Dark green corrosion product identified as paratacamite, atacamite $\text{Cu}_2\text{Cl}(\text{OH})_3$ by XRD. Microscopic examination under polarized light,

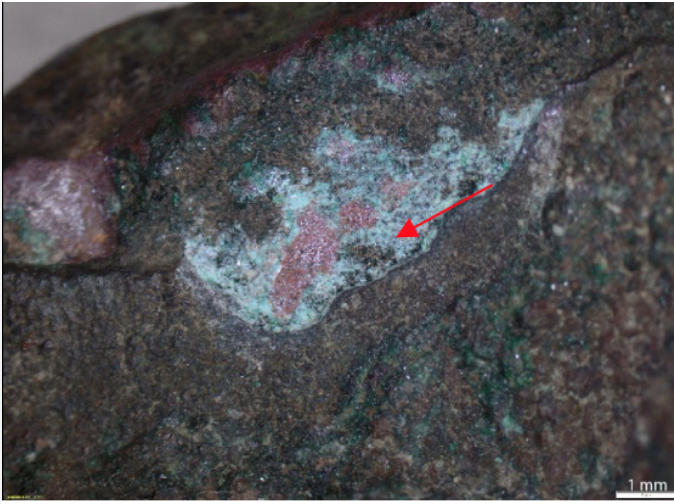
Fig. 15: Observation of the light green corrosion product,

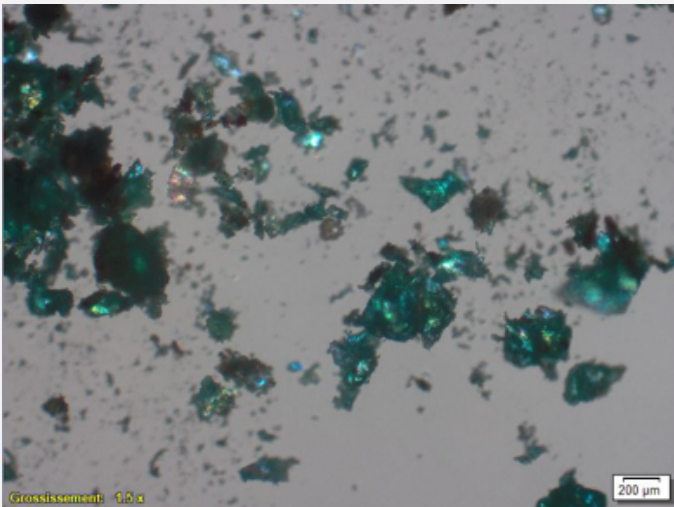
Fig. 16: Light green corrosion product identified as paratacamite, atacamite ($\text{Cu}_2\text{Cl}(\text{OH})_3$) by XRD. Microscopic examination under polarized light,

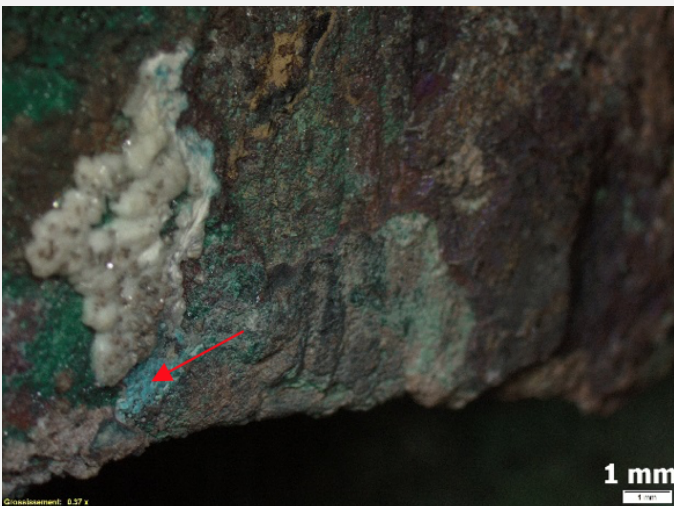
Fig. 17: Observation of the light blue corrosion product,

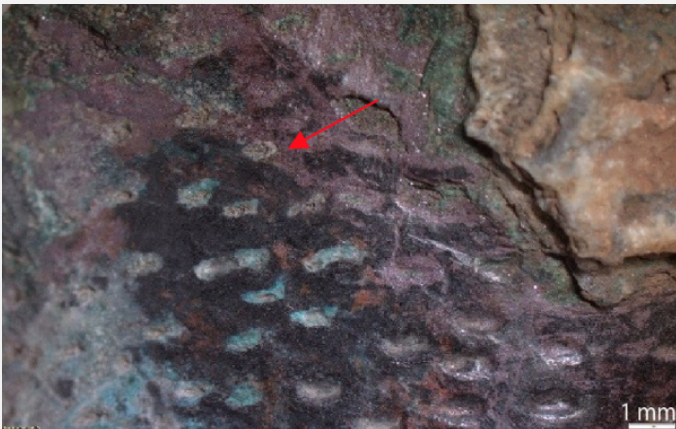
Fig. 20: Dark red corrosion product identified as cuprite Cu_2O as major component and tenorite CuO as minor component. Microscopic examination under polarized light,
