# FRAGMENT OF AN AEGIS OF NEÏTH 1886.305.0096 - LEADED BRONZE

Fragment of an Aegis of Neïth 1886.305.0096 Artefact name

**Authors** Line. Pedersen (HE-Arc, Neuchâtel, Neuchâtel, Switzerland) & Christian. Degrigny (HE-Arc CR, Neuchâtel,

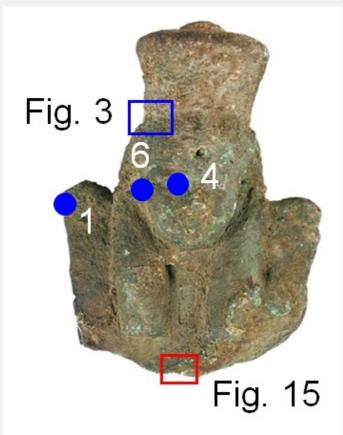
> Traces of leaf gilding is still present in certain areas (Fig. 3). The lower part of the collar and the upper part of the crown are broken (Fig. 2 and 4). The surface is covered with a thick and hard, green-brown corrosion crust (Fig. 2, 3 and 4). A cross-section was studied on the lower edge that was broken after excavation. Dimensions: L = 96mm; W = 72mm; T = 40mm; WT

Fig. 2: Front face of the aegis with location of XRF measurements (blue spots), powder sample (red square) and gilding remains on the surface (blue square),

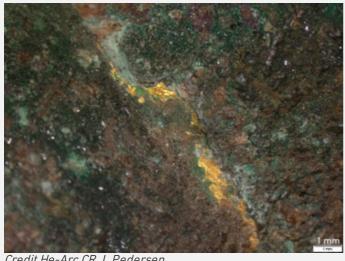
Fig. 3: Remains of foil-gilding on the corroded surface,

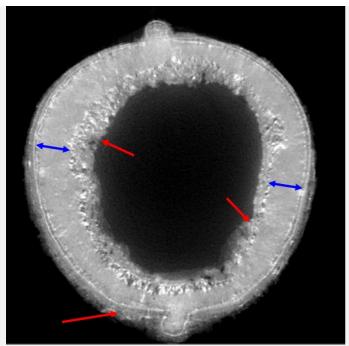
As indicated by the X-ray tomography, the metal of the aegis seems to be well preserved (Figs. 11-12). The metal (M2 in Fig. 9 and M1 in Fig. 10) was analysed on the broken edge of the bottom of the artefact where despite a highly corroded surface, the metal seems to be the best preserved. The XRF analyses revealed that the metal is a leaded bronze with remains of gold leaf on the surface (Table 1, Au was detected in the measurement spots 4,5 and 6) (Scott 2002; Gouda 2012; Mohammed 2012).

Fig. 11: X-ray tomography by cross section of the crown showing a dense and non-porous metal core (blue arrows). The corrosion products however are porous (red arrows). The

external limitos is visible as a fine line preserved under corrosion layers,

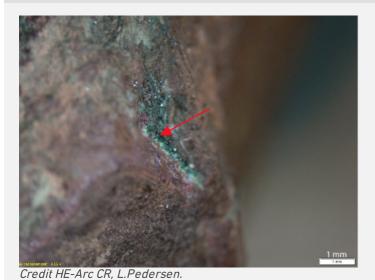
Fig. 13: Observation of the dark green corrosion product,

Fig. 14: Dark green corrosion product identified as paratacamite, atacamite Cu2Cl(OH)3 by XRD. Microscopic examination under polarized light,

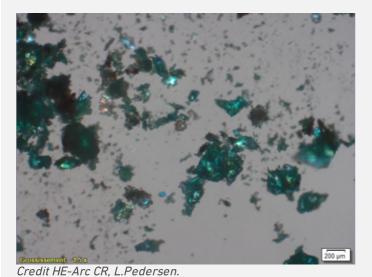
Fig. 16: Light green corrosion product identified as paratacamite, atacamite (Cu2Cl(OH)3) by XRD. Microscopic examination under polarized light,

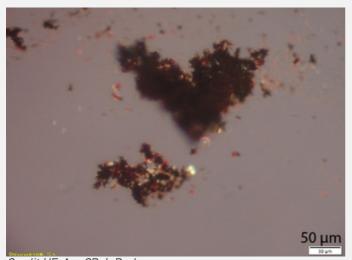
Fig. 19: Observation of the red corrosion product above the black original surface containing corresponding markers such as engravings,

Fig. 20: Dark red corrosion product identified as cuprite Cu20 as major component and tenorite CuO as minor component. Microscopic examination under polarized light,
