# VOTIVE FIGURE OF A BAT IVB4168 – GILDED BRASS – MODERN TIMES

**Artefact name** Votive figure of a bat IVb4168

**Authors** Christian. Degriigny (HE-Arc CR, Neuchâtel, Neuchâtel, Switzerland) & Naima. Gutknecht (HE-Arc CR, Neuchâtel, Neuchâtel, Switzerland) & Valentin. Boissonnas (HE-Arc CR, Neuchâtel, Neuchâtel, Switzerland)

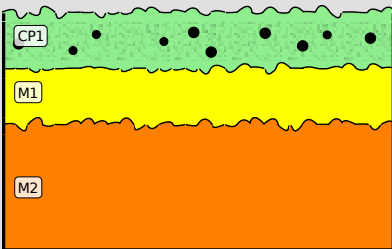
Fig 5: Stratigraphic representation 1 from Fig. 4 using the MiCorr application. The characteristics of the strata are only accessible by clicking on the drawing that redirects you to the search tool by stratigraphy representation, Credit HE-Arc CR, N.Gutknecht.

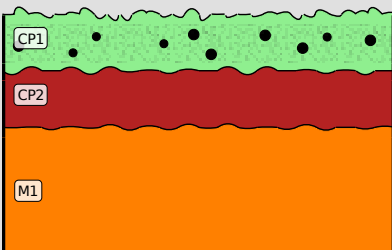
Fig. 6: Stratigraphic representation 2 from Fig. 4 using the MiCorr application. The characteristics of the strata are only accessible by clicking on the drawing that redirects you to the search tool by stratigraphy representation, Credit HE-Arc CR, N.Gutknecht.

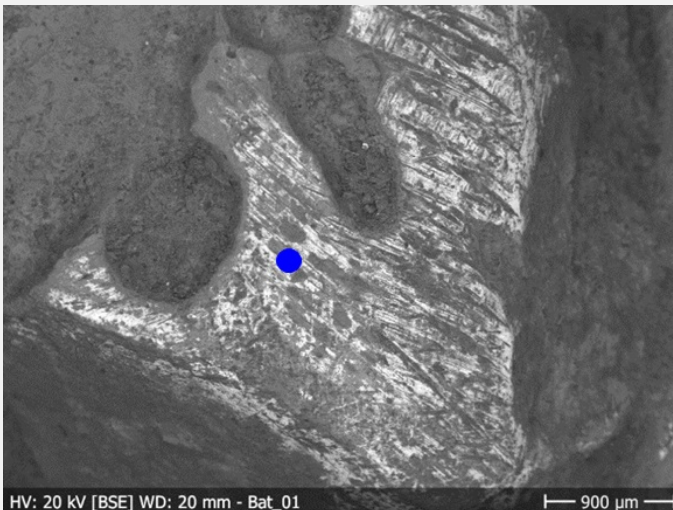
There are two corrosion products (Figs. 7 and 8). The red one (CP2) has a submetallic brightness and is opaque, non-magnetic, compact, hard and adherent. It is very thin (less than a few microns thick) and only appears where the gold layer has been lost. The EDX spectrum (Fig. 9) shows that it is a Cu- and O rich product, probably cuprite ( $\text{Cu}_2\text{O}$ ). The light green to white corrosion product (CP1) has a waxy consistency and is thin, translucent, non-magnetic, powdery and very soft. It is very loosely bound. It is distributed on the whole object (front and back) as disparate clumps. It is mainly located on the cavities and irregularities of the surface. FTIR analyses (ATR mode) of both green and white areas of CP1 have similar spectra and were identified as copper nitrate (Fig. 10).

Figs. 8: SEM images of the metal on the nose of the bat. The blue point represents the area for the EDS point analysis (Fig. 9),
