AIRCRAFT REAR FASTENING PLATE VHS-497 – AL ALLOY – MODERN TIMES

Artefact name Aircraft rear fastening plate VHS-497

Authors Marianne. Senn (EMPA, Dübendorf, Zurich, Switzerland) & Christian. Degrieny (HE-Arc CR, Neuchâtel, Neuchâtel, Switzerland)

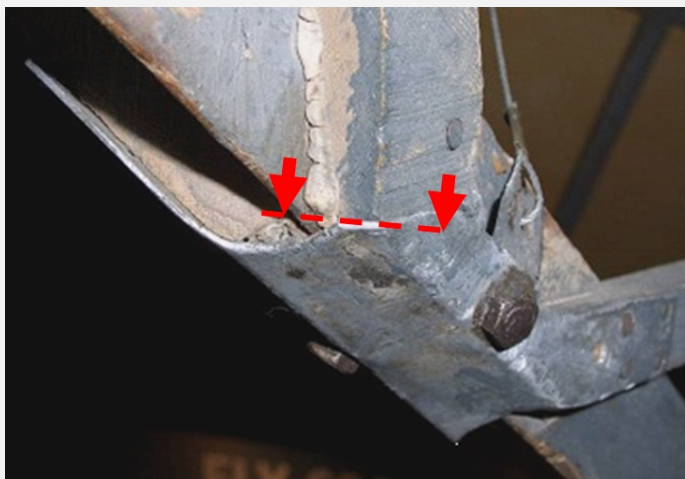
Fig. 2: Location of sampling area,

Sample cut from the corner of the fastening plate (Fig. 2). Dimensions: L = 4mm ; W = 1.2mm.

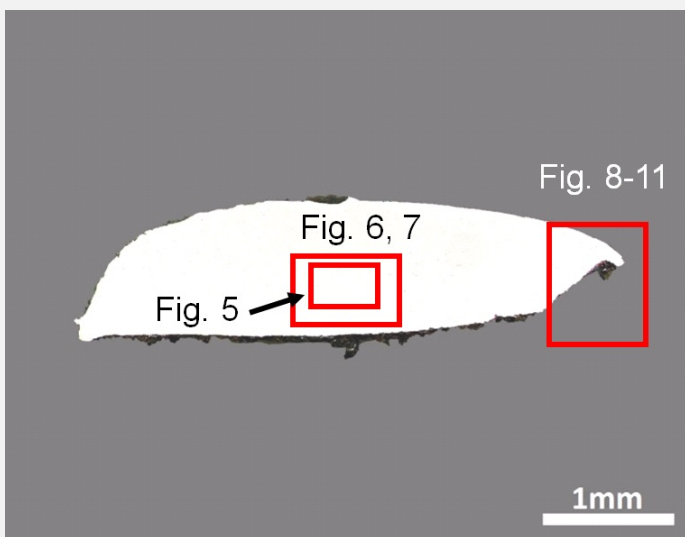
Fig. 3: Micrograph of the cross-section of the sample taken from the back fastening plate showing the location of Figs. 5 to 11,

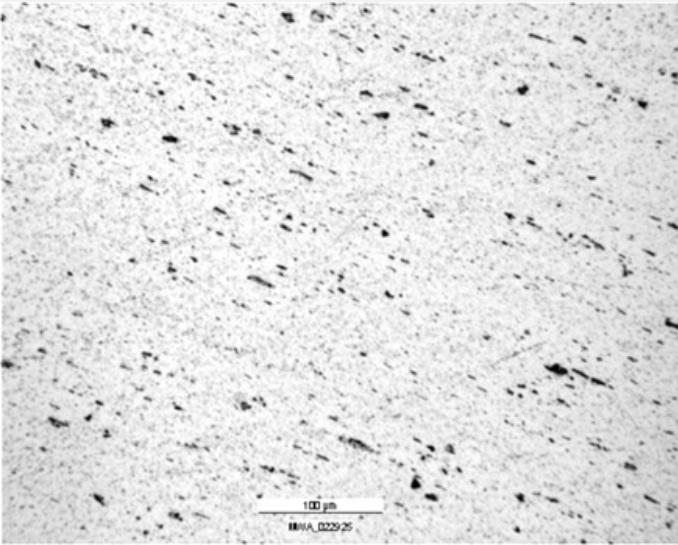
Fig. 6: Micrograph of the metal sample from Fig. 3 (detail), etched, bright field. The metal matrix is in white, the elongated inclusions in dark-grey and black,

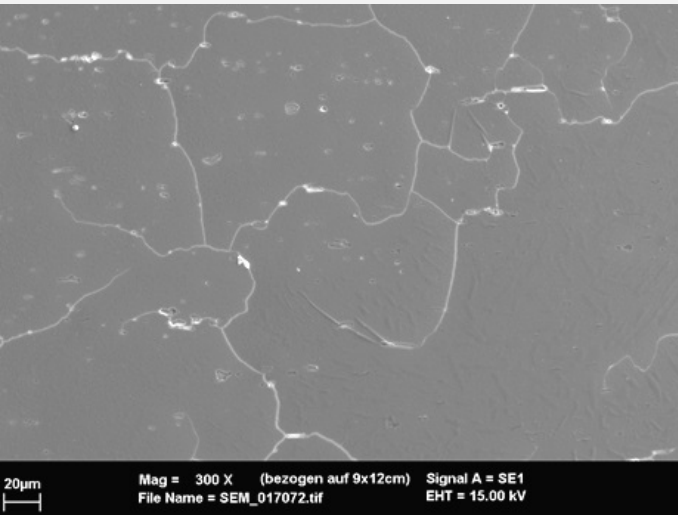
The metal is a relatively pure aluminium alloy with numerous inclusions (Table 1). From the chemical composition of the inclusions they can be interpreted as alpha-AlFeSi intermetallic compounds. In bright field we observe elongated inclusions indicating that the metal was rolled (Fig. 5). The alloy composition is similar to an unalloyed primary aluminium (Al content between 99 and 99.8 mass%). The O content reflects the immediate oxidation of the metal and is not part of the alloy. After etching the organisation of inclusions in rows is more easily seen (Fig. 6). The SEM image shows large grains formed after annealing (Fig. 7). The average hardness of the metal is HV1 40.

Fig. 7: SEM image of the metal sample from Fig. 3 (detail), SE-mode, etched. We observe the presence of large grains and numerous elongated inclusions,

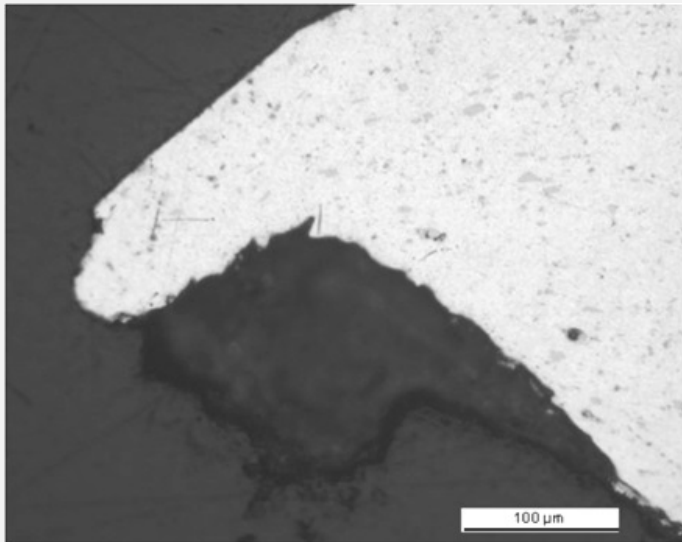
The metal is covered by a very thin corrosion layer (CP1). In addition to this, locally thicker adhering materials can be observed (NMM1, appearing as dark-grey area in Fig. 8). Under polarized light, they appear blue-brown (Fig. 9). Analysis by SEM-EDS indicates that the metal is, as expected, covered by a very thin Al and O-rich layer whereas the particles in the adherent material contain C, O, Si, Ca, Fe, Zn, S and even Ti (Figs. 10 and 11). The location of the adherent material and the presence of both Zn and Ti suggest that it is a residue of a paint coating.

Fig. 8: Micrograph showing the metal - adhering material interface from Fig. 3 (reversed picture, detail), unetched, bright field. We observe in white the metal matrix and dark-grey the adhering material,

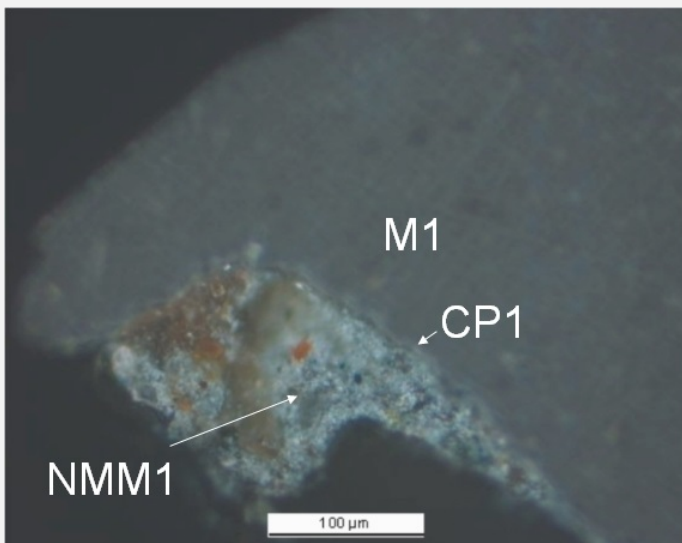
Fig. 9: Micrograph (same as Fig. 8) and corresponding to the stratigraphy of Fig. 4, unetched, polarised light. We observe in grey the metal matrix and blue-brown the adhering material,
