AIRCRAFT REAR FASTENING PLATE VHS-497 – AL ALLOY – MODERN TIMES

Artefact name	Aircraft rear fastening plate VHS-497
Authors	Marianne. Senn (EMPA, Dübendorf, Zurich, Switzerland) & Christian. Degriigny (HE-Arc CR, Neuchâtel, Neuchâtel, Switzerland)
Url	/artefacts/594/

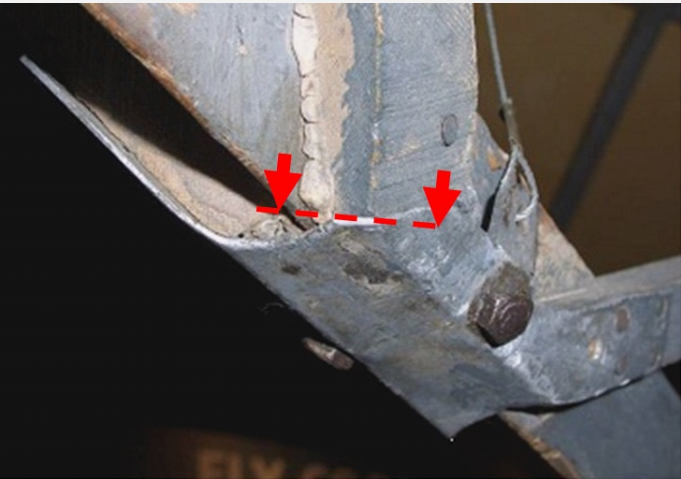
Fig. 2: Location of sampling area,

Sample cut from the corner of the fastening plate (Fig. 2). Dimensions: L = 4mm ; W = 1.2mm.

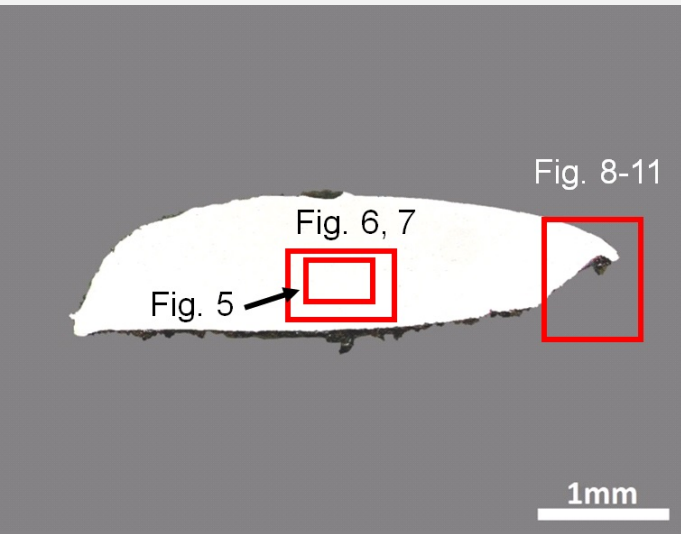
Fig. 3: Micrograph of the cross-section of the sample taken from the back fastening plate showing the location of Figs. 5 to 11,

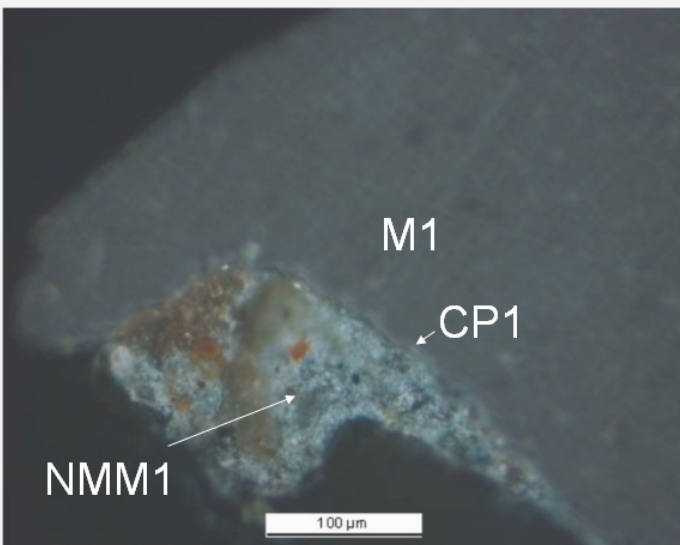
The metal is covered by a very thin corrosion layer (CP1). In addition to this, locally thicker adhering materials can be observed (NMM1, appearing as dark-grey area in Fig. 8). Under polarized light, they appear blue-brown (Fig. 9). Analysis by SEM-EDS indicates that the metal is, as expected, covered by a very thin Al and O-rich layer whereas the particles in the adherent material contain C, O, Si, Ca, Fe, Zn, S and even Ti (Figs. 10 and 11). The location of the adherent material and the presence of both Zn and Ti suggest that it is a residue of a paint coating.

Fig. 9: Micrograph (same as Fig. 8) and corresponding to the stratigraphy of Fig. 4, unetched, polarised light. We observe in grey the metal matrix and blue-brown the adhering material,
