AIRCRAFT FRONT FASTENING PLATE VHS-497 (2) – AL CU SN ZN SI ALLOY – MODERN TIMES

Artefact name	Aircraft front fastening plate VHS-497 (2)
Authors	Marianne. Senn (EMPA, Dübendorf, Zurich, Switzerland) & Christian. Degrieny (HE-Arc CR, Neuchâtel, Neuchâtel, Switzerland)
Url	/artefacts/595/

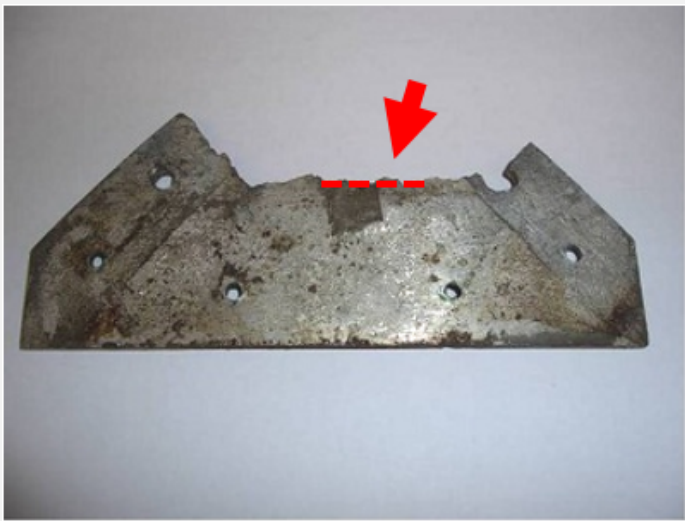
Fig. 2: Location of sampling area,

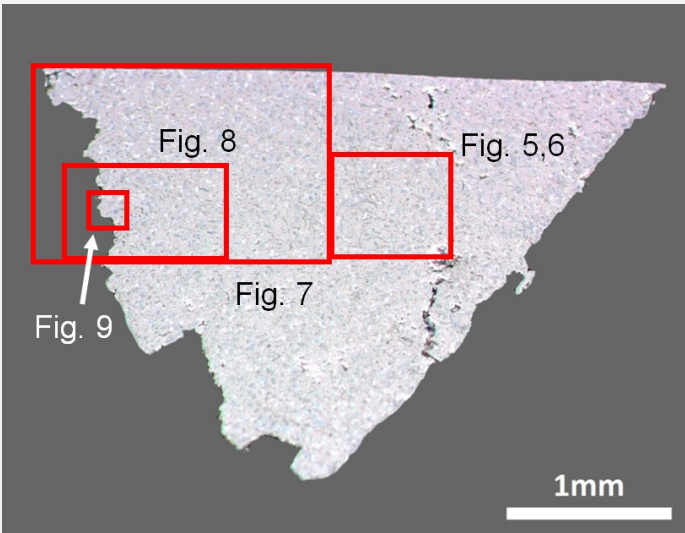
Fig. 3: Micrograph of the cross-section of the sample taken from the front fastening plate showing the location of Figs. 5 to 9,

Description of sample	The top part has been cut during sampling (Fig. 2). The more regular right side is the plate surface and the irregular side is the broken edge (Fig. 3). Dimensions: L = 4mm ; W = 4mm.
Alloy	Al Cu Sn Zn Si Alloy
Technology	As-cast
Lab number of sample	DUF-4
Sample location	Empa (Marianne Senn)
Responsible institution	Swiss Museum of Transport, Luzern, Lucerne
Date and aim of sampling	September 2007, metallography and alloy composition

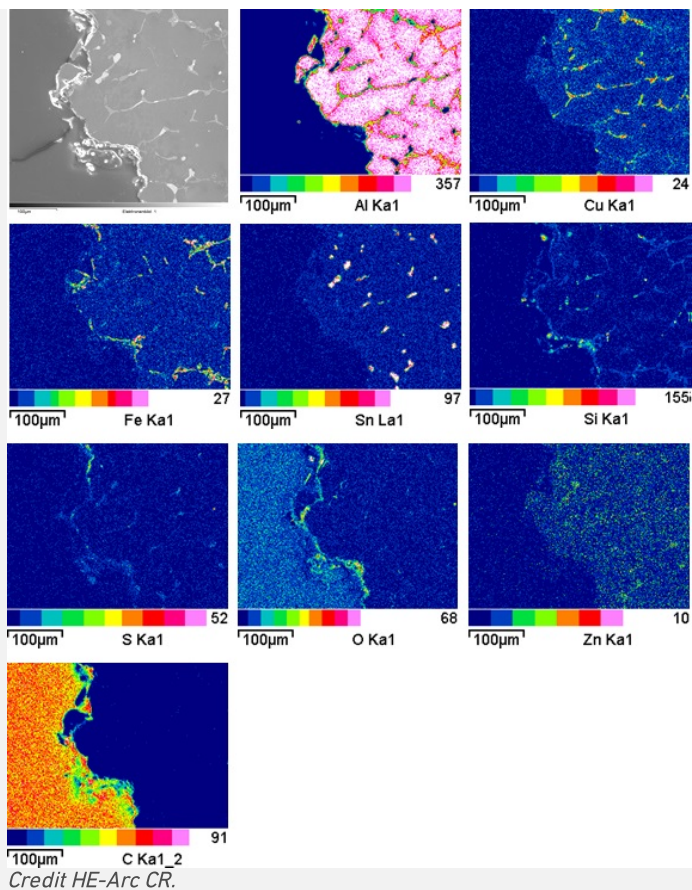
No corrosion layer can be seen on the metal surface (Figs. 3 and 7). Under polarized light small white and brown particles are visible on the broken edge (D1, Fig. 8). Their analysis reveals the presence of silica particles surrounded by dirt (Table 2 and Fig. 9). The metal surface is covered by a thin oxygen bearing skin (CP1, Fig. 9).

Fig. 9: SEM image, BSE-mode, and elemental chemical distribution of the selected area from Fig. 8 (reversed picture, detail). Method of examination: SEM/EDS, Laboratory of Analytical Chemistry, Empa,

Although not common at the beginning of the 20th, this Al-Cu-Sn-Zn-Si cast alloy was used on the Dufaux IV plane. No corrosion layer has been found on the metal surface except adherent silica-rich particles and the thin oxidised skin typical of Al alloys. The presence of these materials can be explained by the regular maintenance of the metal, probably using silicon carbide abrasive paper.
