AIRCRAFT FRONT FASTENING PLATE VHS-497 (2) - AL CU SN ZN SI ALLOY - MODERN TIMES

Artefact name Aircraft front fastening plate VHS-497 (2)

Authors Marianne. Senn (EMPA, Dübendorf, Zurich, Switzerland) & Christian. Degriigny (HE-Arc CR, Neuchâtel, Neuchâtel, Switzerland)

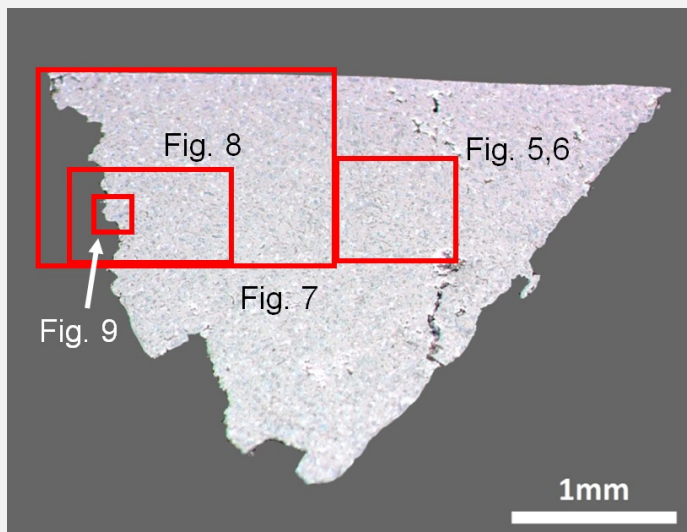
Fig. 3: Micrograph of the cross-section of the sample taken from the front fastening plate showing the location of Figs. 5 to 9,

Description of sample	The top part has been cut during sampling (Fig. 2). The more regular right side is the plate surface and the irregular side is the broken edge (Fig. 3). Dimensions: L = 4mm ; W = 4mm.
Alloy	Al Cu Sn Zn Si Alloy
Technology	As-cast
Lab number of sample	DUF-4
Sample location	Empa (Marianne Senn)
Responsible institution	Swiss Museum of Transport, Luzern, Lucerne
Date and aim of sampling	September 2007, metallography and alloy composition

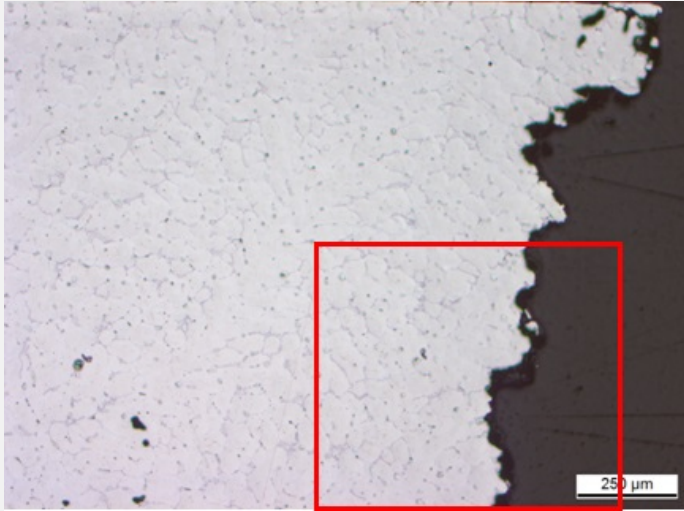
No corrosion layer can be seen on the metal surface (Figs. 3 and 7). Under polarized light small white and brown particles are visible on the broken edge (D1, Fig. 8). Their analysis reveals the presence of silica particles surrounded by dirt (Table 2 and Fig. 9). The metal surface is covered by a thin oxygen bearing skin (CP1, Fig. 9).

Fig. 7: Micrograph showing the metal - "corrosion products" interface from Fig. 3 (reversed picture, detail), unetched, bright field. We observe in white the metal matrix, in dark-grey Al, Fe, Si & Cu phase and light-grey Al₂Cu intermetallic compounds. The micrograph of Fig. 8 is marked by a rectangle,

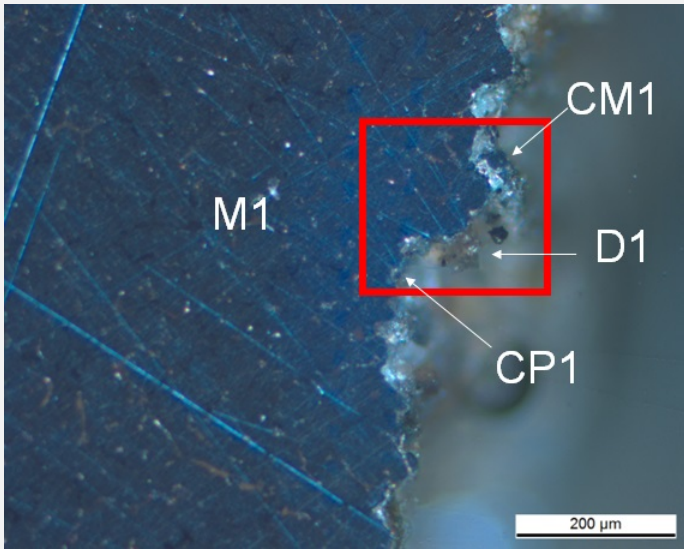
Fig. 8: Micrograph from Fig. 7 (detail) and corresponding to the stratigraphy of Fig. 4, unetched, polarised light. We observe in grey the metal matrix and blue-brown the adherent material. The area selected for elemental chemical distribution (Fig. 9) is marked by a rectangle,

Although not common at the beginning of the 20th, this Al-Cu-Sn-Zn-Si cast alloy was used on the Dufaux IV plane. No corrosion layer has been found on the metal surface except adherent silica-rich particles and the thin oxidised skin typical of Al alloys. The presence of these materials can be explained by the regular maintenance of the metal, probably using silicon carbide abrasive paper.
