ARMATURE FROM A CLOCK MOVEMENT MIH IV-212 – ZN AL SN CU ALLOY – MODERN TIMES

Artefact name	Armature from a clock movement MIH IV-212
Authors	Marianne. Senn (EMPA, Dübendorf, Zurich, Switzerland) & Christian. Degriigny (HE-Arc CR, Neuchâtel, Neuchâtel, Switzerland)
Url	/artefacts/597/

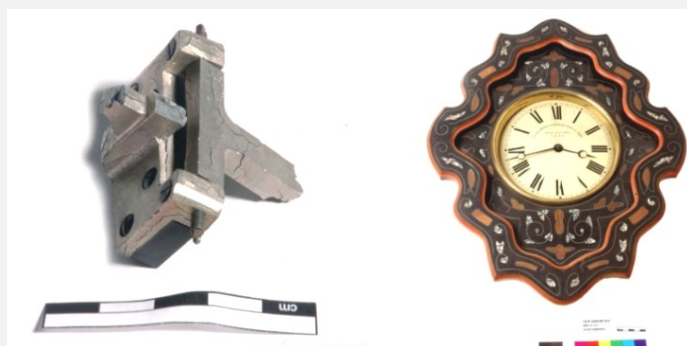
Fig. 1: Broken armature (left) from the clock movement of a wooden wall clock (right) (after Seematter 2009),

Description of the artefact	Armature from the clock movement of a wooden wall clock with electric movement broken in two elements (Fig. 1 and Fig. 2) with a heavily cracked surface.
Type of artefact	Horological object
Origin	Wooden wall clock
Recovering date	1902-1904
Chronology category	Modern Times
chronology tpe	1902 A.D. ▼
chronology taq	1904 A.D. ▼
Chronology comment	
Burial conditions / environment	Indoor atmosphere
Artefact location	International museum of horology (IMH), La Chaux-de-Fonds, Neuchâtel
Owner	International museum of horology (IMH), La Chaux-de-Fonds, Neuchâtel
Inv. number	MIH IV-212
Recorded conservation data	Not conserved

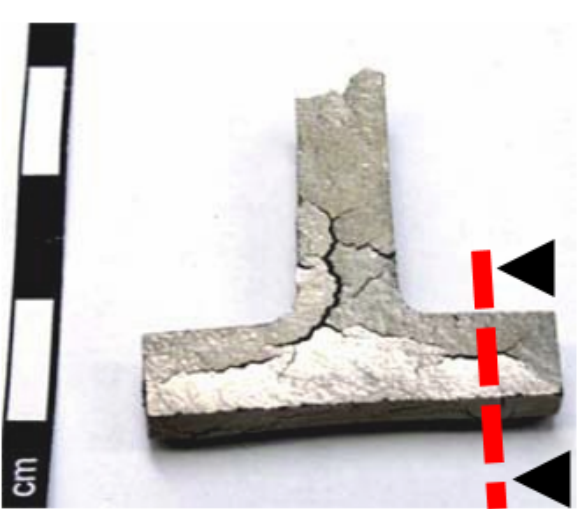
Fig. 2: Location of sampling area on the second element of the armature,

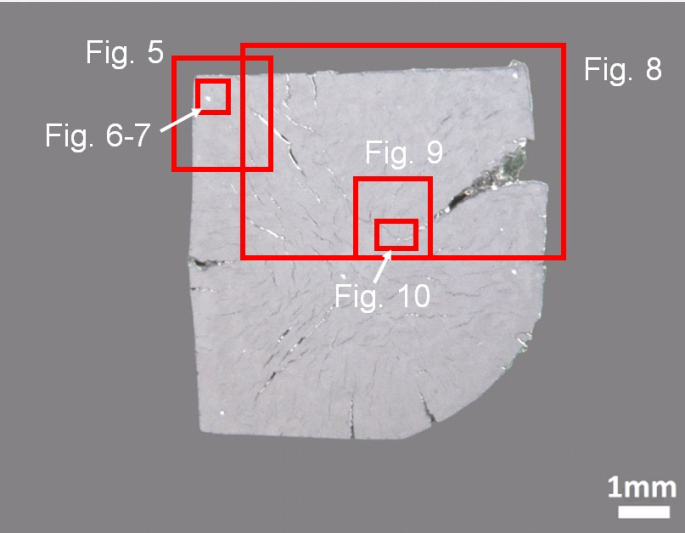
Fig. 3: Micrograph of the cross-section of the fragment sampled from the armature showing the location of Figs. 5 to 10,

Description of sample	This sample is the complete cross-section from an element of the armature (Fig. 2). The metal has huge cracks radiating from the centre to the outside which have deformed the armature (Fig. 3). The metal is covered with a Ni coating.														
Alloy	Zn Al Sn Cu Alloy														
Technology	As-cast														
Lab number of sample	MIH-VI-212														
Sample location	HE-Arc CR, Neuchâtel, Neuchâtel														
Responsible institution	International museum of horology (IMH), La Chaux-de-Fonds, Neuchâtel														
Date and aim of sampling	2009, metal analysis														
Complementary information															
Nothing to report.															
⌵ Analyses and results															
Analyses performed: Metallography (unetched), Vickers hardness testing, SEM/EDS.															
⌵ Non invasive analysis															
⌵ Metal															
<p>The metal is a Zn-Al-Sn-Cu alloy (Table 1) with an average hardness of HV1 105. A fine dendritic structure is observed (Fig. 5) which consists of clearly separated Zn, Al-Cu and Sn-rich phases (Figs. 6 and 7). Pb is associated with Sn but also forms tiny nodules.</p> <table><tr><th>Elements</th><th>Zn</th><th>Al</th><th>Sn</th><th>Cu</th><th>Pb</th><th>Total</th></tr><tr><td>Metal</td><td>67</td><td>17</td><td>11</td><td>4</td><td><1</td><td>99</td></tr></table> <p>Table 1: Chemical composition (mass %) of the metal (oxygen not shown). Method of analysis: SEM/EDS, Lab of Electronic Microscopy and microanalysis, IMA (Néode), HEI Arc.</p>		Elements	Zn	Al	Sn	Cu	Pb	Total	Metal	67	17	11	4	<1	99
Elements	Zn	Al	Sn	Cu	Pb	Total									
Metal	67	17	11	4	<1	99									
<p>Fig. 5: Micrograph of the metal sample from Fig. 3 (inverted picture, rotated by 270°, detail), unetched, bright field. A dendritic structure is visible. The micrograph of Fig. 6 is marked by a square,</p>

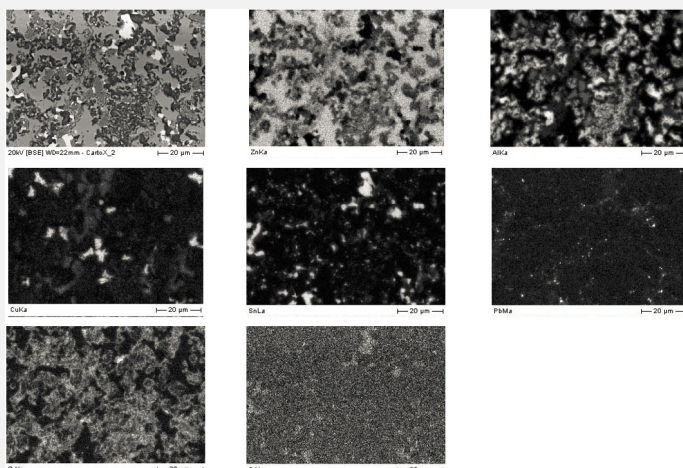
Fig. 6: SEM image, BSE-mode, detail from Fig. 5 (detail), unetched, bright field. Three phases appear: in light-grey the Zn-rich phase, in dark-grey the Al and Cu-rich phase and in white the Sn-rich phase,

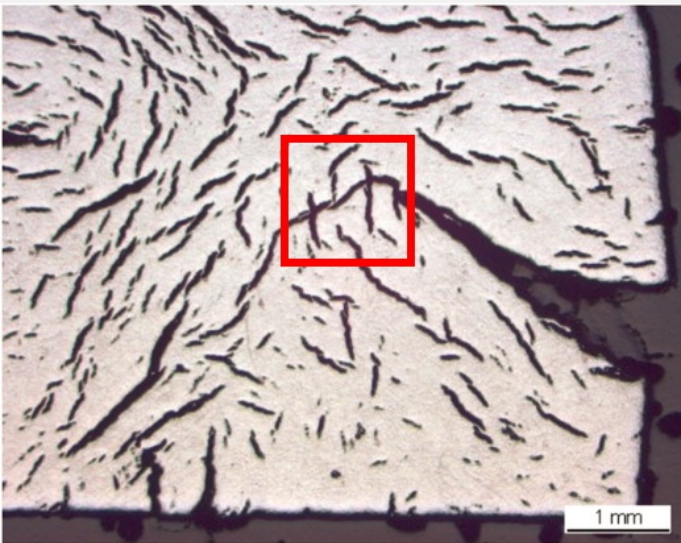
The Zn-rich phase is heavily oxidised internally (Fig. 7). The corrosion has developed throughout the entire metal body, generating cracks (Figs. 8 and 9). The cracks are Zn, O and C-rich (Fig. 10) and could be composed of zinc carbonate.

Fig. 8: Micrograph showing the metal - "corrosion products" interface from Fig. 3 (reversed picture, detail), unetched, bright field. We observe in white the metal matrix and dark-grey the adhering material,

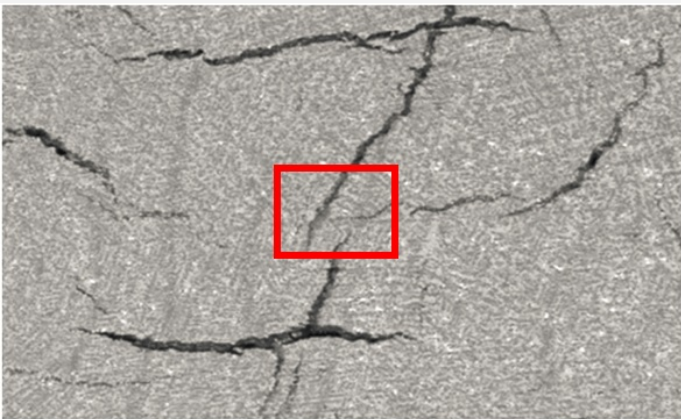
Fig. 9: Micrograph of the metal sample, detail from Fig. 8 (reversed and rotated by 90°), unetched, bright field. A dendritic structure is visible. The area selected for elementary mapping (Fig. 10) is marked by a rectangle,

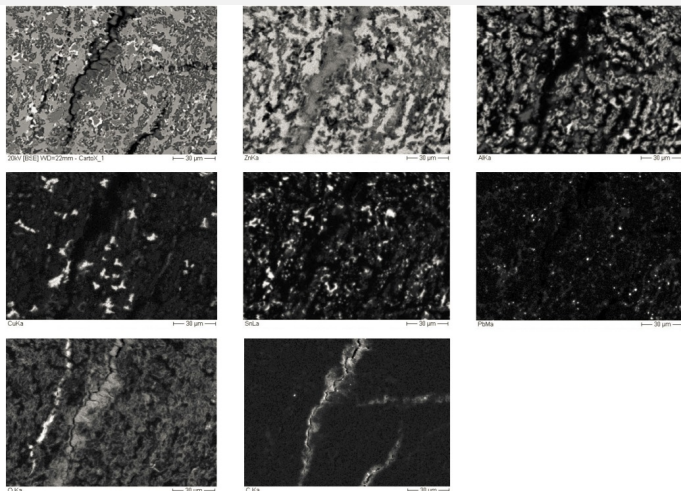
Fig. 10: SEM image, BSE-mode, and elemental chemical distribution of the selected area from Fig. 9 (detail). Method of examination: SEM/EDX, Lab of Electronic Microscopy and microanalysis, IMA (Néode), HEI Arc,

Corrosion form	Internal cracking
Corrosion type	zinc pest
