ARMATURE FROM A CLOCK MOVEMENT MIH IV-212 – ZN AL SN CU ALLOY – MODERN TIMES

Artefact name	Armature from a clock movement MIH IV-212
Authors	Marianne. Senn (EMPA, Dübendorf, Zurich, Switzerland) & Christian. Degriigny (HE-Arc CR, Neuchâtel, Neuchâtel, Switzerland)
Url	/artefacts/597/

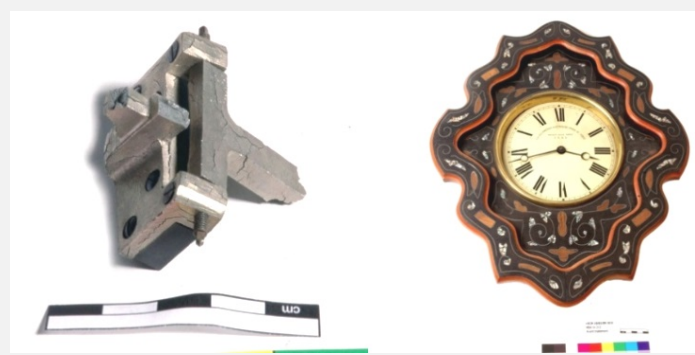
Fig. 1: Broken armature (left) from the clock movement of a wooden wall clock (right) (after Seematter 2009),

Description of the artefact	Armature from the clock movement of a wooden wall clock with electric movement broken in two elements (Fig. 1 and Fig. 2) with a heavily cracked surface.
Type of artefact	Horological object
Origin	Wooden wall clock
Recovering date	1902-1904
Chronology category	Modern Times
chronology tpg	<input type="text" value="1902"/> A.D. ∨
chronology taq	<input type="text" value="1904"/> A.D. ∨
Chronology comment	
Burial conditions / environment	Indoor atmosphere
Artefact location	International museum of horology (IMH), La Chaux-de-Fonds, Neuchâtel
Owner	International museum of horology (IMH), La Chaux-de-Fonds, Neuchâtel
Inv. number	MIH IV-212
Recorded conservation data	Not conserved

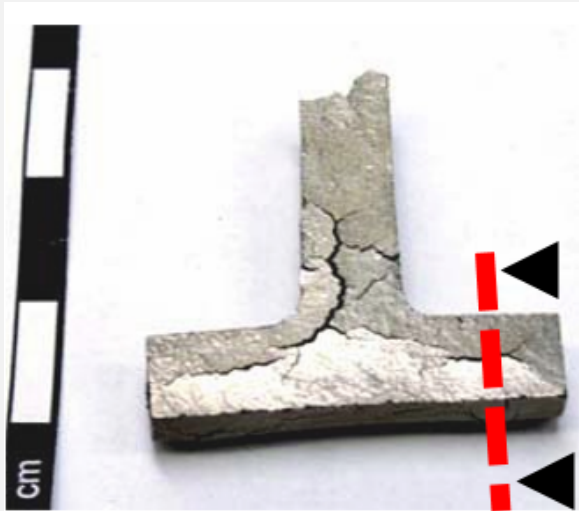
Fig. 2: Location of sampling area on the second element of the armature,

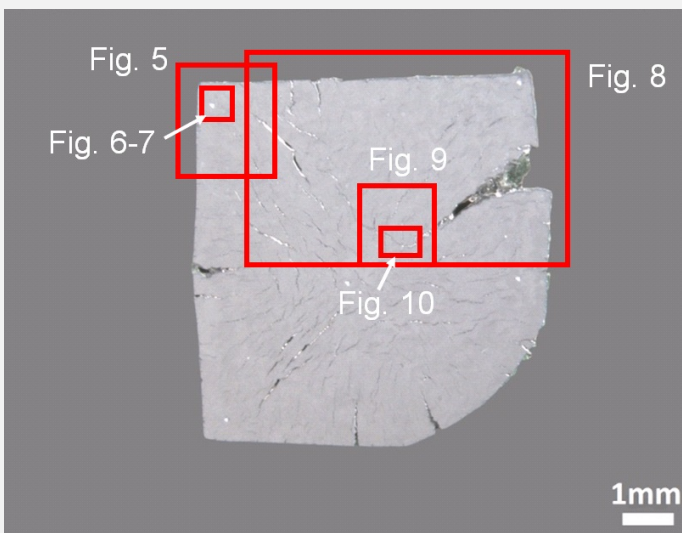
Fig. 3: Micrograph of the cross-section of the fragment sampled from the armature showing the location of Figs. 5 to 10,

Description of sample	This sample is the complete cross-section from an element of the armature (Fig. 2). The metal has huge cracks radiating from the centre to the outside which have deformed the armature (Fig. 3). The metal is covered with a Ni coating.
Alloy	Zn Al Sn Cu Alloy
Technology	As-cast
Lab number of sample	MIH-VI-212
Sample location	HE-Arc CR, Neuchâtel, Neuchâtel
Responsible institution	International museum of horology (IMH), La Chaux-de-Fonds, Neuchâtel
Date and aim of sampling	2009, metal analysis

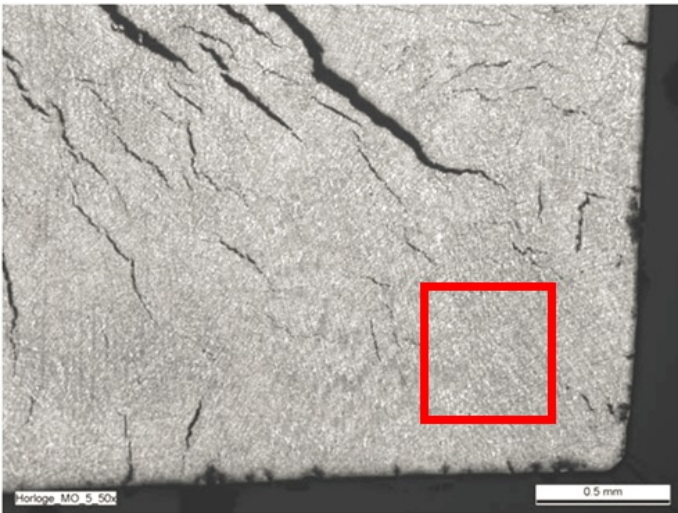
The metal is a Zn-Al-Sn-Cu alloy (Table 1) with an average hardness of HV1 105. A fine dendritic structure is observed (Fig. 5) which consists of clearly separated Zn, Al-Cu and Sn-rich phases (Figs. 6 and 7). Pb is associated with Sn but also forms tiny nodules.

Fig. 5: Micrograph of the metal sample from Fig. 3 (inverted picture, rotated by 270°, detail), unetched, bright field. A dendritic structure is visible. The micrograph of Fig. 6 is marked by a square,

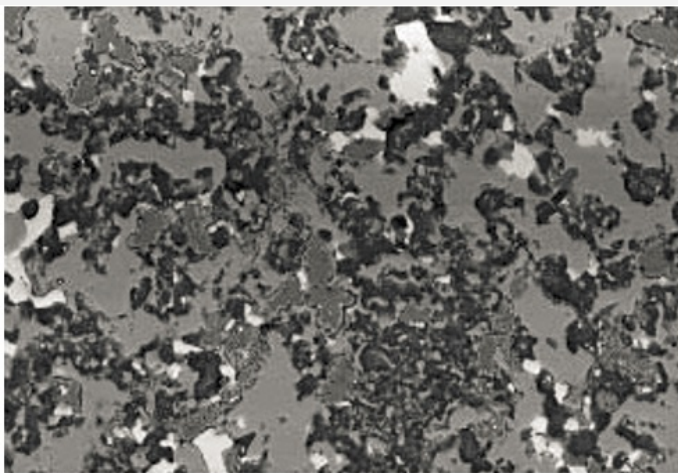
Fig. 6: SEM image, BSE-mode, detail from Fig. 5 (detail), unetched, bright field. Three phases appear: in light-grey the Zn-rich phase, in dark-grey the Al and Cu-rich phase and in white the Sn-rich phase,

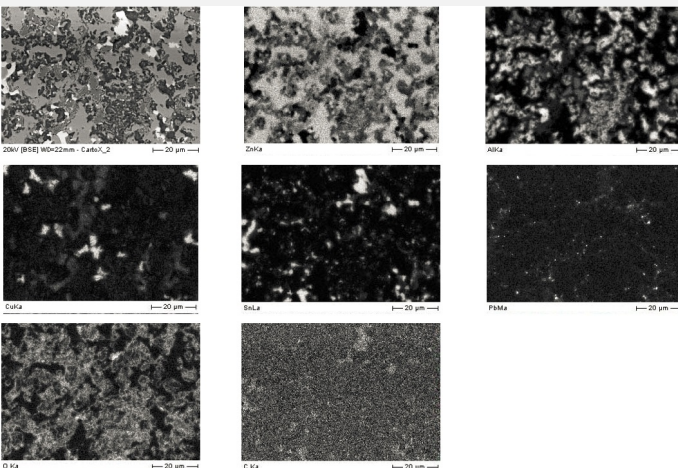
Fig. 7: SEM image, BSE-mode, and elemental chemical distribution of the selected area from Fig. 6. Method of examination: SEM/EDS, Lab of Electronic Microscopy and microanalysis, IMA (Néode), HEI Arc,

The Zn-rich phase is heavily oxidised internally (Fig. 7). The corrosion has developed throughout the entire metal body, generating cracks (Figs. 8 and 9). The cracks are Zn, O and C-rich (Fig. 10) and could be composed of zinc carbonate.

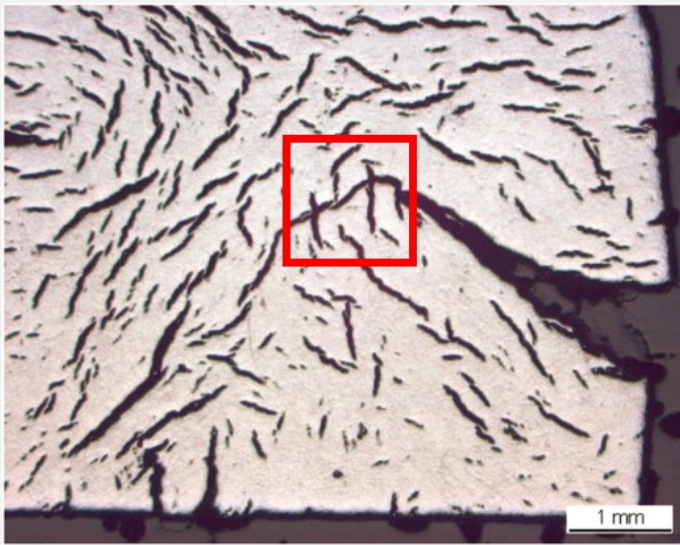
Fig. 8: Micrograph showing the metal - "corrosion products" interface from Fig. 3 (reversed picture, detail), unetched, bright field. We observe in white the metal matrix and dark-grey the adhering material,

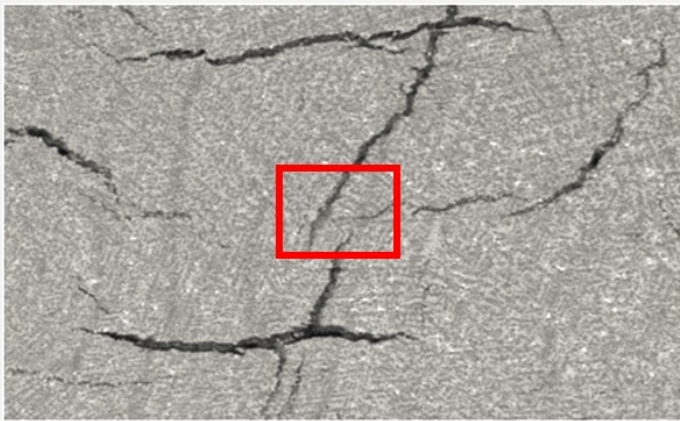
Fig. 9: Micrograph of the metal sample, detail from Fig. 8 (reversed and rotated by 90°), unetched, bright field. A dendritic structure is visible. The area selected for elementary mapping (Fig. 10) is marked by a rectangle,

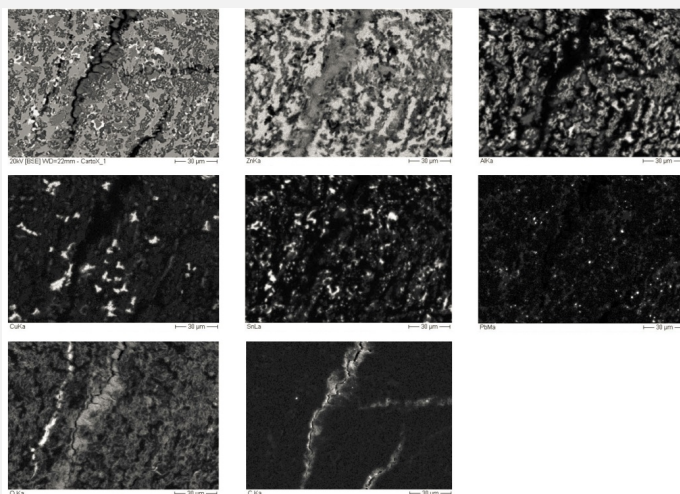
Fig. 10: SEM image, BSE-mode, and elemental chemical distribution of the selected area from Fig. 9 (detail). Method of examination: SEM/EDX, Lab of Electronic Microscopy and microanalysis, IMA (Néode), HEI Arc,

Corrosion form	Internal cracking
Corrosion type	zinc pest
