ARMATURE FROM A CLOCK MOVEMENT MIH IV-212 - ZN AL SN CU ALLOY - MODERN TIMES

Artefact name	Armature from a clock movement MIH IV-212
Authors	Marianne. Senn (EMPA, Dübendorf, Zurich, Switzerland) & Christian. Degryny (HE-Arc CR, Neuchâtel, Neuchâtel, Switzerland)
Url	/artefacts/597/

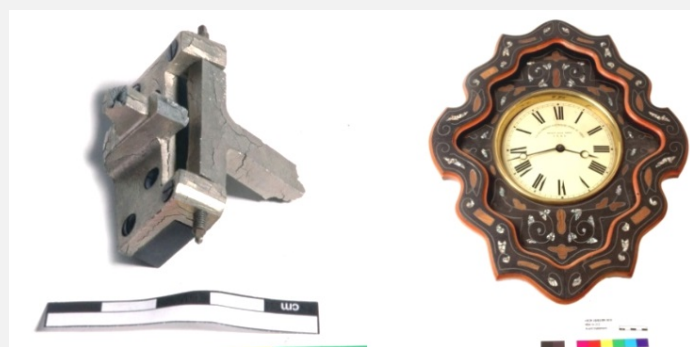
Fig. 1: Broken armature (left) from the clock movement of a wooden wall clock (right) (after Seematter 2009),

Description of the artefact	Armature from the clock movement of a wooden wall clock with electric movement broken in two elements (Fig. 1 and Fig. 2) with a heavily cracked surface.
Type of artefact	Horological object
Origin	Wooden wall clock
Recovering date	1902-1904
Chronology category	Modern Times
chronology tpg	<input type="text" value="1902"/> A.D. ▼
chronology taq	<input type="text" value="1904"/> A.D. ▼
Chronology comment	
Burial conditions / environment	Indoor atmosphere
Artefact location	International museum of horology (IMH), La Chaux-de-Fonds, Neuchâtel
Owner	International museum of horology (IMH), La Chaux-de-Fonds, Neuchâtel
Inv. number	MIH IV-212

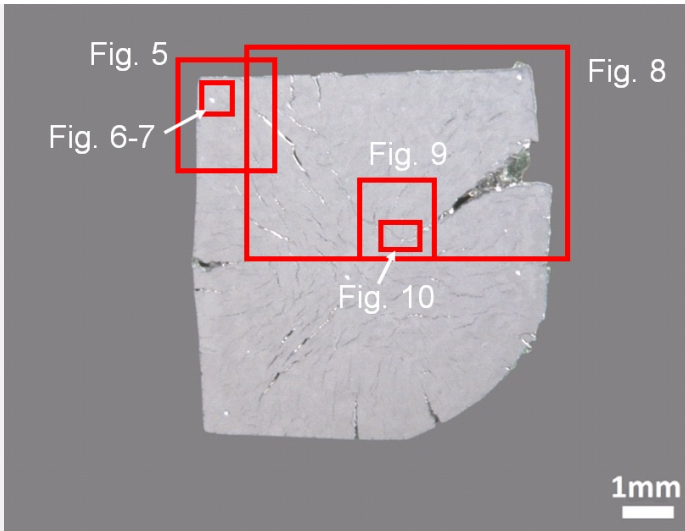
Fig. 3: Micrograph of the cross-section of the fragment sampled from the armature showing the location of Figs. 5 to 10,

Description of sample	This sample is the complete cross-section from an element of the armature (Fig. 2). The metal has huge cracks radiating from the centre to the outside which have deformed the armature (Fig. 3). The metal is covered with a Ni coating.
Alloy	Zn Al Sn Cu Alloy
Technology	As-cast
Lab number of sample	MIH-VI-212
Sample location	HE-Arc CR, Neuchâtel, Neuchâtel
Responsible institution	International museum of horology (IMH), La Chaux-de-Fonds, Neuchâtel
Date and aim of sampling	2009, metal analysis

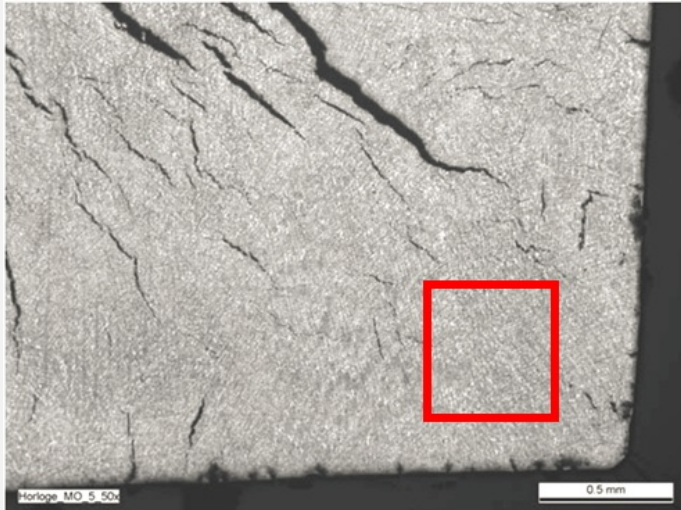
The metal is a Zn-Al-Sn-Cu alloy (Table 1) with an average hardness of HV1 105. A fine dendritic structure is observed (Fig. 5) which consists of clearly separated Zn, Al-Cu and Sn-rich phases (Figs. 6 and 7). Pb is associated with Sn but also forms tiny nodules.

Fig. 5: Micrograph of the metal sample from Fig. 3 (inverted picture, rotated by 270°, detail), unetched, bright field. A dendritic structure is visible. The micrograph of Fig. 6 is marked by a square,

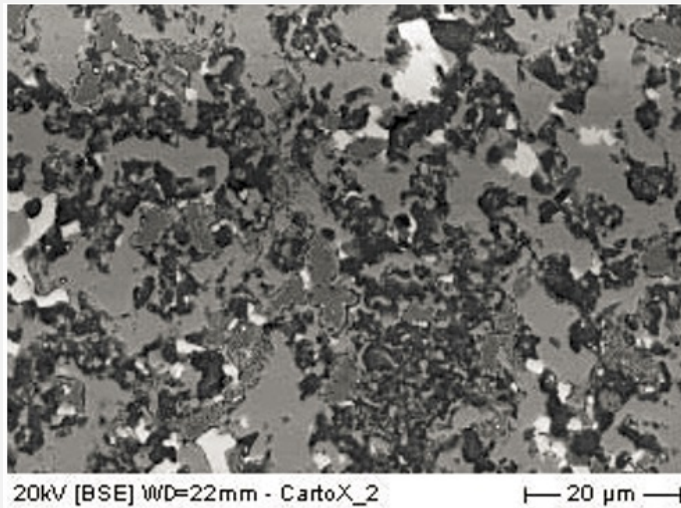
Fig. 6: SEM image, BSE-mode, detail from Fig. 5 (detail), unetched, bright field. Three phases appear: in light-grey the Zn-rich phase, in dark-grey the Al and Cu-rich phase and in white the Sn-rich phase,

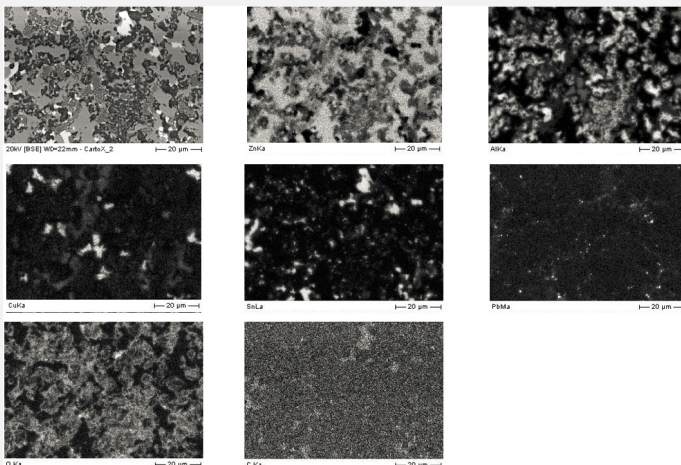
Fig. 7: SEM image, BSE-mode, and elemental chemical distribution of the selected area from Fig. 6. Method of examination: SEM/EDS, Lab of Electronic Microscopy and microanalysis, IMA (Néode), HEI Arc,

The Zn-rich phase is heavily oxidised internally (Fig. 7). The corrosion has developed throughout the entire metal body, generating cracks (Figs. 8 and 9). The cracks are Zn, O and C-rich (Fig. 10) and could be composed of zinc carbonate.

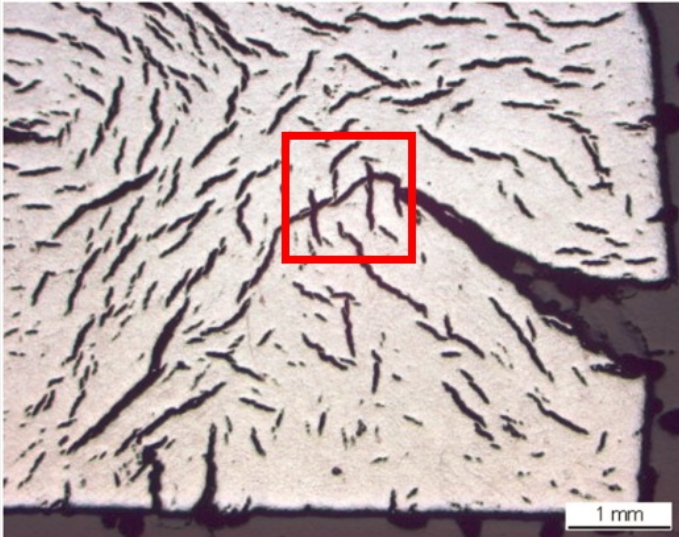
Fig. 8: Micrograph showing the metal - "corrosion products" interface from Fig. 3 (reversed picture, detail), unetched, bright field. We observe in white the metal matrix and dark-grey the adhering material,

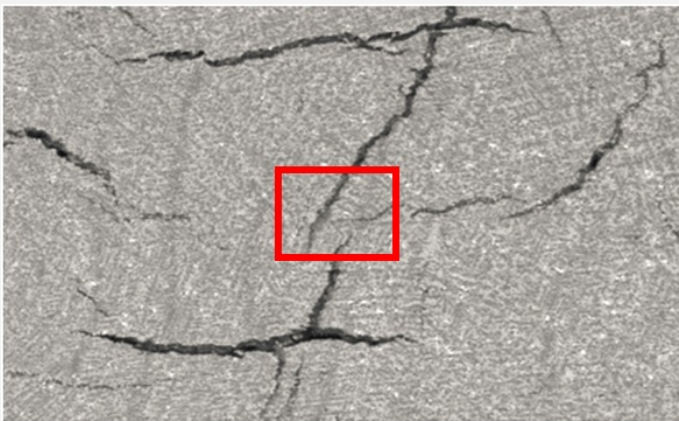
Fig. 9: Micrograph of the metal sample, detail from Fig. 8 (reversed and rotated by 90°), unetched, bright field. A dendritic structure is visible. The area selected for elementary mapping (Fig. 10) is marked by a rectangle,

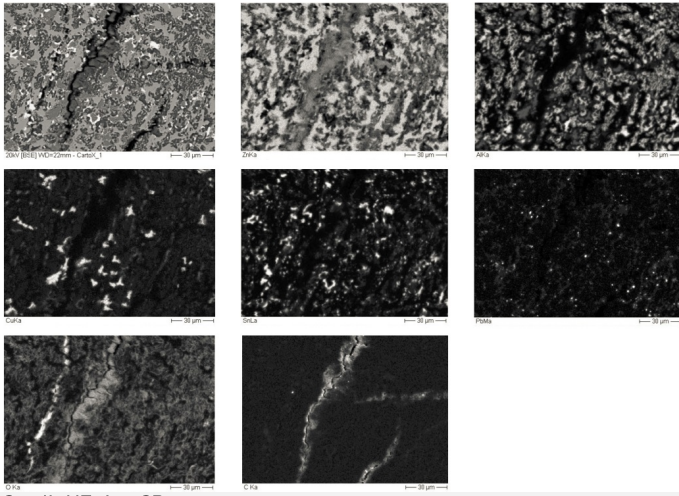
Fig. 10: SEM image, BSE-mode, and elemental chemical distribution of the selected area from Fig. 9 (detail). Method of examination: SEM/EDX, Lab of Electronic Microscopy and microanalysis, IMA (Néode), HEI Arc,

Corrosion form Internal cracking
Corrosion type zinc pest
