ARMATURE FROM A CLOCK MOVEMENT MIH IV-212 – ZN AL SN CU ALLOY – MODERN TIMES

Artefact name	Armature from a clock movement MIH IV-212
Authors	Marianne. Senn (EMPA, Dübendorf, Zurich, Switzerland) & Christian. Degriigny (HE-Arc CR, Neuchâtel, Neuchâtel, Switzerland)
Url	/artefacts/597/

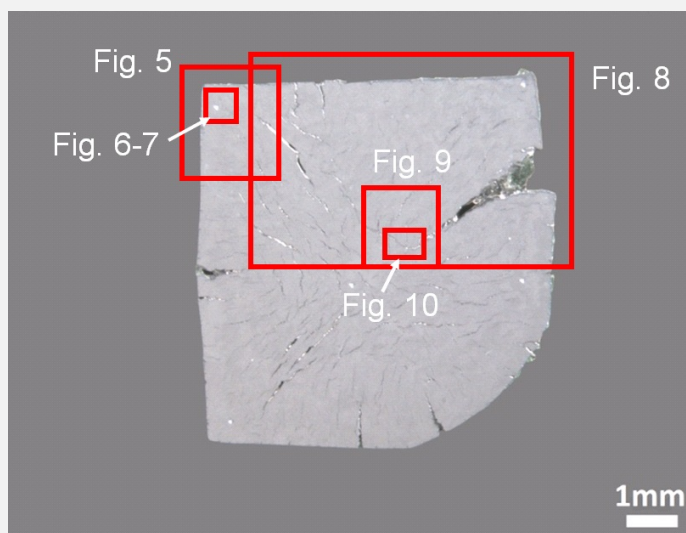
Fig. 3: Micrograph of the cross-section of the fragment sampled from the armature showing the location of Figs. 5 to 10,

Description of sample	This sample is the complete cross-section from an element of the armature (Fig. 2). The metal has huge cracks radiating from the centre to the outside which have deformed the armature (Fig. 3). The metal is covered with a Ni coating.
Alloy	Zn Al Sn Cu Alloy
Technology	As-cast
Lab number of sample	MIH-VI-212
Sample location	HE-Arc CR, Neuchâtel, Neuchâtel
Responsible institution	International museum of horology (IMH), La Chaux-de-Fonds, Neuchâtel
Date and aim of sampling	2009, metal analysis

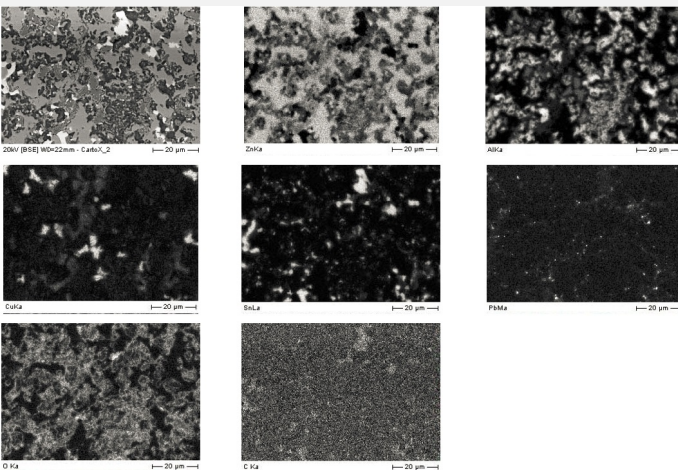
Fig. 7: SEM image, BSE-mode, and elemental chemical distribution of the selected area from Fig. 6. Method of examination: SEM/EDS, Lab of Electronic Microscopy and microanalysis, IMA (Néode), HEI Arc,

The Zn-rich phase is heavily oxidised internally (Fig. 7). The corrosion has developed throughout the entire metal body, generating cracks (Figs. 8 and 9). The cracks are Zn, O and C-rich (Fig. 10) and could be composed of zinc carbonate.

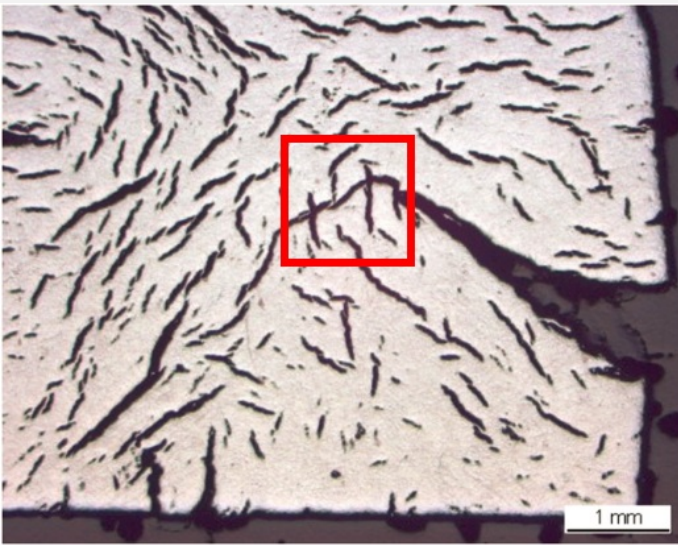
Fig. 8: Micrograph showing the metal - "corrosion products" interface from Fig. 3 (reversed picture, detail), unetched, bright field. We observe in white the metal matrix and dark-grey the adhering material,

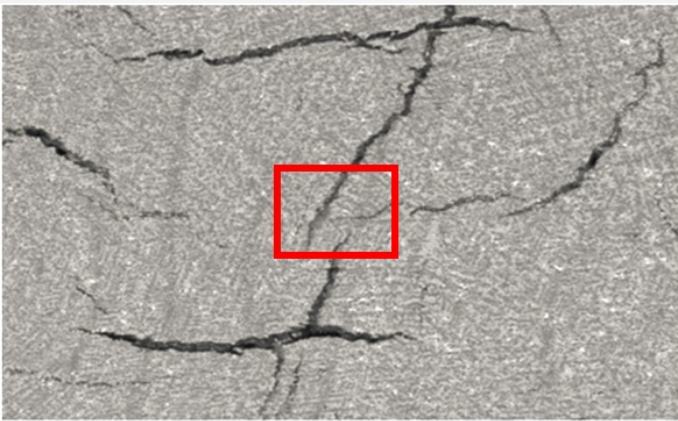
Fig. 9: Micrograph of the metal sample, detail from Fig. 8 (reversed and rotated by 90°), unetched, bright field. A dendritic structure is visible. The area selected for elementary mapping (Fig. 10) is marked by a rectangle,

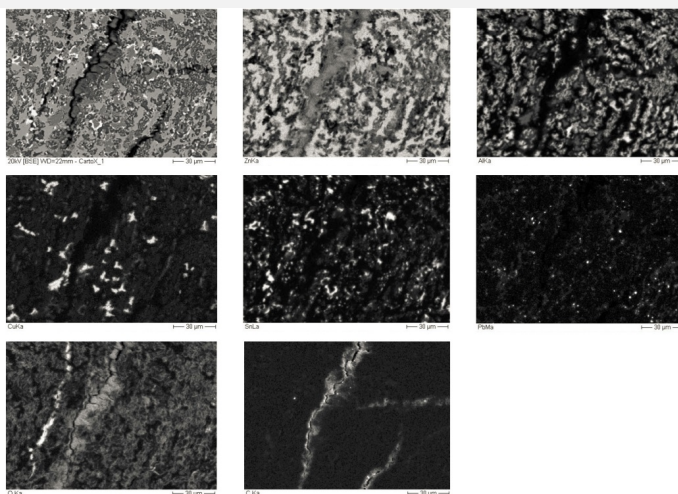
Fig. 10: SEM image, BSE-mode, and elemental chemical distribution of the selected area from Fig. 9 (detail). Method of examination: SEM/EDX, Lab of Electronic Microscopy and microanalysis, IMA (Néode), HEI Arc,

Corrosion form	Internal cracking
Corrosion type	zinc pest
