# ARMATURE FROM A CLOCK MOVEMENT MIH IV-212 – ZN AL SN CU ALLOY – MODERN TIMES

| Artefact name | Armature from a clock movement MIH IV-212 |
| Authors | Marianne. Senn (EMPA, Dübendorf, Zurich, Switzerland) & Christian. Degrigny (HE-Arc CR, Neuchâtel, Neuchâtel, Switzerland) |

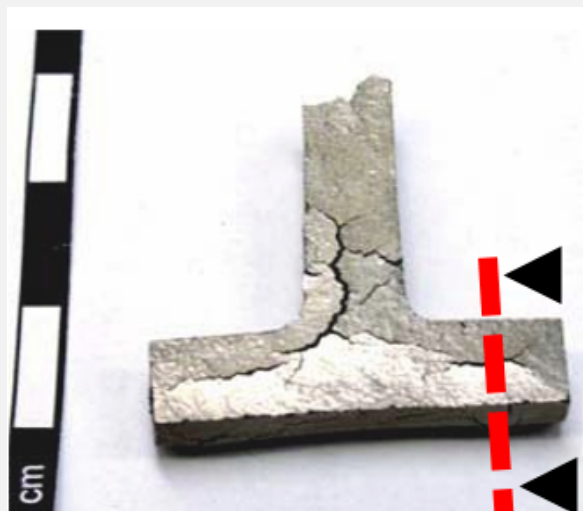
Fig. 2: Location of sampling area on the second element of the armature,

| Description of sample | This sample is the complete cross-section from an element of the armature (Fig. 2). The metal has huge cracks radiating from the centre to the outside which have deformed the armature (Fig. 3). The metal is covered with a Ni coating. |

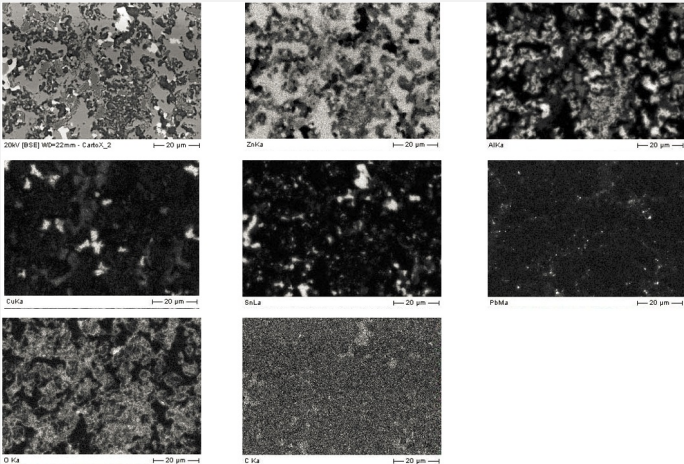
Fig. 7: SEM image, BSE-mode, and elemental chemical distribution of the selected area from Fig. 6. Method of examination: SEM/EDS, Lab of Electronic Microscopy and microanalysis, IMA (Néode), HEI Arc,

The Zn-rich phase is heavily oxidised internally (Fig. 7). The corrosion has developed throughout the entire metal body, generating cracks (Figs. 8 and 9). The cracks are Zn, O and C-rich (Fig. 10) and could be composed of zinc carbonate.

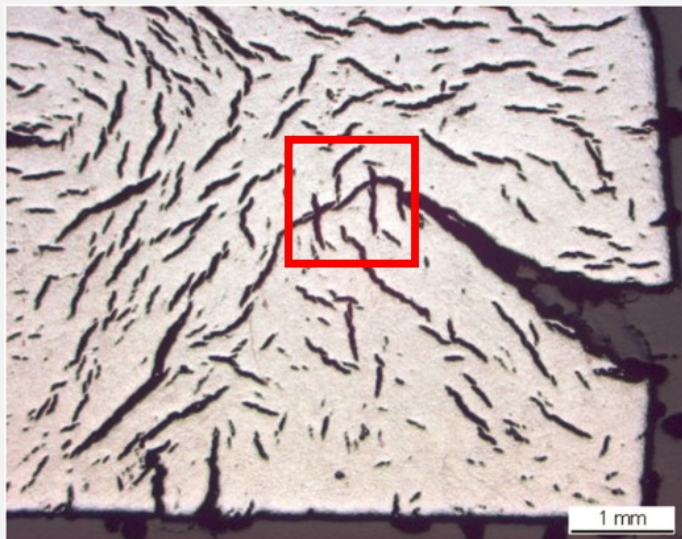
Fig. 8: Micrograph showing the metal - "corrosion products" interface from Fig. 3 (reversed picture, detail), unetched, bright field. We observe in white the metal matrix and dark-grey the adhering material,

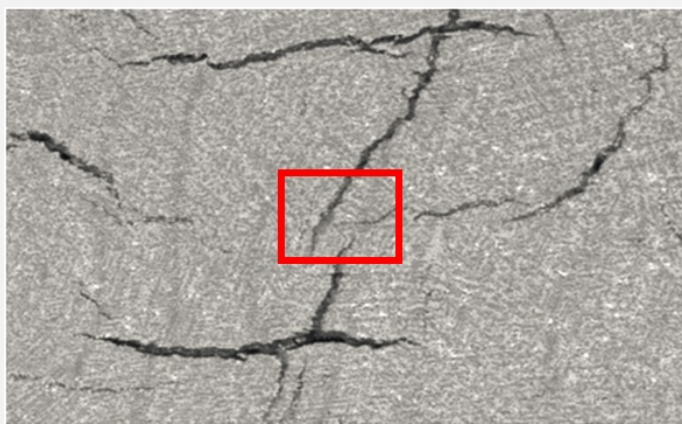
Fig. 9: Micrograph of the metal sample, detail from Fig. 8 (reversed and rotated by 90°), unetched, bright field. A dendritic structure is visible. The area selected for elementary mapping (Fig. 10) is marked by a rectangle,

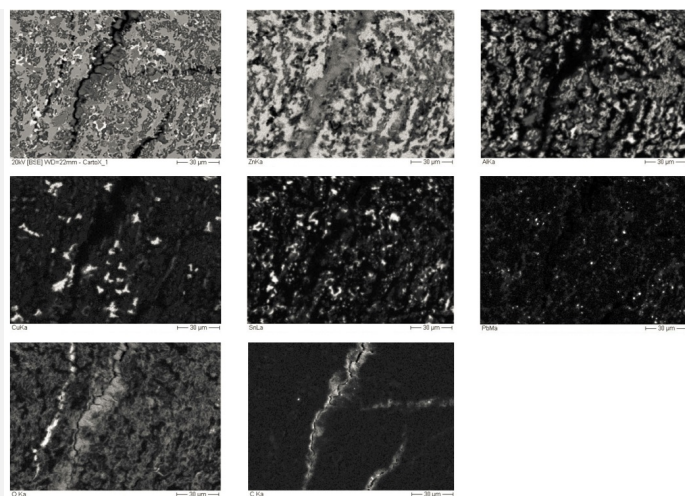
Fig. 10: SEM image, BSE-mode, and elemental chemical distribution of the selected area from Fig. 9 (detail). Method of examination: SEM/EDX, Lab of Electronic Microscopy and microanalysis, IMA (Néode), HEI Arc,
