# SHOE NAIL 2637 1370.B. - HYPOEUTECTOID STEEL - ROMAN TIMES - SWITZERLAND

Artefact name Shoe nail 2637 1370.B.

Authors Christian. Degrigny (HE-Arc CR, Neuchâtel, Neuchâtel, Switzerland) & Valentin. Boissonnas (HE-Arc CR, Neuchâtel,

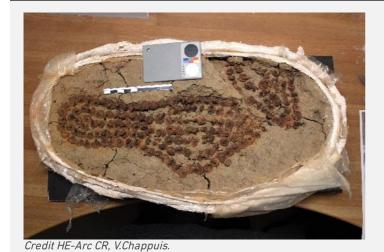
Fig. 1: A nail from a block-lifted Roman shoes before conservation.

# Description of the artefact A nail from a block-lifted Roman shoes (Fig. 1) covered with a thick corrosion crust. The forged nails were hammered into the leather soles on a bucking tool. Average dimensions of the shoe nails: L = about 14mm; diamter = 11mm; W = up to 0.8g. Type of artefact Shoe nail Origin Hofstetterfeld, near Roman Necropolis, Sursee, Lucerne, Switzerland

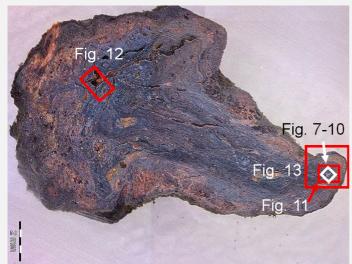
Fig. 4: Micrograph of the cross-section of the nail showing the location of figs. 7 to 13,

**Description of sample**A longitudinal cut through the nail (Fig. 4). Dimensions: L = 16.4mm; W = about 12.0mm.

The metal is heavily corroded and the thickness of the corrosion crust is irregular, varying from 0.8 to 3.8mm, with an average of about 2mm. The corrosion has replaced most of the metal (Fig. 4). Between corrosion layers the limit of the original structure is visible. Some leather fibers seem to be preserved as pseudomorphic structures in voids of the metal core (POM1, Figs. 11 and 12). The carbon mapping (Fig.13) shows the presence of carbon in these areas. This can also be due to the penetration of the mounting resin in the cracks.

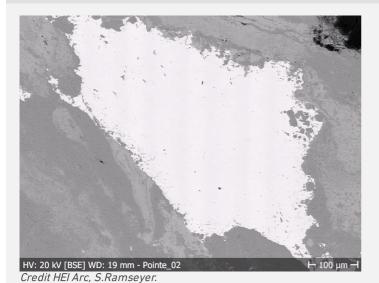
The remaining metal is an hypoeutectoid steel (Fig. 7 and 8), containing Fe, Si and O slags inclusions (possibly fayalite FeO,SiO2), and consisting of less than 1% of the total volume of the highly mineralized nail. After Nital etching, it shows intergranular corrosion on one of its sides (Figs. 9 and 10).

Fig. 7: SEM, BSE-mode picture of remaining metal,

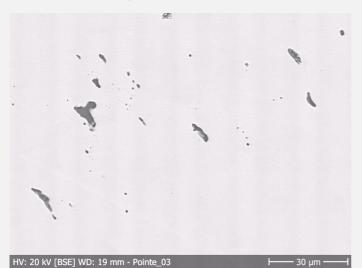
Fig. 8: SEM, BSE-mode picture of inclusions in remaining metal,

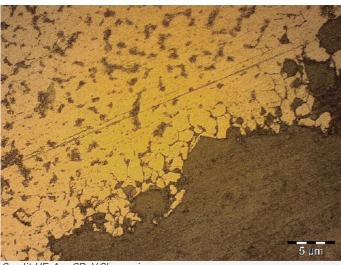
Fig. 10: Micrograph of the selected area of Fig. 9, Nital etched with no clear grain structure, bright field, Intergranular corrosion and grey phase (perlite?) are observed,

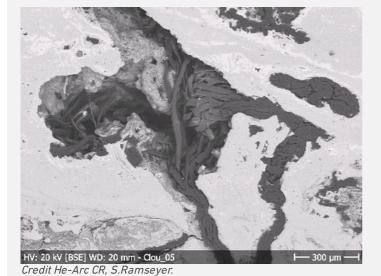
Fig. 11: Micrograph of the metal sample, bright field. The deliminated zone shows what could be leather pseudomorphic fibers filling a void,

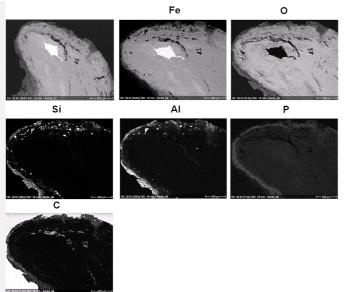
Si, Al, P and K can be considered external markers, helping to determine the limit of the original surface (Fig. 13 and Table 1). The outer layer of corrosion products (CP1-3) ranges from dark grey to orange in bright field and contains less 0 and Fe on its borders than the inner layer (CP4-5, Figs. 4 and 13, Table 1). The SEM pictures show a marbling appearance of the inner corrosion layer (CP5). Cl and S do not seem to be present in the sampled nail.

Fig. 13: Elemental chemical distribution of the selected area from Fig. 4 (90° counter-clockwise rotated). SEM-EDS,
