SHOE NAIL 2637 1370.B. – HYPOEUTECTOID STEEL – ROMAN TIMES – SWITZERLAND

Artefact name	Shoe nail 2637 1370.B.
Authors	Christian. Degriigny (HE-Arc CR, Neuchâtel, Neuchâtel, Switzerland) & Valentin. Boissonnas (HE-Arc CR, Neuchâtel, Neuchâtel, Switzerland) & Vincent Chappuis. (HE-Arc CR, Neuchâtel, Neuchâtel, Switzerland)
Url	/artefacts/598/

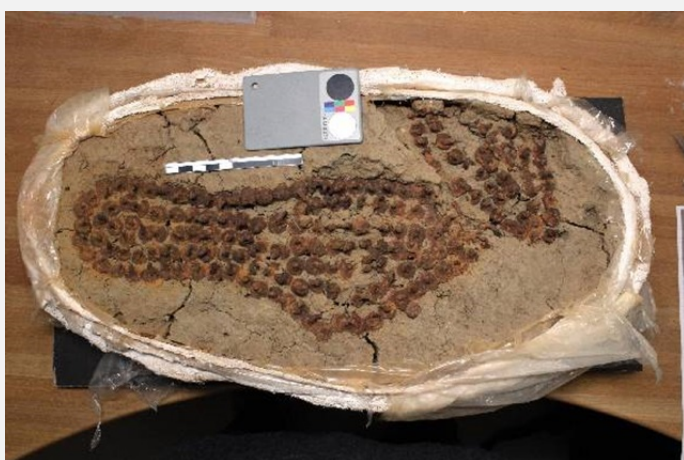
Fig. 1: A nail from a block-lifted Roman shoes before conservation.

Description of the artefact	A nail from a block-lifted Roman shoes (Fig. 1) covered with a thick corrosion crust. The forged nails were hammered into the leather soles on a bucking tool. Average dimensions of the shoe nails: L = about 14mm; diamter = 11mm; W = up to 0.8g.	
Type of artefact	Shoe nail	
Origin	Hofstetterfeld, near Roman Necropolis, Sursee, Lucerne, Switzerland	
Recovering date	None	
Chronology category	Roman Times	
chronology tpq	<input type="text" value="50"/>	A.D. ▼
chronology taq	<input type="text" value="100"/>	A.D. ▼
Chronology comment	2nd half 1st century AD.

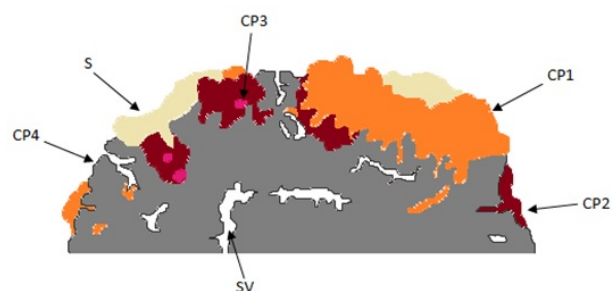
S = compact sand-clay soil.
 CP1 = powdery soil, orange-coloured by corrosion products.
 CP2 = dark-red corrosion crust, breaks into bits.
 CP3 = vivid pink-red and globular corrosion products.
 CP4 = dark grey to black and very hard corrosion products, results in a dark-orange powder when scratched.
 SV = structural void near the center of the cross section, seems to draw a square shape.

Fig. 3: Preliminary stratigraphy of the corrosion layers based on the observation of a broken nail,

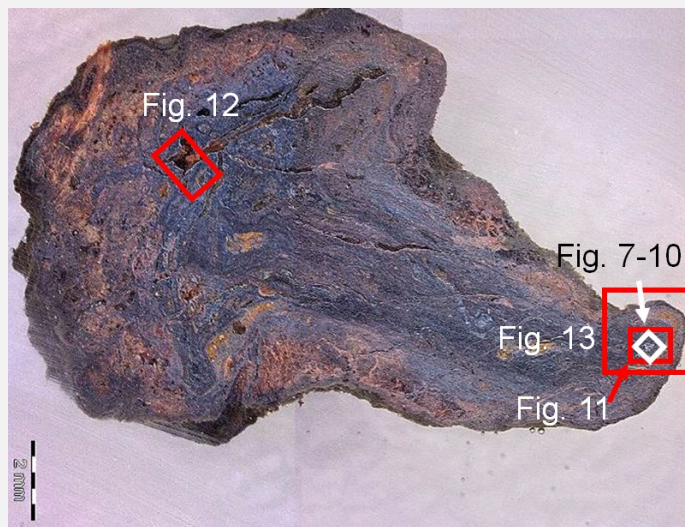
Fig. 4: Micrograph of the cross-section of the nail showing the location of figs. 7 to 13,

The metal is heavily corroded and the thickness of the corrosion crust is irregular, varying from 0.8 to 3.8mm, with an average of about 2mm. The corrosion has replaced most of the metal (Fig. 4). Between corrosion layers the limit of the original structure is visible. Some leather fibers seem to be preserved as pseudomorphic structures in voids of the metal core (POM1, Figs. 11 and 12). The carbon mapping (Fig.13) shows the presence of carbon in these areas. This can also be due to the penetration of the mounting resin in the cracks.

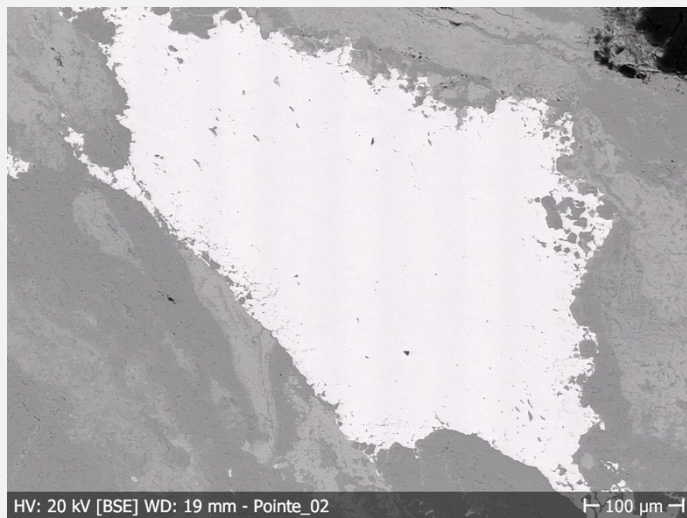
The remaining metal is an hypoeutectoid steel (Fig. 7 and 8), containing Fe, Si and O slags inclusions (possibly fayalite FeO, SiO_2), and consisting of less than 1% of the total volume of the highly mineralized nail. After Nital etching, it shows intergranular corrosion on one of its sides (Figs. 9 and 10).

Fig. 7: SEM, BSE-mode picture of remaining metal,

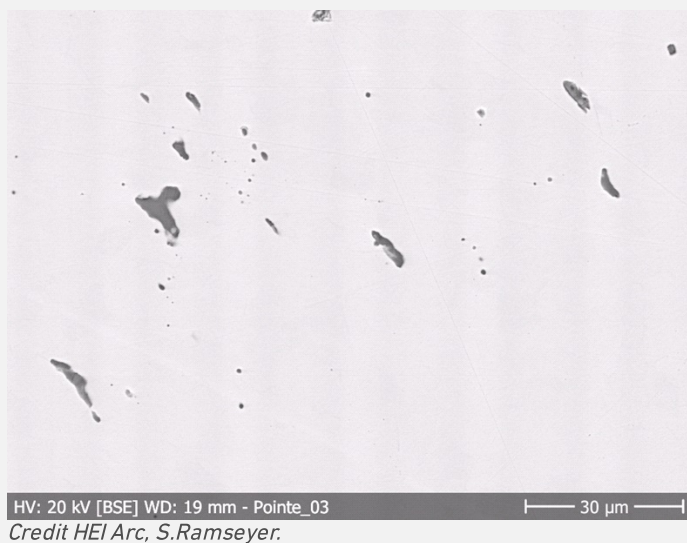
Fig. 8: SEM, BSE-mode picture of inclusions in remaining metal,

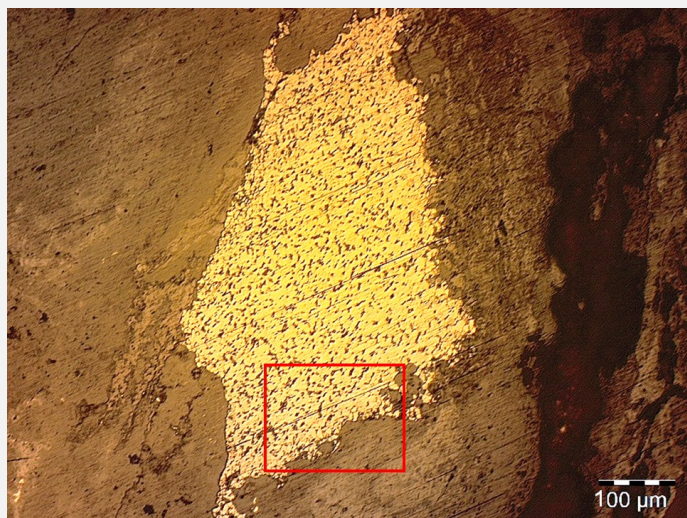
Fig. 9: Micrograph of the metal sample from Fig. 7 (detail, rotated 90°), Nital etched, bright field,

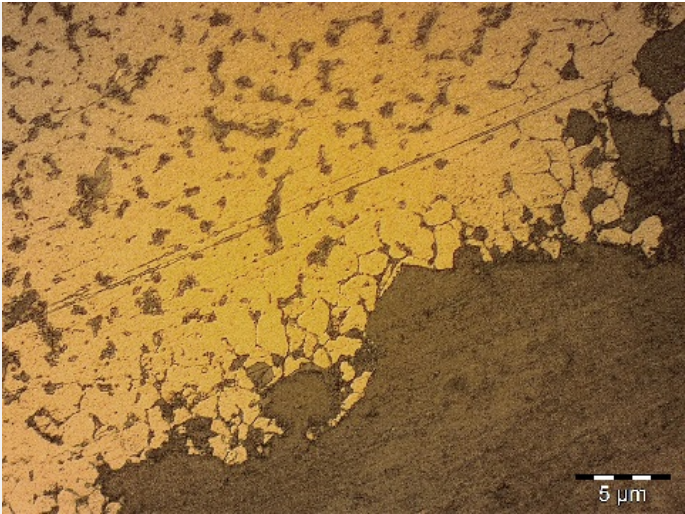
Fig. 10: Micrograph of the selected area of Fig. 9, Nital etched with no clear grain structure, bright field, Intergranular corrosion and grey phase (perlite?) are observed,

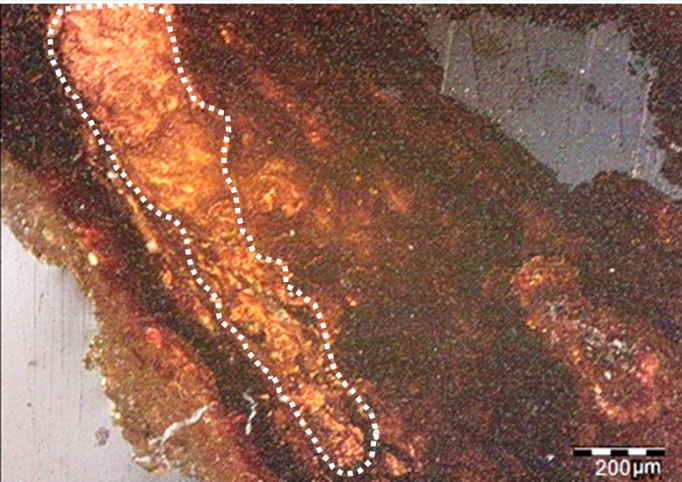
Fig. 11: Micrograph of the metal sample, bright field. The delimited zone shows what could be leather pseudomorphic fibers filling a void,

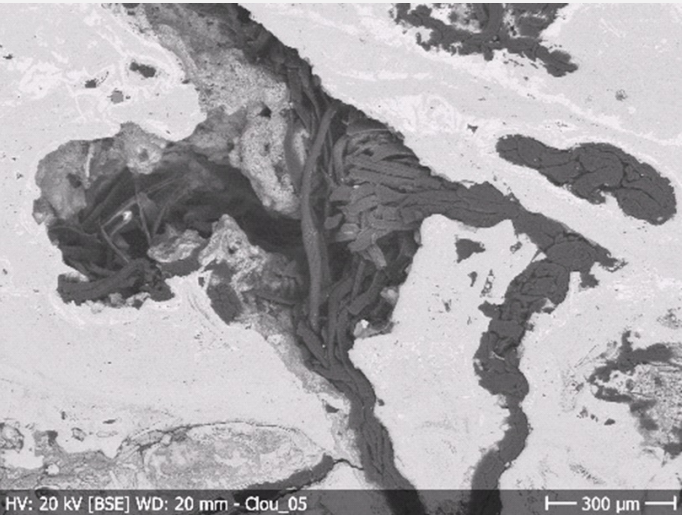
Fig. 12: Micrograph (SEM - BSE-mode) of another void filled with fibers in the head of the nail,

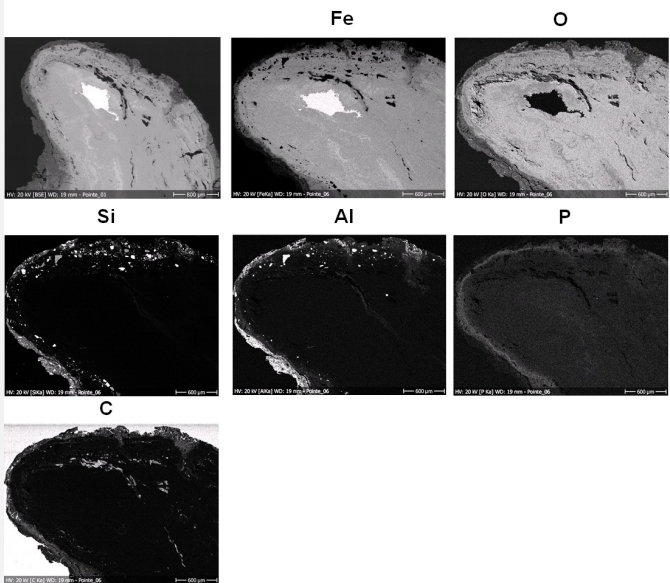
Si, Al, P and K can be considered external markers, helping to determine the limit of the original surface (Fig. 13 and Table 1). The outer layer of corrosion products (CP1-3) ranges from dark grey to orange in bright field and contains less O and Fe on its borders than the inner layer (CP4-5, Figs. 4 and 13, Table 1). The SEM pictures show a marbling appearance of the inner corrosion layer (CP5). Cl and S do not seem to be present in the sampled nail.

Fig. 13: Elemental chemical distribution of the selected area from Fig. 4 (90° counter-clockwise rotated). SEM-EDS,

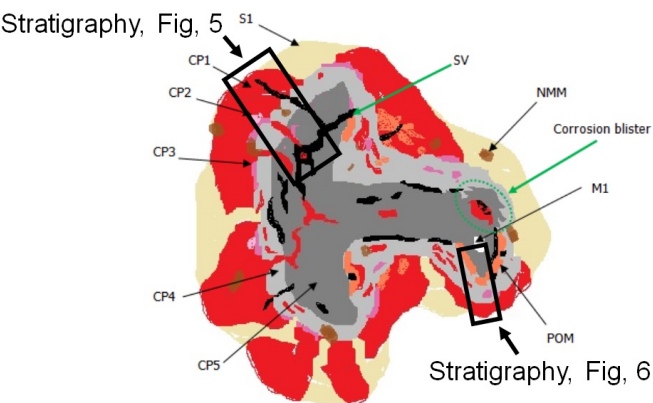
The schematic representation of corrosion layers of Fig. 3 integrating additional information based on the analyses carried out is given in Fig. 14. The following strata were identified:

Fig. 14: Improved stratigraphic representation of the nail from visual observations and analyses and visualization of the two stratigraphies of Figs, 5 and 6,
