SITULA EMT09-554.665 – TIN BRONZE – IRON AGE – SWITZERLAND

Artefact name	Situla EMT09-554.665
Authors	Christian. Degriigny (HE-Arc CR, Neuchâtel, Neuchâtel, Switzerland) & Marie-Jeanne. Scholl (HE-Arc CR, Neuchâtel, Neuchâtel, Switzerland) & Valentin. Boissonnas (HE-Arc CR, Neuchâtel, Neuchâtel, Switzerland)
Url	/artefacts/601/

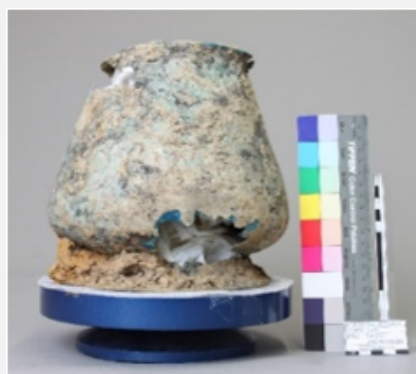
Fig. 1: Situla (Archeodunum (Gollion), 2009) inverted as found in situ,

Description of the artefact	Situla (Fig. 1) covered with blue-green corrosion products and sediments. Attached to two riveted iron loops is an iron handle terminating in two swan heads (not shown here). Dimensions of the main body: Hmax = 340mm, Ømax = 220mm.
Type of artefact	Situla
Origin	Mormont sanctuary, La Sarraz, Vaud, Switzerland
Recovering date	Excavated in 2011
Chronology category	Iron Age
chronology tpq	140 B.C. ▼
chronology taq	30 B.C. ▼
Chronology comment	La Tène D
Burial conditions / environment	Soil
Artefact location	Musée cantonal d'archéologie et d'histoire, Lausanne, Vaud
Owner	Musée cantonal d'archéologie et d'histoire, Lausanne, Vaud
Inv. number	EMT09/554.665
Recorded conservation data	Not conserved

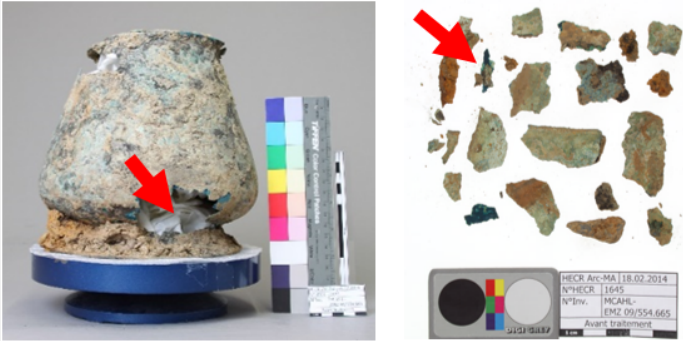
Fig. 2: Location of sampling area and sample selected from detached fragments,

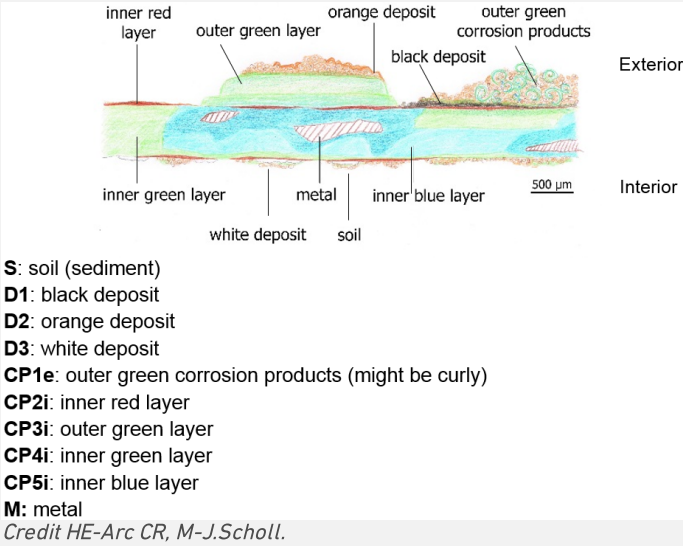
The schematic representation below gives an overview of the corrosion layers encountered on the situla from a first visual macroscopic observation (additional e and i within the coding correspond to strata in contact with the environment (e) and internal strata (i)).

Fig. 3: Stratigraphic representation of the situla in cross-section by macroscopic observation,

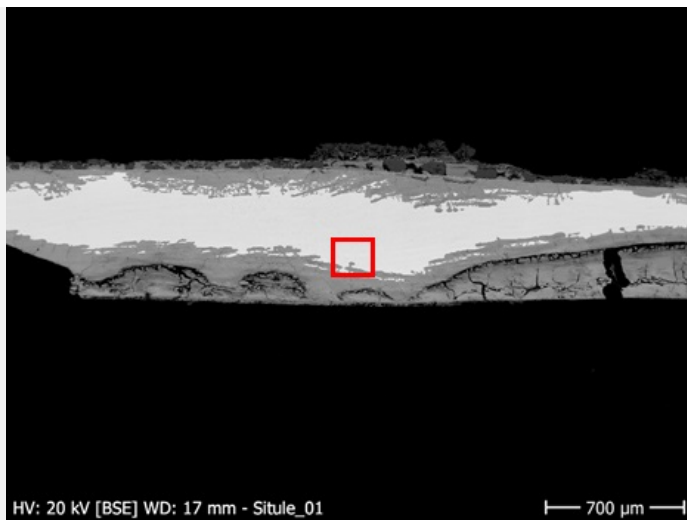
The remaining metal is a dense tin bronze (Fig. 7, Table 1), showing no inclusion. In bright field, the etched alloy shows a structure principally consisting of polygonal alpha phase grains (Fig. 8). Some of the grains include twin lines (Fig. 9). The presence of strain lines (slip lines) indicates a final cold work without annealing (Fig. 9).

Fig. 8: Micrograph of the metal structure from Fig. 7 (detail), etched, bright field, 50x. The alpha phase of the alloy shows polygonal grains. Area of Fig. 9 is marked by a red rectangle,

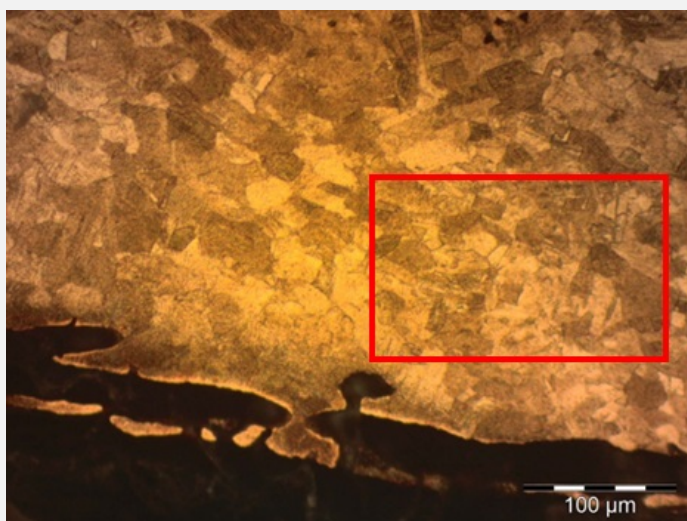
Fig. 9: Micrograph of the selected area of Fig. 8, etched, bright field, 500x. The grains show both twin and strain lines,

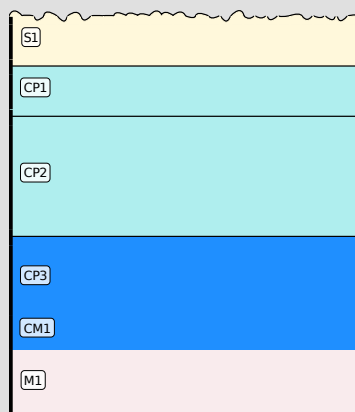
Fig. 5: Stratigraphic representation of the sample taken from the detached fragment of the situla in cross-section using the MiCorr application. The characteristics of the strata are only accessible by clicking on the drawing that redirects you to the search tool by stratigraphy representation. This representation shows the exterior face and can be compared to Fig. 10 (bottom red rectangle), Credit HE-Arc CR, M-J.Scholl.

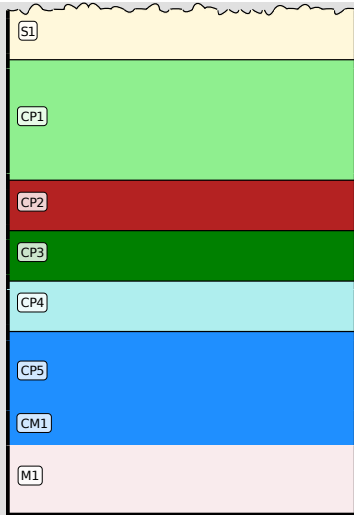
There are 2 stratigraphies (Fig. 5 corresponding to the interior face of the situla and Fig. 6 to its exterior face). The strata are similar in composition but their coding is different: CP1 to CP3 in Fig. 5 correspond to CP3 to CP5 in Fig. 6. Since the stratigraphy of Fig. 6 is more complete, the composition of each of its strata is given below.

Fig. 6: Stratigraphic representation of the sample taken from the detached fragment of the situla in cross-section using the MiCorr application. The characteristics of the strata are only accessible by clicking on the drawing that redirects you to the search tool by stratigraphy representation. This representation shows the interior face and can be compared to Fig. 10 (top red rectangle), Credit HE-Arc CR, M-J.Scholl.

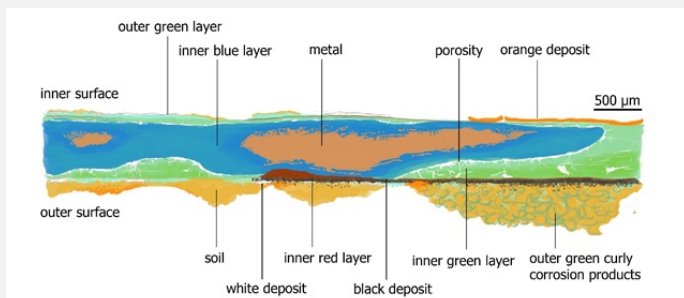
Fig. 16: Improved stratigraphic representation of the situla from visual observations and analyses,

Strata	Composition
Soil (S)	Ca, Si, Al, Fe
Black deposit (D1)	C
Orange deposit (D2)	Ferrous oxides
White deposit (D3)	Ca
Outer green curly corrosion product (CP1e)	Copper carbonates (curly malachite)
Inner red (CP2i)	Copper oxide (cuprite ?)
Outer green layer (CP3i)	Copper carbonates (malachite)
Inner green layer (CP4i)	Copper carbonates (?) + Sn
Inner blue layer (CP5i)	Copper carbonates (?) + Sn
Remnant metal phase (M)	Bronze (90%Cu, 10% Sn)
