SITULA EMT09-554.665 – TIN BRONZE – IRON AGE – SWITZERLAND

Artefact name	Situla EMT09-554.665
Authors	Christian. Degriigny (HE-Arc CR, Neuchâtel, Neuchâtel, Switzerland) & Marie-Jeanne. Scholl (HE-Arc CR, Neuchâtel, Neuchâtel, Switzerland) & Valentin. Boissonnas (HE-Arc CR, Neuchâtel, Neuchâtel, Switzerland)
Url	/artefacts/601/

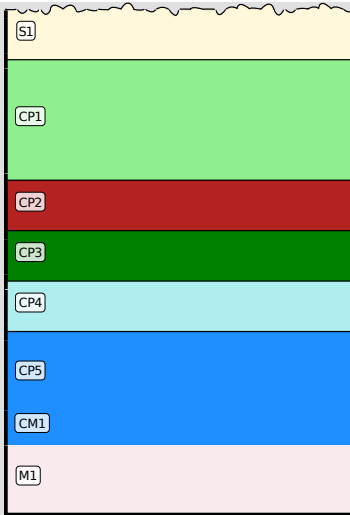
Fig. 14: FTIR spectrum (ATR mode) of the inner blue layer compared to the silicate and malachite standard spectrum. Method of analysis: FTIR spectroscopy, HE- Arc CR,

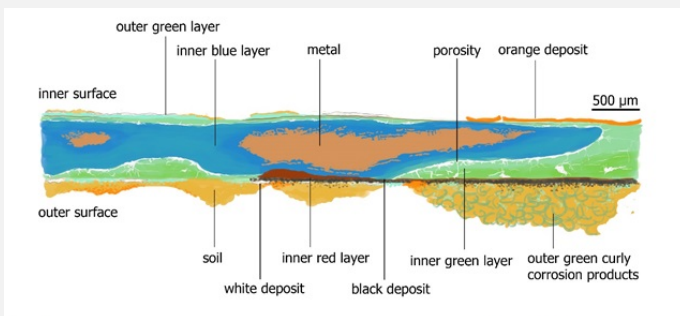
Fig. 16: Improved stratigraphic representation of the situla from visual observations and analyses,

Strata	Composition
Soil (S)	Ca, Si, Al, Fe
Black deposit (D1)	C
Orange deposit (D2)	Ferrous oxides
White deposit (D3)	Ca
Outer green curly corrosion product (CP1e)	Copper carbonates (curly malachite)
Inner red (CP2i)	Copper oxide (cuprite ?)
Outer green layer (CP3i)	Copper carbonates (malachite)
Inner green layer (CP4i)	Copper carbonates (?) + Sn
Inner blue layer (CP5i)	Copper carbonates (?) + Sn
Remnant metal phase (M)	Bronze (90%Cu, 10% Sn)

The metal structure of this low-tin bronze shows extensive cold work and multiple annealing cycles with a final cold work. The total absence of inclusions highlights a highly developed knowledge in bronze metallurgy. The metal is much corroded. Transgranular corrosion is visible. The majority of the internal corrosion products are composed of copper carbonates that have replaced much of the metal. Curly malachite has developed in clusters on the outside of the surface. This pattern is characteristic of a long-term burial period. The presence of inner enriched Sn layers shows a decuprification phenomenon (dissolution of Cu). Because of the friable nature of the inner green layer that supports the limit of the original surface, as well as its cleavage with the blue layer underneath, the original surface has become very fragile. The corrosion is thought to be of type 1 according to Robbiola et al. 1998.
