SITULA EMT09-554.665 – TIN BRONZE – IRON AGE – SWITZERLAND

Artefact name	Situla EMT09-554.665
Authors	Christian. Degriigny (HE-Arc CR, Neuchâtel, Neuchâtel, Switzerland) & Marie-Jeanne. Scholl (HE-Arc CR, Neuchâtel, Neuchâtel, Switzerland) & Valentin. Boissonnas (HE-Arc CR, Neuchâtel, Neuchâtel, Switzerland)
Url	/artefacts/601/

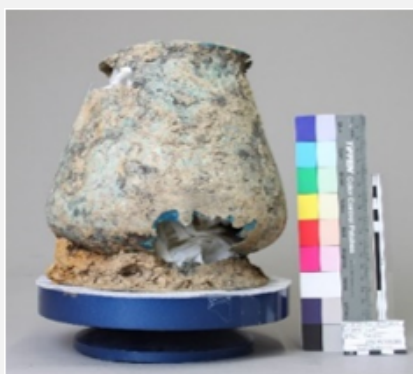
Fig. 1: Situla (Archeodunum (Gollion), 2009) inverted as found in situ,

Description of the artefact	Situla (Fig. 1) covered with blue-green corrosion products and sediments. Attached to two riveted iron loops is an iron handle terminating in two swan heads (not shown here). Dimensions of the main body: Hmax = 340mm, Ømax = 220mm.
Type of artefact	Situla
Origin	Mormont sanctuary, La Sarraz, Vaud, Switzerland
Recovering date	Excavated in 2011
Chronology category	Iron Age
chronology tpq	<input type="text" value="140"/> B.C. ▾
chronology taq	<input type="text" value="30"/> B.C. ▾
Chronology comment	La Tène D
Burial conditions / environment	Soil
Artefact location	Musée cantonal d'archéologie et d'histoire, Lausanne, Vaud
Owner	Musée cantonal d'archéologie et d'histoire, Lausanne, Vaud
Inv. number	EMT09/554.665

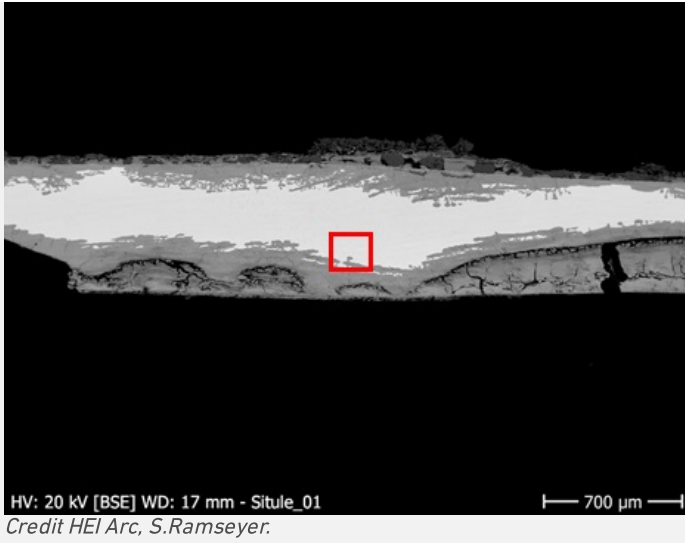
The remaining metal is a dense tin bronze (Fig. 7, Table 1), showing no inclusion. In bright field, the etched alloy shows a structure principally consisting of polygonal alpha phase grains (Fig. 8). Some of the grains include twin lines (Fig. 9). The presence of strain lines (slip lines) indicates a final cold work without annealing (Fig. 9).

Fig. 7: SEM image, BSE-mode, of the metal sample from Fig. 4. Area of Fig. 8 is marked by a red square,

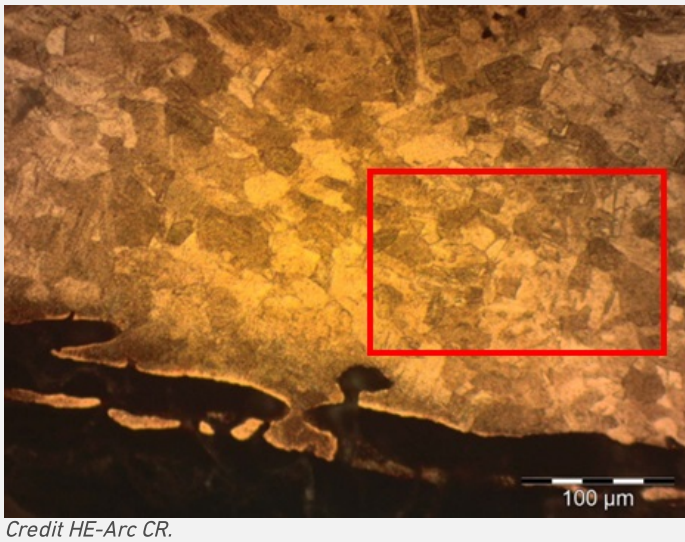
Fig. 8: Micrograph of the metal structure from Fig. 7 (detail), etched, bright field, 50x. The alpha phase of the alloy shows polygonal grains. Area of Fig. 9 is marked by a red rectangle,

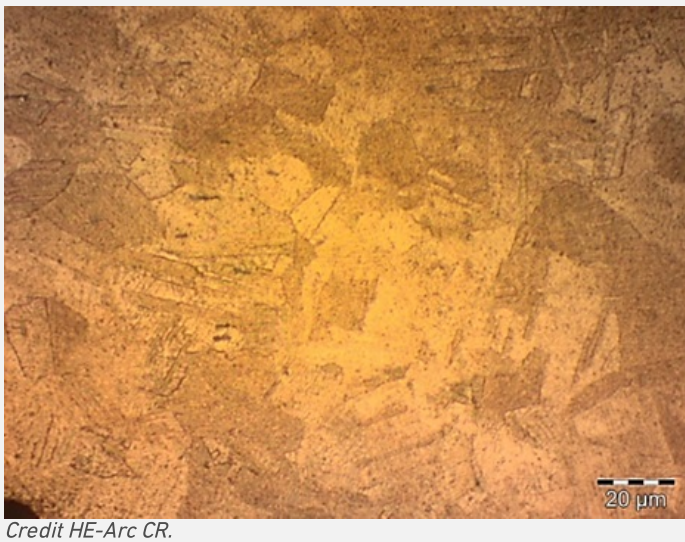
Fig. 9: Micrograph of the selected area of Fig. 8, etched, bright field, 500x. The grains show both twin and strain lines,

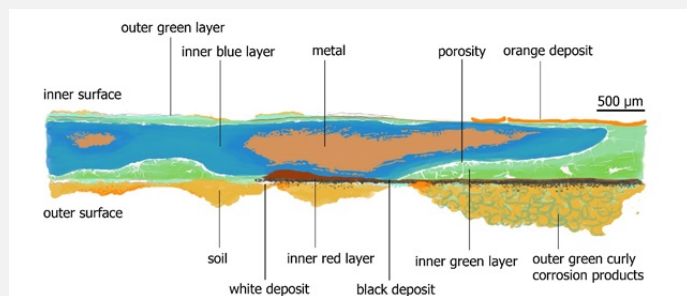
Fig. 16: Improved stratigraphic representation of the situla from visual observations and analyses,

Strata	Composition
Soil (S)	Ca, Si, Al, Fe
Black deposit (D1)	C
Orange deposit (D2)	Ferrous oxides
White deposit (D3)	Ca
Outer green curly corrosion product (CP1e)	Copper carbonates (curly malachite)
Inner red (CP2i)	Copper oxide (cuprite ?)
Outer green layer (CP3i)	Copper carbonates (malachite)
Inner green layer (CP4i)	Copper carbonates (?) + Sn
Inner blue layer (CP5i)	Copper carbonates (?) + Sn
Remnant metal phase (M)	Bronze (90%Cu, 10% Sn)
