SITULA EMT09-554.665 – TIN BRONZE – IRON AGE – SWITZERLAND

Artefact name Situla EMT09-554.665

Authors Christian. Degriigny (HE-Arc CR, Neuchâtel, Neuchâtel, Switzerland) & Marie-Jeanne. Scholl (HE-Arc CR, Neuchâtel, Neuchâtel, Switzerland) & Valentin. Boissonnas (HE-Arc CR, Neuchâtel, Neuchâtel, Switzerland)

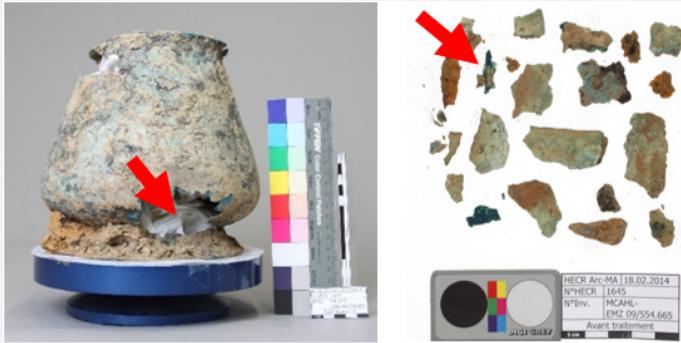
Fig. 2: Location of sampling area and sample selected from detached fragments,

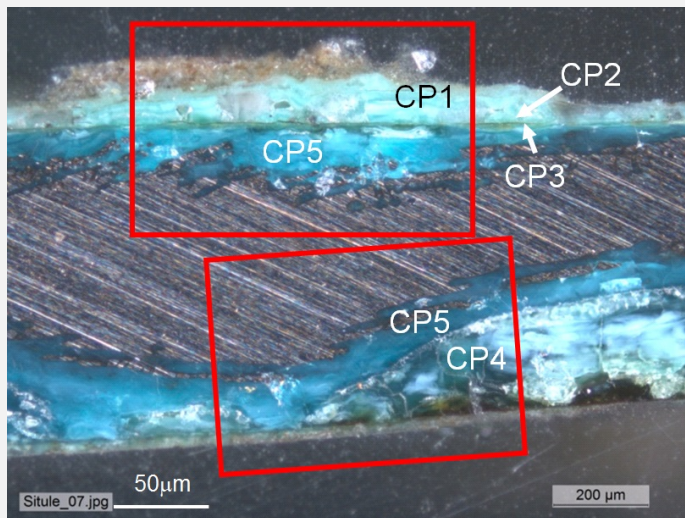
Table 2: Chemical composition of the corrosion crust from Fig. 10. SEM-EDS, Lab of Electronic Microscopy and Microanalysis, IMA (Néode) (+++: high concentration, ++ medium concentration, + low concentration, nd: not-detected).

Fig. 10: Micrograph of the metal sample from Fig. 4, unetched, dark field, 50x. Areas of Fig. 11 (bottom, corresponding to the stratigraphy of Fig. 5) and Figs. 12 and 13 (top, corresponding to the stratigraphy of Fig. 6) are marked by a rectangle. Codes are those of Fig. 6.

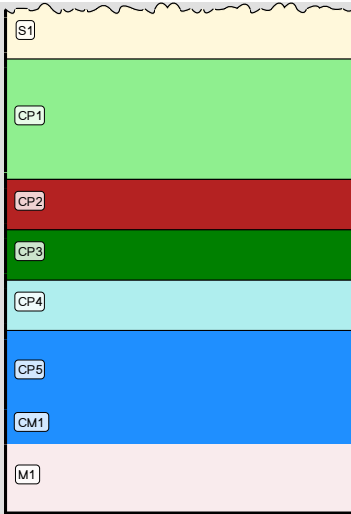
There are 2 stratigraphies (Fig. 5 corresponding to the interior face of the situla and Fig. 6 to its exterior face). The strata are similar in composition but their coding is different: CP1 to CP3 in Fig. 5 correspond to CP3 to CP5 in Fig. 6. Since the stratigraphy of Fig. 6 is more complete, the composition of each of its strata is given below.

Fig. 6: Stratigraphic representation of the sample taken from the detached fragment of the situla in cross-section using the MiCorr application. The characteristics of the strata are only accessible by clicking on the drawing that redirects you to the search tool by stratigraphy representation. This representation shows the interior face and can be compared to Fig. 10 (top red rectangle), Credit HE-Arc CR, M-J.Scholl.

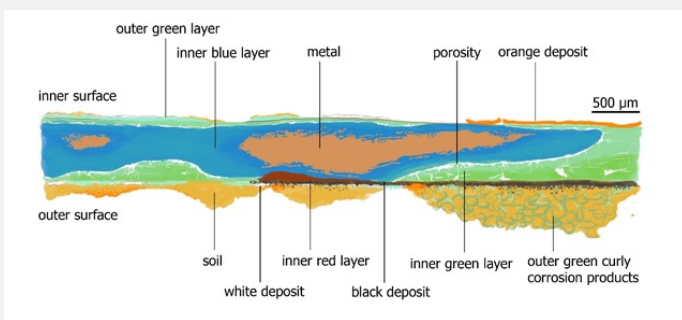
Fig. 16: Improved stratigraphic representation of the situla from visual observations and analyses,

Strata	Composition
Soil (S)	Ca, Si, Al, Fe
Black deposit (D1)	C
Orange deposit (D2)	Ferrous oxides
White deposit (D3)	Ca
Outer green curly corrosion product (CP1e)	Copper carbonates (curly malachite)
Inner red (CP2i)	Copper oxide (cuprite ?)
Outer green layer (CP3i)	Copper carbonates (malachite)
Inner green layer (CP4i)	Copper carbonates (?) + Sn
Inner blue layer (CP5i)	Copper carbonates (?) + Sn
Remnant metal phase (M)	Bronze (90%Cu, 10% Sn)
