## HISPANO-SUIZA WATER PUMP - AL ALLOY - FRANCE

<b>Artefact name</b>	Hispano-Suiza water pump
<b>Authors</b>	Granget, Elodie (, None) & . (MNAM (Musée National de l'Automobile de Mulhouse), Mulhouse, Alsace, France)
<b>Url</b>	/artefacts/669/

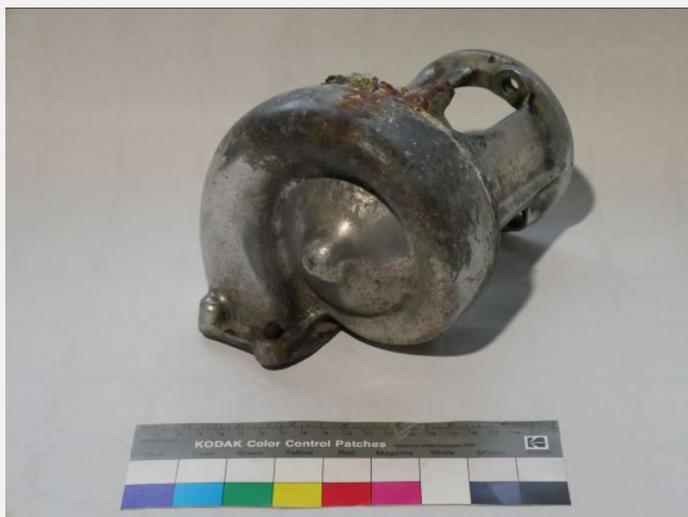
Fig. 1: Hispano-suiza water pump, unknown model,

This Hispano-suiza water pump (Fig. 1), measuring around 15x15x20 cm, is made of 3 parts (Fig. 2):

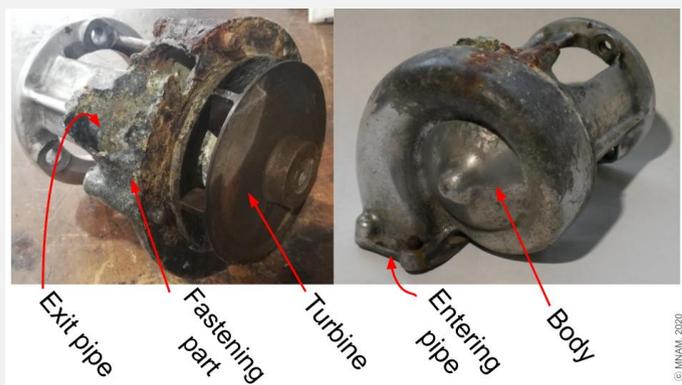
Fig. 2: Body, turbine, fastening part and pipes located on the Hispano water pump,

- > A body (or cover), shaped like a snail, containing the entering pipe,
- > A turbine, inside the pump, connected through the fastening part to a rotating shaft of the engine,
- > A fastening part, screwed on the body with steel screws and brass gasket-rings containing the exit pipe.

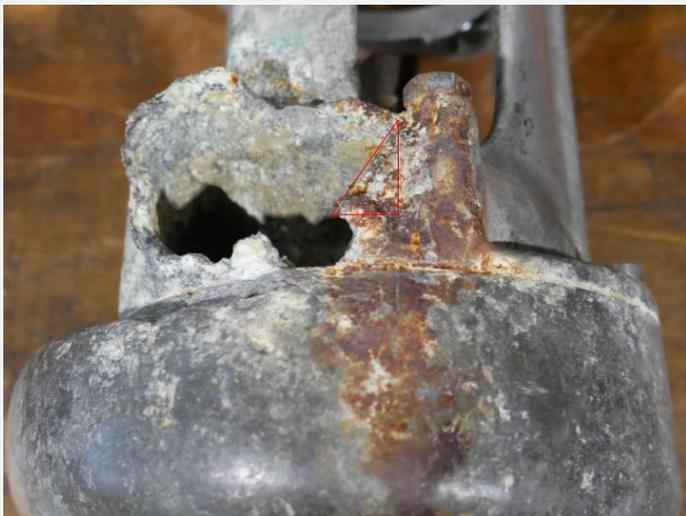
Fig. 3: Location of sampling area on the Hispano water pump,

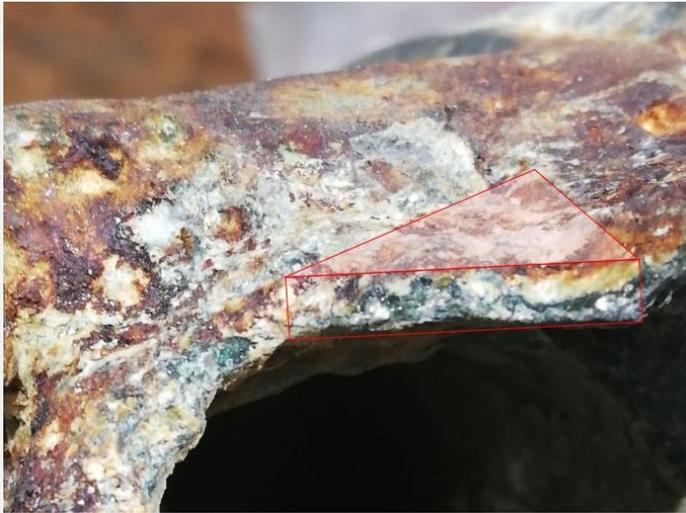
The exit pipe of the fastening part considered within this study is heavily corroded.

Fig. 4: Close-up view of the Hispano water pump, with the exit pipe sampling area,

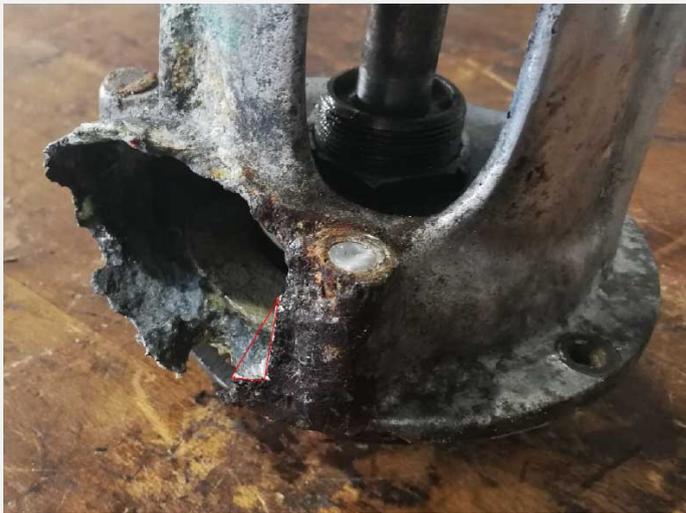
Fig. 5: Close-up view of the corroded exit pipe of the disassembled Hispano water pump, showing the sampled area,

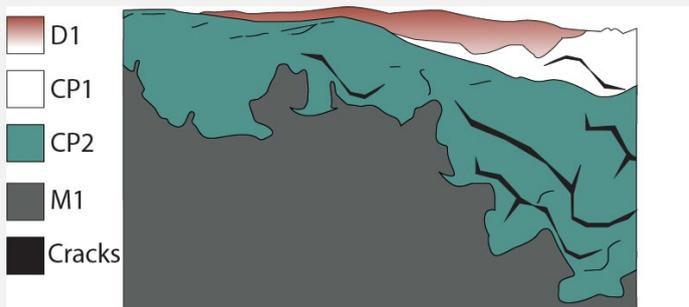
The CP strata show big cracks and can be removed with a bit of scratching (severable). CP2 has a green-blueish color. Over most of the corroded part there is a thick red-orange deposit. This is probably coming from the corroded steel screws, used to fasten the parts of the water-pump.

Fig. 6: Stratigraphic representation of the corroded exit pipe of the water pump in cross-section by macroscopic observation, M = metal, CP = corrosion product, D = deposit,

During the sampling, the orange colored deposit layer (D1 on Fig. 6) was lost.

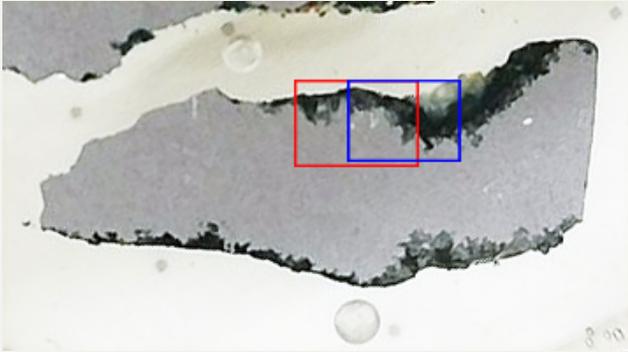
Fig. 7: Micrograph of the sample taken from the corroded exit pipe of the fastening part of the water pump (Figs. 3 to 5), showing the location of Figs. 9-10 in red and Figs. 12-16 in blue. This is a transversal cut of what is left of the exit pipe, severely consumed by corrosion,

A fragment of the exit pipe of the fastening part of the pump has been sampled and embedded as shown on Fig. 7. This is a transversal cut of what is left of the exit pipe, severely consumed by corrosion.

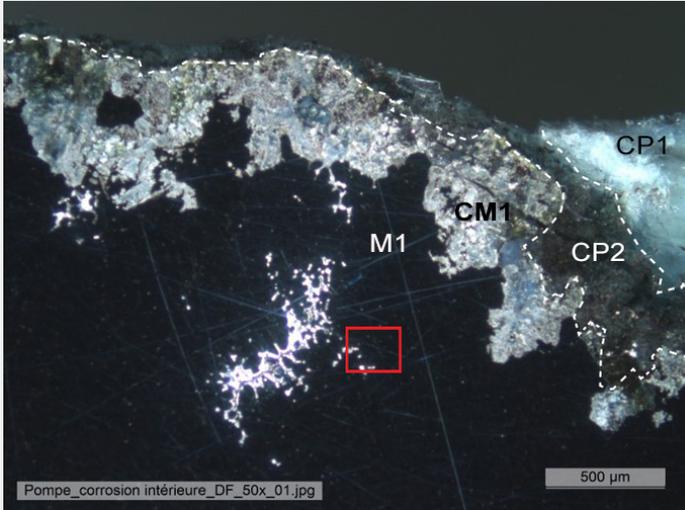
The porosity of this aluminium-copper alloy (Table 1) has been confirmed by optical (Figs. 9 and 10) and SEM observations on the cross-section of the fastening part's fragment (Fig. 11). The metal has a dendritic microstructure (Fig. 11).

Fig. 9: Micrograph of the selected area (in red) of the sample shown on Fig. 7, unetched, dark field with location of Fig. 11,

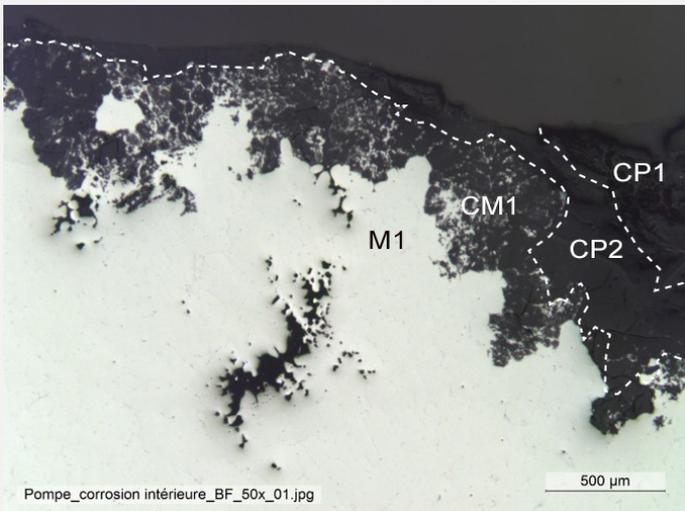
Fig. 10: Micrograph similar to Fig. 9, unetched, bright field,

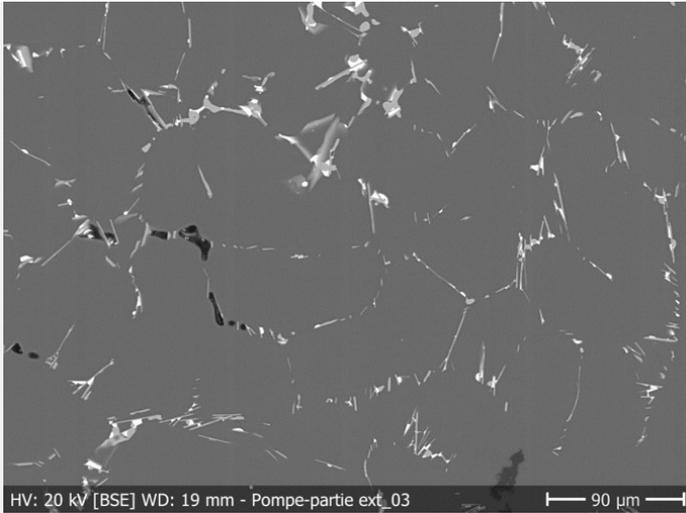
Ponctual analyses on each phase appearing on Fig. 11 showed that the main phase is composed of Al and the interdendritic phases are composed of Al, Cu and Fe as well as Sn precipitates. This distribution is given through EDS elemental chemical distributions (Figs. 13 to 15).

Fig. 11: SEM image (BSE mode) of the metal sample from Fig. 9 showing the microstructure of the fastening part. Black = pore, dark grey = main phase, light grey = interdendritic phase and white = Sn precipitate,

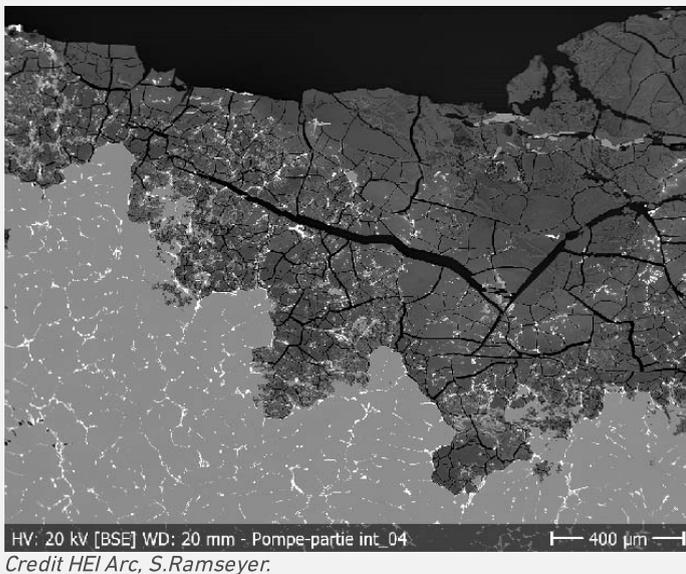
The SEM image of Fig. 12 clearly shows a network of cracks throughout CM1 and CPs. These cracks are not marking any clear separation between strata, but seem to affect all corrosion layers. The main Al phase is preferentially oxidized, while the interdendritic phase seems to be preserved in the corrosion products (Figs. 12 to 14). Na and K but no Fe are detected in the corrosion layers CM1 and CPs (Fig. 15). This surface is in contact with the coolant (glycol + additives, usually mixed 1/1 in water), which sometimes contain Na or K-based corrosion inhibitors. A cluster of CaCO<sub>3</sub> was identified on the very surface of the sample (Fig. 16). CaCO<sub>3</sub> can sometimes precipitate if the water used to mix the coolant is hard.

Fig. 12: SEM image (BSE mode) of the selected area (in blue) of the sample shown on Fig. 7, showing the remaining metal on the bottom and CM1 /CPs on top,

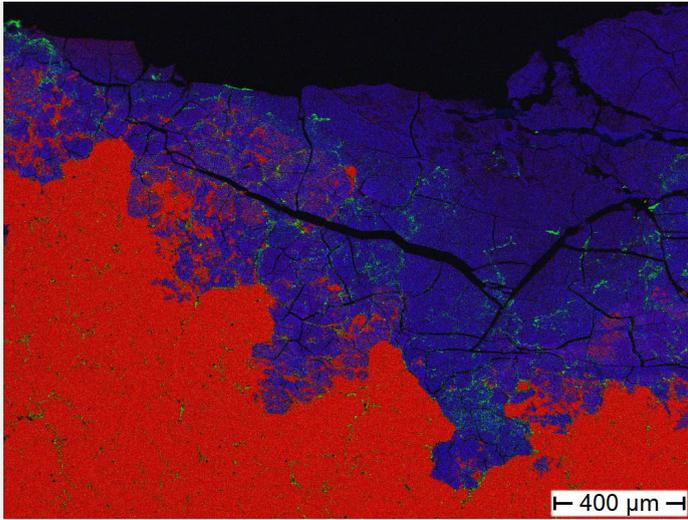
Fig. 13: Al (red), O (blue) and Cu (green) distribution of the area of Fig. 12. Method of analysis: SEM-EDS. Lab. of Electronic Microscopy and Microanalysis, Néode, HEI Arc,

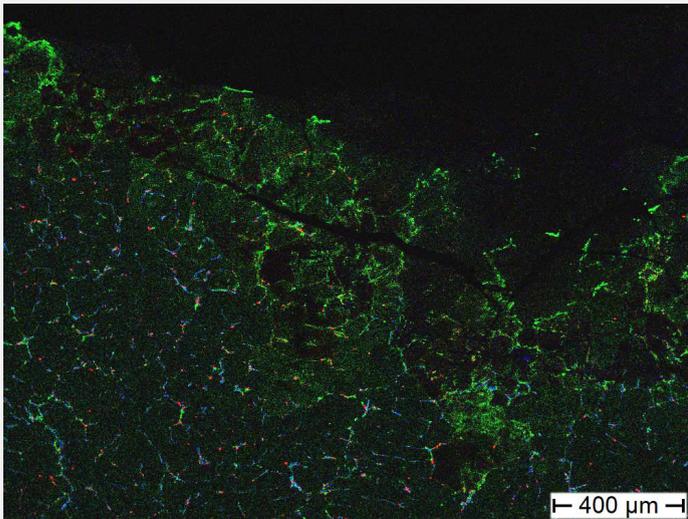
Fig. 14: Sn (red), Fe (blue) and Cu (green) distribution of the area of Fig. 12. Method of analysis: SEM-EDS. Lab. of Electronic Microscopy and Microanalysis, Néode, HEI Arc,

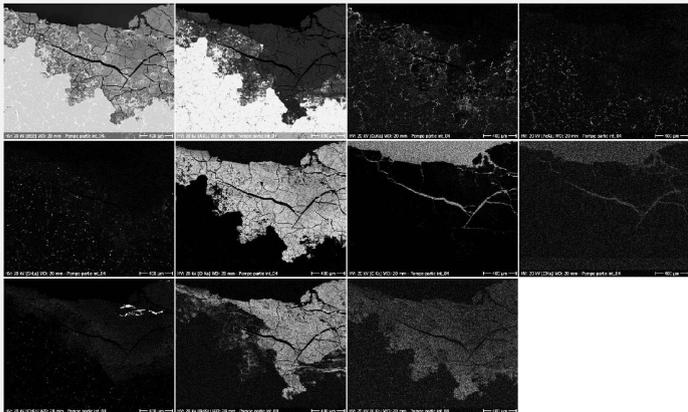
Fig. 15: SEM image and elemental chemical distribution of the area of Fig. 12. Method of analysis: SEM-EDS. Lab. of Electronic Microscopy and Microanalysis, Néode, HEI Arc,

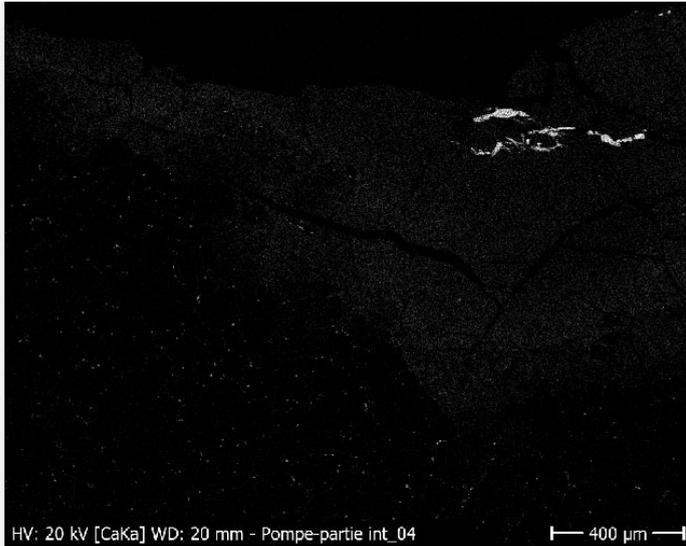
Fig. 16: Ca distribution of the area of Fig. 12. Method of analysis: SEM-EDS. Lab. of Electronic Microscopy and Microanalysis, Néode, HEI Arc,

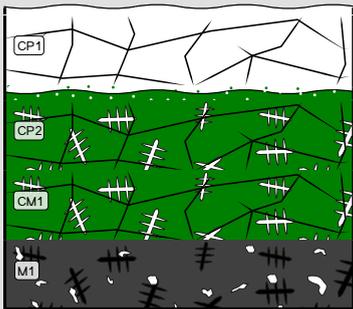
Fig. 8: Stratigraphic representation of the sample taken from the fastening part of the Hispano water pump in cross-section (dark field) using the MiCorr application. The characteristics of the strata are only accessible by clicking on the drawing that redirects you to the search tool by stratigraphy representation. This representation can be compared to Fig. 9, Credit HE-Arc CR, E.Granget.

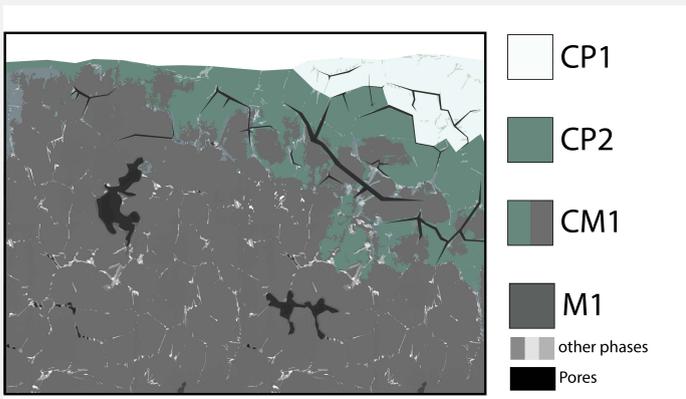
The schematic representation of corrosion layers of Fig. 6 integrating additional information based on the analyses carried out is given in Fig. 17.

Fig. 17: Improved stratigraphic representation of the corrosion structure of the exit pipe of the disassembled Hispano water pump,

The heavily corroded exit pipe of the fastening part of this Hispano-suiza water pump is made out of an Al-Cu cast alloy with traces of Sn, Fe and Si(?). The corrosion is through the dendritic microstructure: the main phase (Al) is preferentially oxidized, while the interdendritic phase (Fe, Sn, Cu) and Sn precipitates are preserved in the corrosion products. This component of the engine being in contact with the coolant might explain the presence of Na, K and Ca in the corrosion layers.
