BUGATTI COOLING SYSTEM PIPE – AL ALLOY – FRANCE

Artefact name Bugatti cooling system pipe

Authors Granget. Elodie (, None) & . (MNAM (Musée National de l'Automobile de Mulhouse), Mulhouse, Alsace, France)

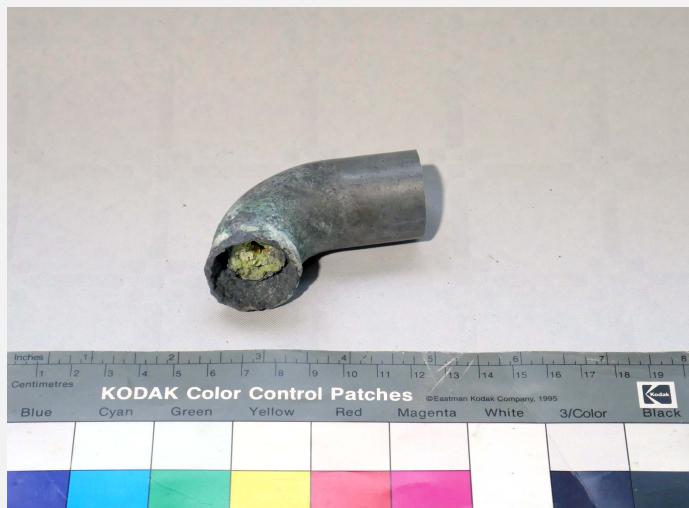
Fig. 1: Bugatti water pipe, unknown model,

Description of the artefact	This section of a pipe was given to the MNAM as study material, without indication of provenance. The pipe is angled, sharply cut on one end and heavily corroded on the other, the inside being clugged by a brittle yellowish deposit.	
Looking at its shape, it is safe to assume that this is an exit pipe from the upper part of the engine (Fig. 2 and complementary information below).		
Type of artefact	Technical object	
Origin	MNAM (Musée National de l'Automobile de Mulhouse), Mulhouse, Alsace, France	
Recovering date	None	
Chronology category	None	
chronology tpp	1920	A.D. ▾
chronology taq	1930	A.D. ▾
Chronology comment		
Burial conditions / environment	Outdoor to indoor atmosphere	
Artefact location	MNAM (Musée National de l'Automobile de Mulhouse), Mulhouse, Alsace	
Owner	MNAM (Musée National de l'Automobile de Mulhouse), Mulhouse, Alsace	
Inv. number	None	
Recorded conservation data	None

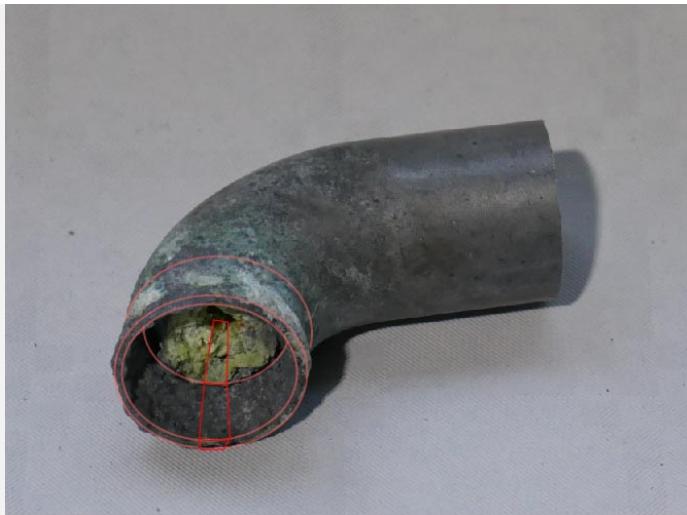
Fig. 3: Heavily corroded side of the Bugatti water pipe showing the sampling area indicated in red,

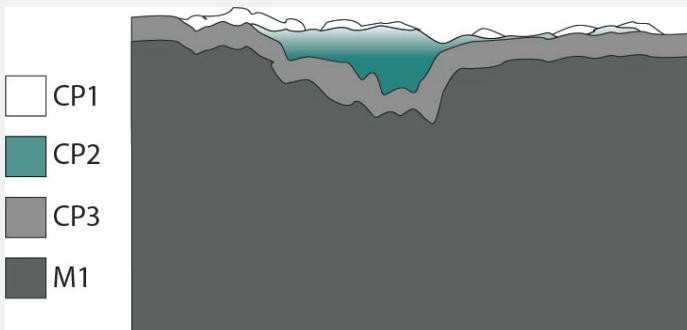
The stratum M is an aluminium alloy. Three CP strata have been identified. CP3 has a greyish mate color and is covering all of the corroded side of the pipe. Scattered over this uniform layer, blue-green (CP2) and white (CP1) spots of corrosion products can be found.

Fig. 4: Stratigraphic representation of the corrosion structure of the external surface of the water pipe in cross section,

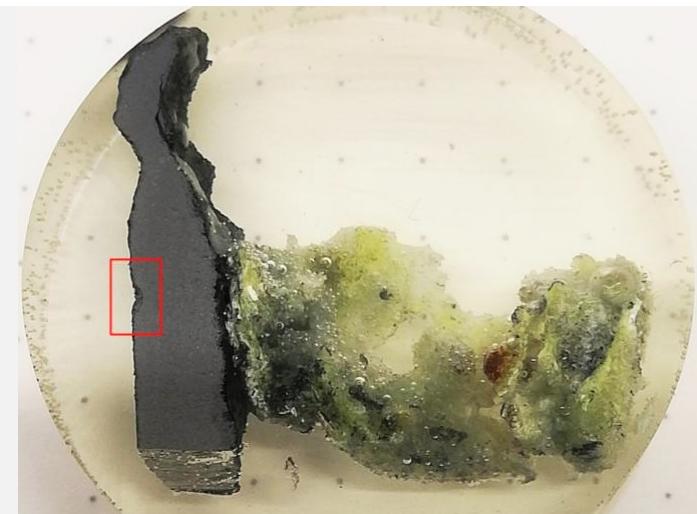
Fig. 6: Micrograph of the sample taken from the corroded exit pipe of the Bugatti water pump (Fig. 3), showing the location of Figs. 8-9 and 12 to 15 in red,

The cross-section shows not only the metal sampled but the accompanying thick yellow deposit that was clugging the pipe. Pitting corrosion develops all along the profile of the sample. A selected area (in red) is further investigated in Figs. 8-9 and 12-15.

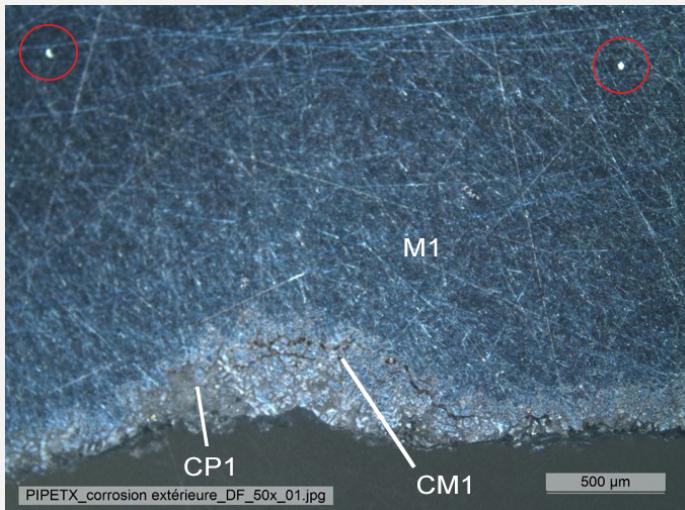
The metal is slightly porous (Fig. 8, red circles). Its dendritic microstructure is revealed by observation in bright field (Fig. 9) and with SEM (Fig. 10).

Fig. 8: Micrograph of the selected area shown on Fig.6 (rotated by 90°), unetched, dark field with indication of pores (red circles),

The BF and DF images (Figs. 8 and 9) show a few big cracks at the interface between CM1 and M1. The SEM image shows that they expand in a network of additional microcracks (Fig. 14). The pipe suffers from a uniform interdendritic corrosion. The Al, Cu and Zn phase is oxidising preferentially, developing then aluminium oxides, versus the interdendritic phases. In some places, pits of corrosion formed. SEM cartography showed a concentration of Cl at the base of the pit (Fig. 14: Green).

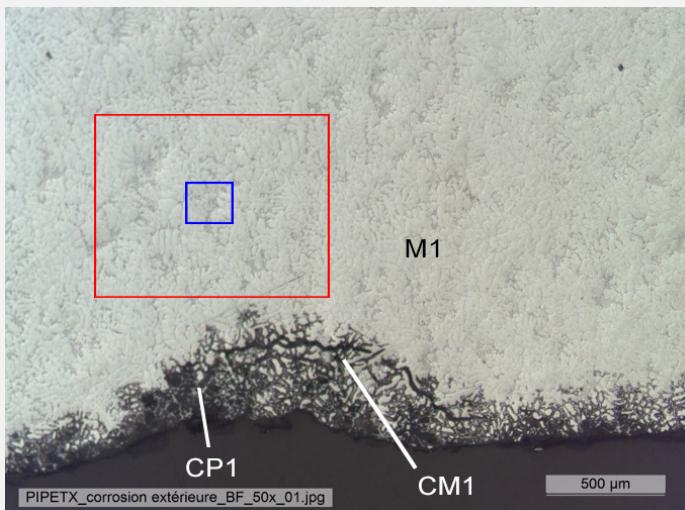
Fig. 9: Micrograph similar to Fig. 8, unetched, bright field showing the locations of Fig. 10 (in red) and Fig. 11 (in blue),

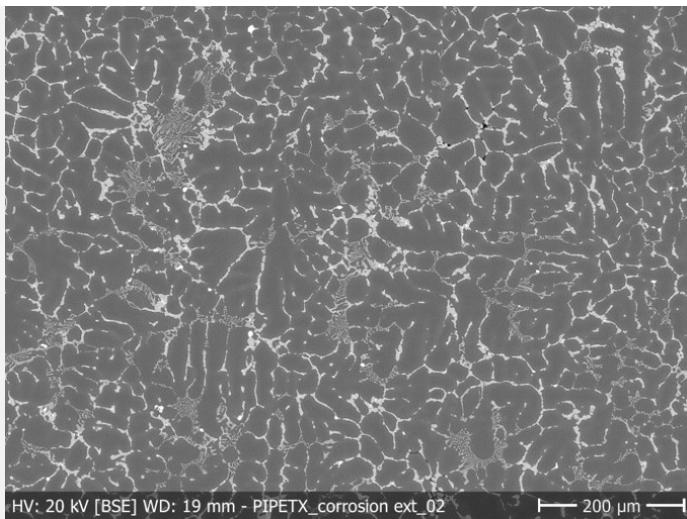
Fig. 10: SEM image (BSE mode) of the metal sample from Fig. 9 showing the microstructure of the pipe. Dark grey = main phase (Al), medium grey = interdendritic phase 1 (eutectic Fe, Cu), light grey = interdendritic phase 2 (Cu) and white = precipitates (Si, Sn),

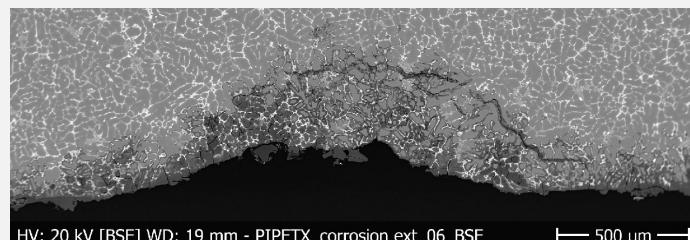
Fig. 14: SEM image of the pitting corrosion of the pipe. BSE, 20kV. Black = Cracks, Dark grey = oxydation, Medium grey = main phase, Light grey = interdendritic phase,

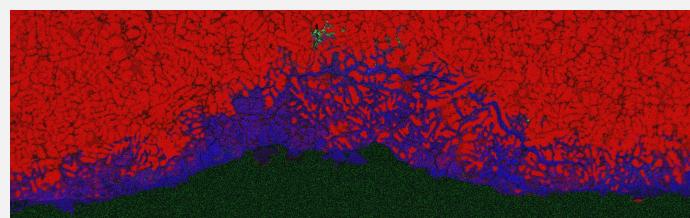
Fig. 15: SEM cartography of a pit of corrosion developing on the pipe. 20kV. Red = Al, Green = Cl, Blue = O,

The external surface shows a uniform interdendritic corrosion preferentially consuming the dentritic phase (Al, Cu, Zn). Pitting corrosion has been identified, with Cl pockets at the base of the pit.

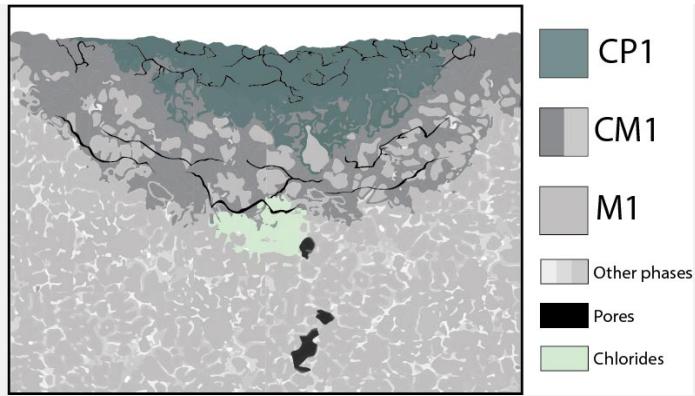
The schematic representation of corrosion layers of Fig. 4 integrating additional information based on the analyses carried out is given in Fig. 16.

Fig. 16: Improved stratigraphic representation of the exit pipe,
