BUGATTI COOLING SYSTEM PIPE – AL ALLOY – FRANCE

Artefact name	Bugatti cooling system pipe
Authors	Granget. Elodie (, None) & . (MNAM (Musée National de l'Automobile de Mulhouse), Mulhouse, Alsace, France)
Url	/artefacts/670/

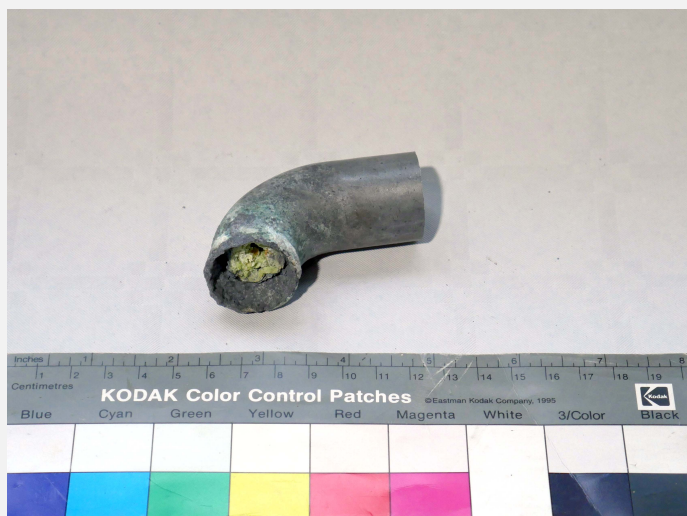
Fig. 1: Bugatti water pipe, unknown model,

Description of the artefact	<p>This section of a pipe was given to the MNAM as study material, without indication of provenance. The pipe is angled, sharply cut on one end and heavily corroded on the other, the inside being clogged by a brittle yellowish deposit.</p> <p>Looking at its shape, it is safe to assume that this is an exit pipe from the upper part of the engine (Fig. 2 and complementary information below).</p>
Type of artefact	Technical object
Origin	MNAM (Musée National de l'Automobile de Mulhouse), Mulhouse, Alsace, France
Recovering date	None
Chronology category	None
chronology tpq	<input type="text" value="1920"/> A.D. ▼
chronology taq	<input type="text" value="1930"/> A.D. ▼
Chronology comment	
Burial conditions / environment	Outdoor to indoor atmosphere
Artefact location	MNAM (Musée National de l'Automobile de Mulhouse), Mulhouse, Alsace
Owner	MNAM (Musée National de l'Automobile de Mulhouse), Mulhouse, Alsace

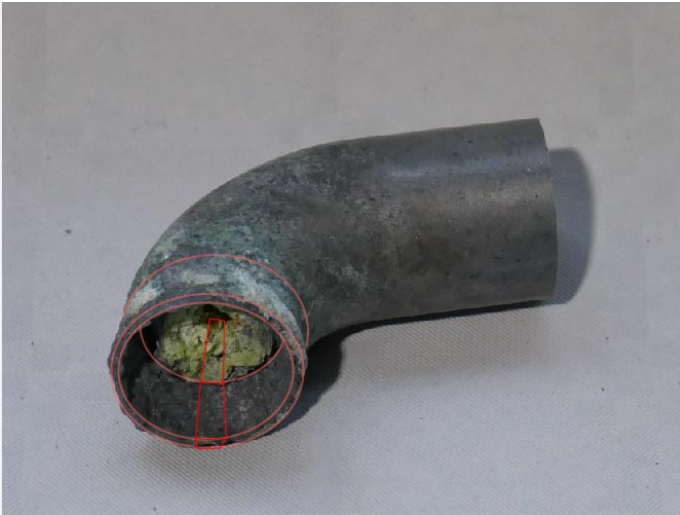
Fig. 3: Heavily corroded side of the Bugatti water pipe showing the sampling area indicated in red,

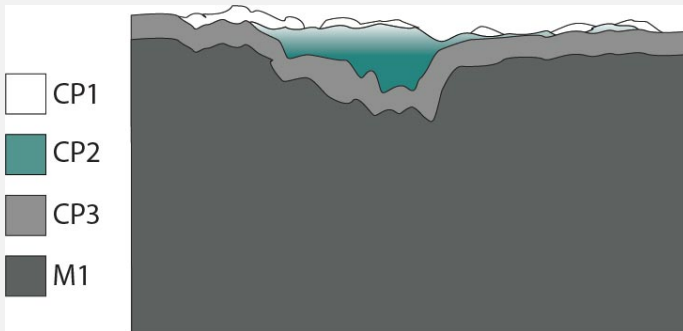
The schematic representation below gives an overview of the corrosion layers encountered on the Bugatti pipe. The stratum M is an aluminium alloy. Three CP strata have been identified. CP3 has a greyish mate color and is covering all of the corroded side of the pipe. Scattered over this uniform layer, blue-green (CP2) and white (CP1) spots of corrosion products can be found.

Fig. 4: Stratigraphic representation of the corrosion structure of the external surface of the water pipe in cross section,

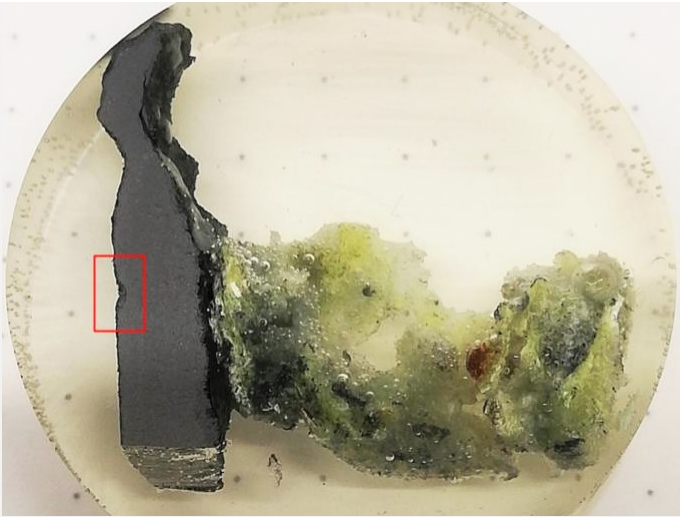
Fig. 6: Micrograph of the sample taken from the corroded exit pipe of the Bugatti water pump (Fig. 3), showing the location of Figs. 8-9

and 12 to 15 in red,

The cross-section shows not only the metal sampled but the accompanying thick yellow deposit that was clogging the pipe. Pitting corrosion develops all along the profile of the sample. A selected area (in red) is further investigated in Figs. 8-9 and 12-15.

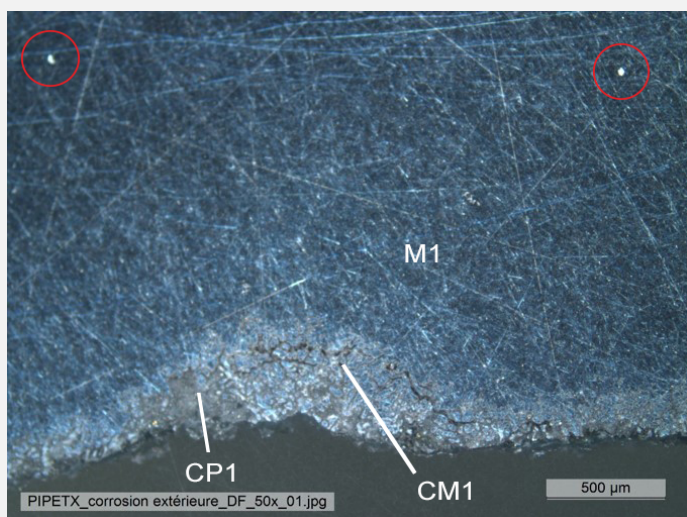
The metal is slightly porous (Fig. 8, red circles). Its dendritic microstructure is revealed by observation in bright field (Fig. 9) and with SEM (Fig. 10).

Fig. 8: Micrograph of the selected area shown on Fig.6 (rotated by 90°), unetched, dark field with indication of pores (red circles),

The BF and DF images (Figs. 8 and 9) show a few big cracks at the interface between CM1 and M1. The SEM image shows that they expand in a network of additional microcracks (Fig. 14). The pipe suffers from a uniform interdendritic corrosion. The Al, Cu and Zn phase is oxidising preferentially, developing then aluminium oxides, versus the interdendritic phases. In some places, pits of corrosion formed. SEM cartography showed a concentration of Cl at the base of the pit (Fig. 14: Green).

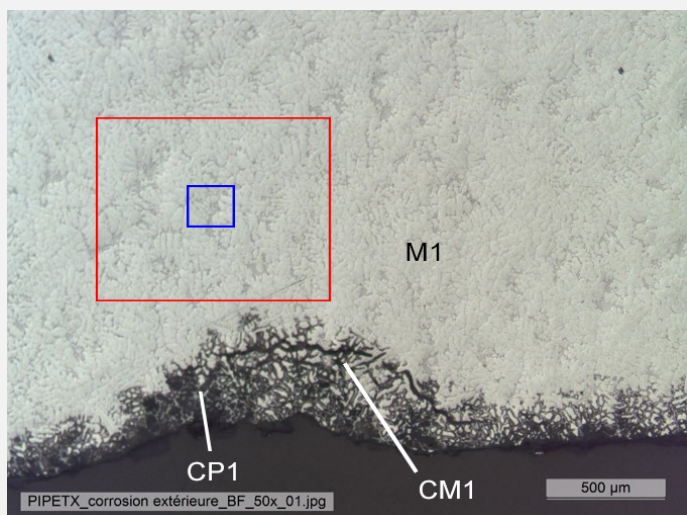
Fig. 9: Micrograph similar to Fig. 8, unetched, bright field showing the locations of Fig. 10 (in red) and Fig. 11 (in blue),

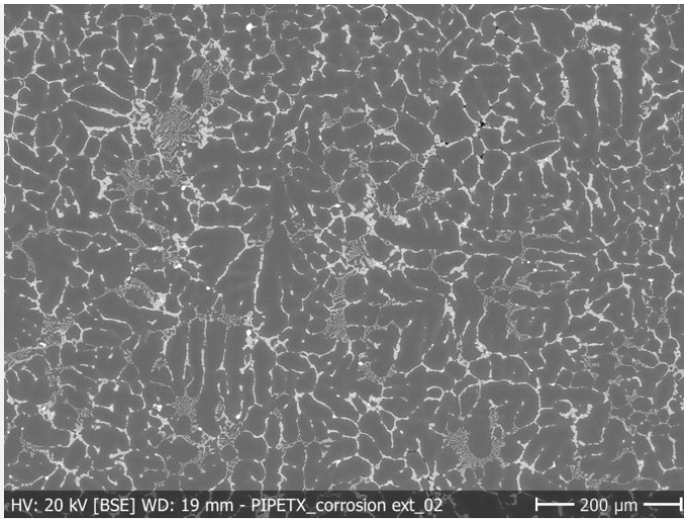
Fig. 10: SEM image (BSE mode) of the metal sample from Fig. 9 showing the microstructure of the pipe. Dark grey = main phase (Al), medium grey = interdendritic phase 1 (eutectic Fe, Cu), light grey = interdendritic phase 2 (Cu) and white = precipitates (Si, Sn),

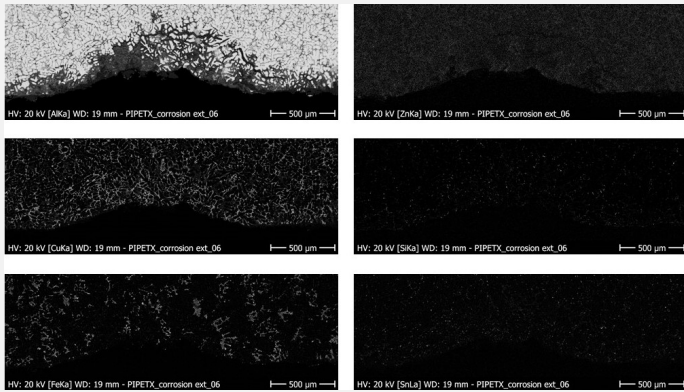
Point analyses of the main dendritic phase showed that it is made of Al, Cu and Zn (Table 1 and Fig. 11). Elemental chemical distribution with EDS allowed to identified the following repartition (Fig. 12): Zn is uniformly present in the alloy. There are two interdendritic phases (Fig. 13): a eutectic phase containing Fe and Cu, and a second phase containing mostly Cu. Additionally Sn and Si precipitates could be identified.

Fig. 12: SEM image and EDS elemental chemical distribution of main and interdendritic phases of the pipe. 20kV,

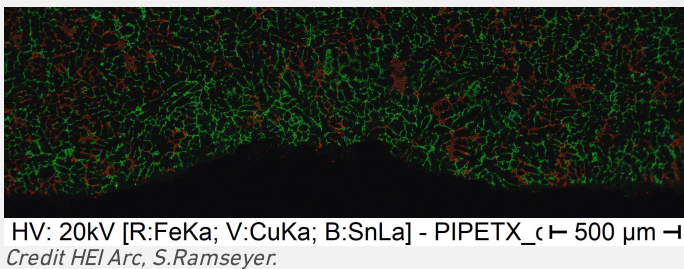
Fig. 13: Fe (red), Cu (green) and Sn (blue) chemical distribution of the area of Fig. 9. Method of analysis: SEM-EDS. Lab. of Electronic Microscopy and Microanalysis, Néode, HEI Arc,

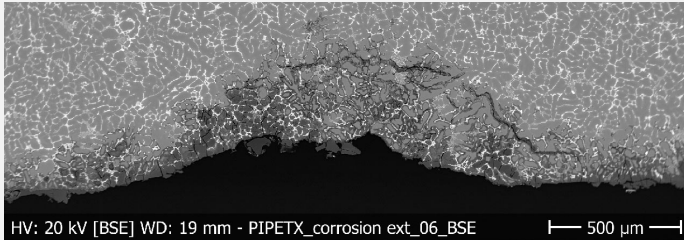
Fig. 14: SEM image of the pitting corrosion of the pipe. BSE, 20kV. Black = Cracks, Dark grey = oxydation, Medium grey = main phase, Light grey = interdendritic phase,

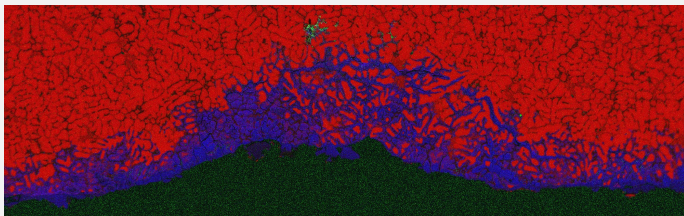
Fig. 15: SEM cartography of a pit of corrosion developing on the pipe. 20kV. Red = Al, Green = Cl, Blue = O,

The external surface shows a uniform interdendritic corrosion preferentially consuming the dendritic phase (Al, Cu, Zn). Pitting corrosion has been identified, with Cl pockets at the base of the pit.

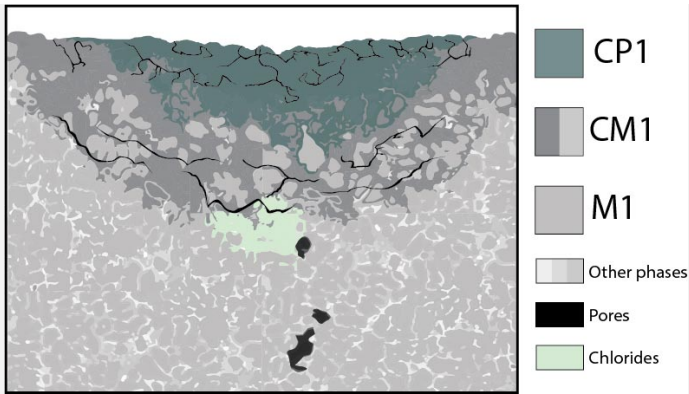
The schematic representation of corrosion layers of Fig. 4 integrating additional information based on the analyses carried out is given in Fig. 16.

Fig. 16: Improved stratigraphic representation of the exit pipe,
