BUGATTI COOLING SYSTEM PIPE – AL ALLOY – FRANCE

Artefact name	Bugatti cooling system pipe
Authors	Granget, Elodie (, None) & . (MNAM (Musée National de l'Automobile de Mulhouse), Mulhouse, Alsace, France)
Url	/artefacts/670/

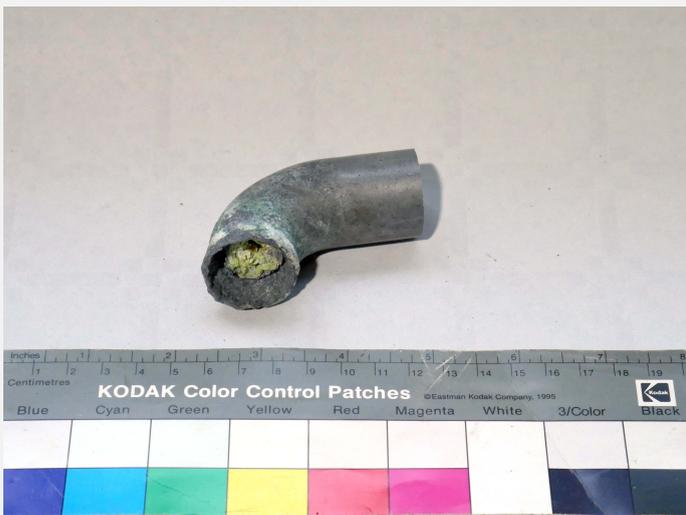
Fig. 1: Bugatti water pipe, unknown model,

Description of the artefact	<p>This section of a pipe was given to the MNAM as study material, without indication of provenance. The pipe is angled, sharply cut on one end and heavily corroded on the other, the inside being clogged by a brittle yellowish deposit.</p> <p>Looking at its shape, it is safe to assume that this is an exit pipe from the upper part of the engine (Fig. 2 and complementary information below).</p>
Type of artefact	Technical object
Origin	MNAM (Musée National de l'Automobile de Mulhouse), Mulhouse, Alsace, France
Recovering date	None
Chronology category	None
chronology tpq	<input type="text" value="1920"/> A.D. ▼
chronology taq	<input type="text" value="1930"/> A.D. ▼
Chronology comment	
Burial conditions / environment	Outdoor to indoor atmosphere
Artefact location	MNAM (Musée National de l'Automobile de Mulhouse), Mulhouse, Alsace
Owner	MNAM (Musée National de l'Automobile de Mulhouse), Mulhouse, Alsace

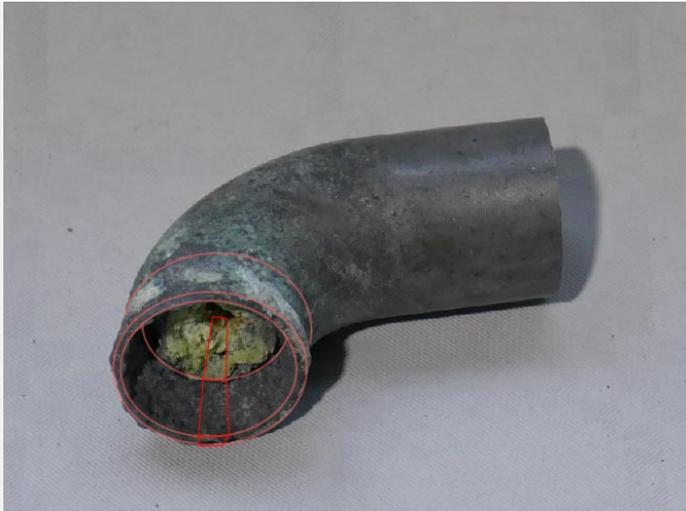
Fig. 3: Heavily corroded side of the Bugatti water pipe showing the sampling area indicated in red,

The schematic representation below gives an overview of the corrosion layers encountered on the Bugatti pipe. The stratum M is an aluminium alloy. Three CP strata have been identified. CP3 has a greyish mate color and is covering all of the corroded side of the pipe. Scattered over this uniform layer, blue-green (CP2) and white (CP1) spots of corrosion products can be found.

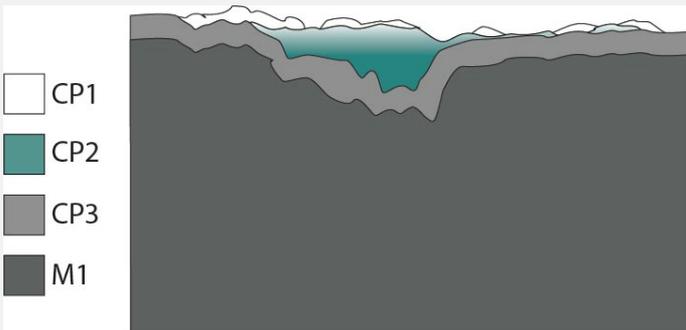
Fig. 4: Stratigraphic representation of the corrosion structure of the external surface of the water pipe in cross section,

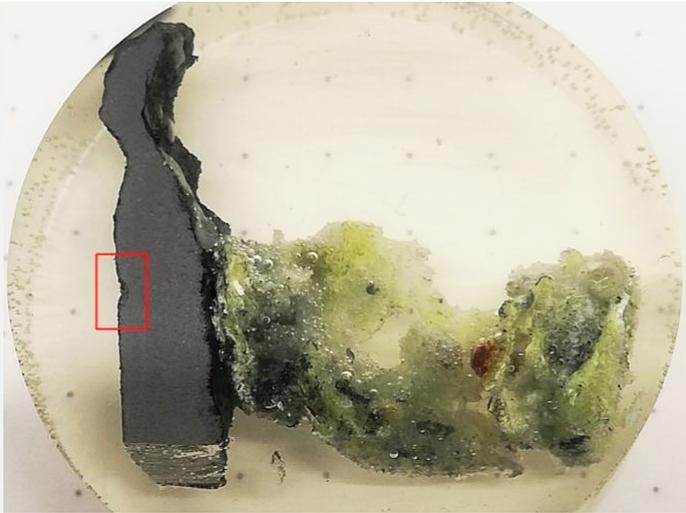
Fig. 6: Micrograph of the sample taken from the corroded exit pipe of the Bugatti water pump (Fig. 3), showing the location of Figs. 8-9 and 12 to 15 in red,

Description of sample	A radial section of the pipe has been sampled and embedded as shown on Fig.6. The cross-section shows not only the metal sampled but the accompanying thick yellow deposit that was clugging the pipe. Pitting corrosion develops all along the profile of the sample. A selected area (in red) is further investigated in Figs. 8-9 and 12-15.
Alloy	Al Alloy
Technology	Cast
Lab number of sample	
Sample location	HE-Arc CR, Neuchâtel, Neuchâtel
Responsible institution	MNAM (Musée National de l'Automobile de Mulhouse), Mulhouse, Alsace
Date and aim of sampling	31.12.2019 - Sampled for Metallography

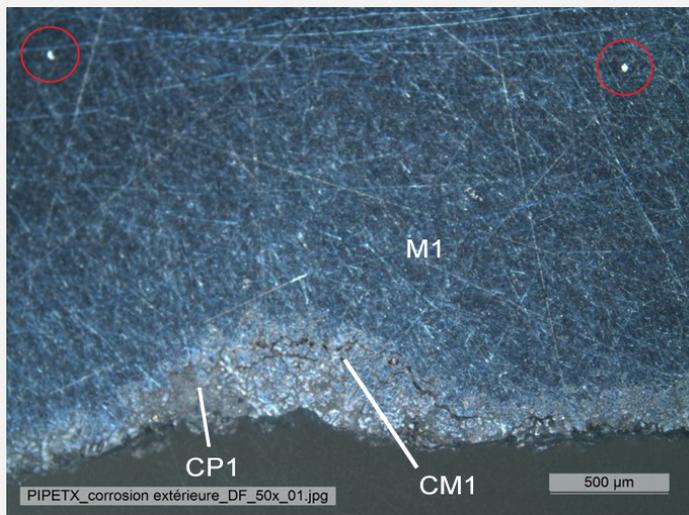
The metal is slightly porous (Fig. 8, red circles). Its dendritic microstructure is revealed by observation in bright field (Fig. 9) and with SEM (Fig. 10).

Fig. 8: Micrograph of the selected area shown on Fig.6 (rotated by 90°), unetched, dark field with indication of pores (red circles),

The BF and DF images (Figs. 8 and 9) show a few big cracks at the interface between CM1 and M1. The SEM image shows that they expand in a network of additional microcracks (Fig. 14). The pipe suffers from a uniform interdendritic corrosion. The Al, Cu and Zn phase is oxidising preferentially, developing then aluminium oxides, versus the interdendritic phases. In some places, pits of corrosion formed. SEM cartography showed a concentration of Cl at the base of the pit (Fig. 14: Green).

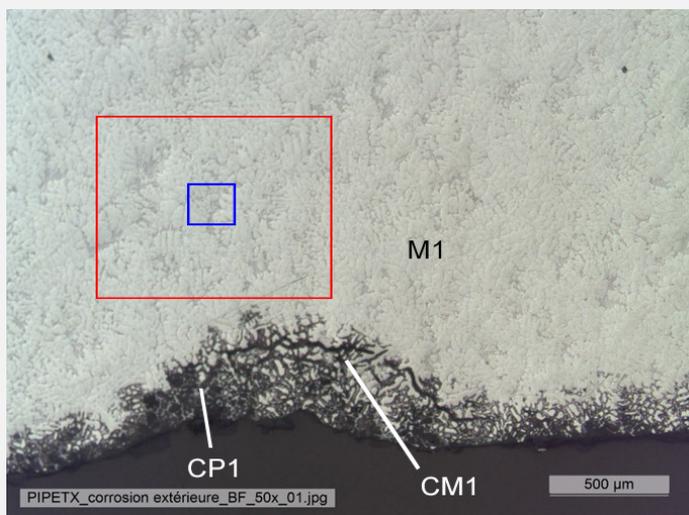
Fig. 9: Micrograph similar to Fig. 8, unetched, bright field showing the locations of Fig. 10 (in red) and Fig. 11 (in blue),

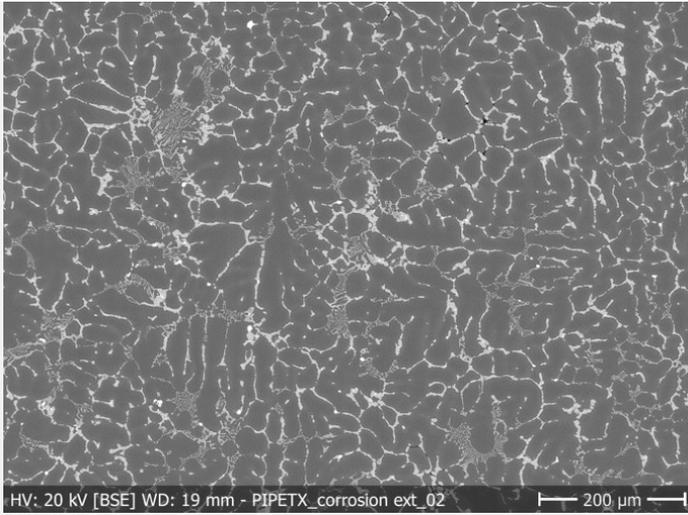
Fig. 10: SEM image (BSE mode) of the metal sample from Fig. 9 showing the microstructure of the pipe. Dark grey = main phase (Al), medium grey = interdendritic phase 1 (eutectic Fe, Cu), light grey = interdendritic phase 2 (Cu) and white = precipitates (Si, Sn),

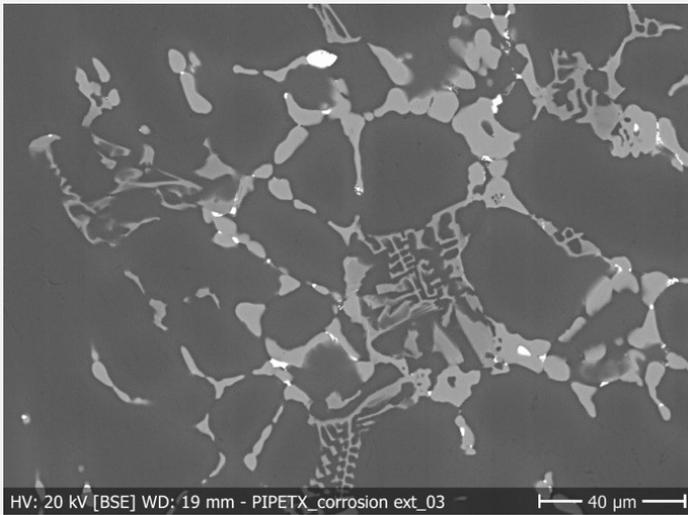
Point analyses of the main dendritic phase showed that it is made of Al, Cu and Zn (Table 1 and Fig. 11). Elemental chemical distribution with EDS allowed to identified the following repartition (Fig. 12): Zn is uniformly present in the alloy. There are two interdendritic phases (Fig. 13): a eutectic phase containing Fe and Cu, and a second phase containing mostly Cu. Additionally Sn and Si precipitates could be identified.

Fig. 11: Close-up image of Fig. 10,

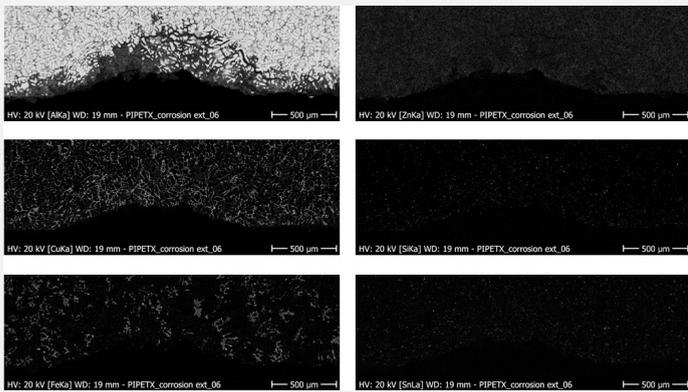
Fig. 12: SEM image and EDS elemental chemical distribution of main and interdendritic phases of the pipe. 20kV,

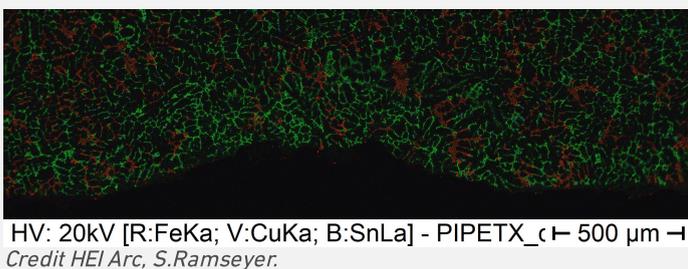
Fig. 13: Fe (red), Cu (green) and Sn (blue) chemical distribution of the area of Fig. 9. Method of analysis: SEM-EDS. Lab. of Electronic Microscopy and Microanalysis, Néode, HEI Arc,

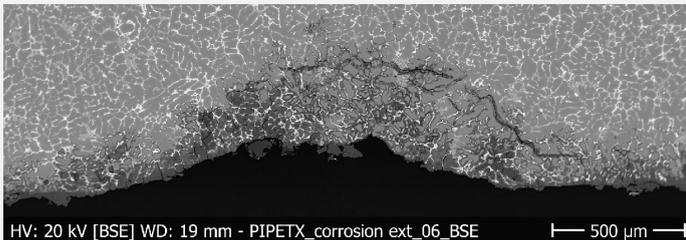
Fig. 14: SEM image of the pitting corrosion of the pipe. BSE, 20kV. Black = Cracks, Dark grey = oxydation, Medium grey = main phase, Light grey = interdendritic phase,

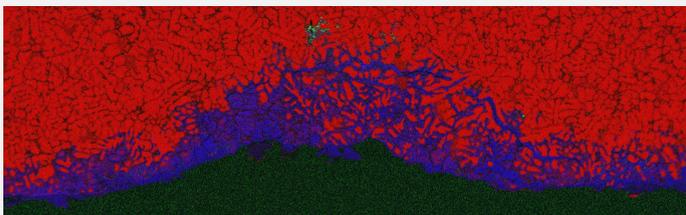
Fig. 15: SEM cartography of a pit of corrosion developing on the pipe. 20kV. Red = Al, Green = Cl, Blue = O,

The external surface shows a uniform interdendritic corrosion preferentially consuming the dendritic phase (Al, Cu, Zn). Pitting corrosion has been identified, with Cl pockets at the base of the pit.

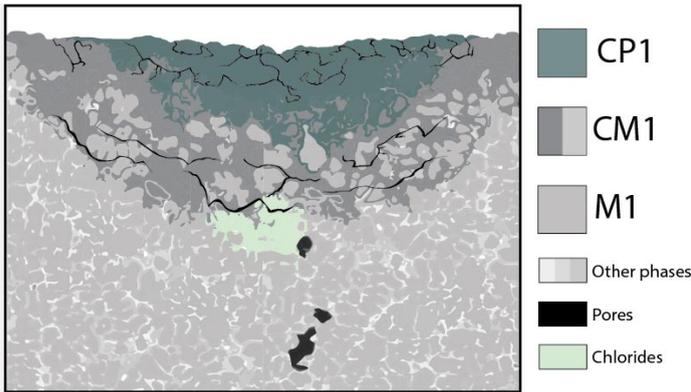
The schematic representation of corrosion layers of Fig. 4 integrating additional information based on the analyses carried out is given in Fig. 16.

Fig. 16: Improved stratigraphic representation of the exit pipe,
