BUGATTI COOLING SYSTEM PIPE – AL ALLOY – FRANCE

Artefact name Bugatti cooling system pipe

Authors Granget. Elodie (, None) & . (MNAM (Musée National de l'Automobile de Mulhouse), Mulhouse, Alsace, France)

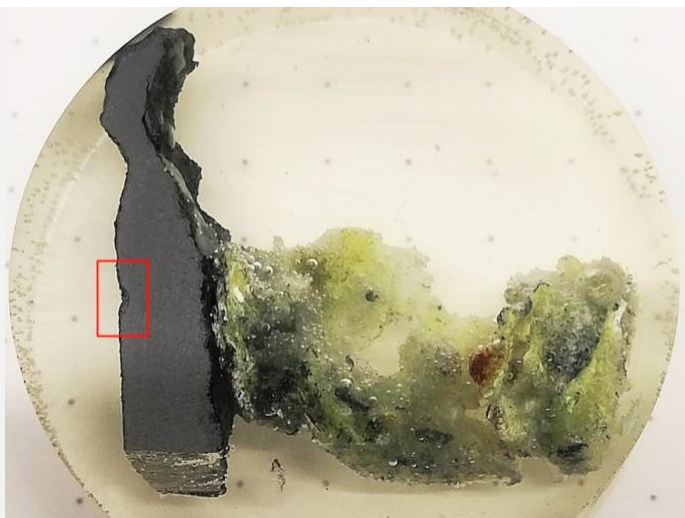
Fig. 6: Micrograph of the sample taken from the corroded exit pipe of the Bugatti water pump (Fig. 3), showing the location of Figs. 8-9

and 12 to 15 in red,

The cross-section shows not only the metal sampled but the accompanying thick yellow deposit that was clogging the pipe. Pitting corrosion develops all along the profile of the sample. A selected area (in red) is further investigated in Figs. 8-9 and 12-15.

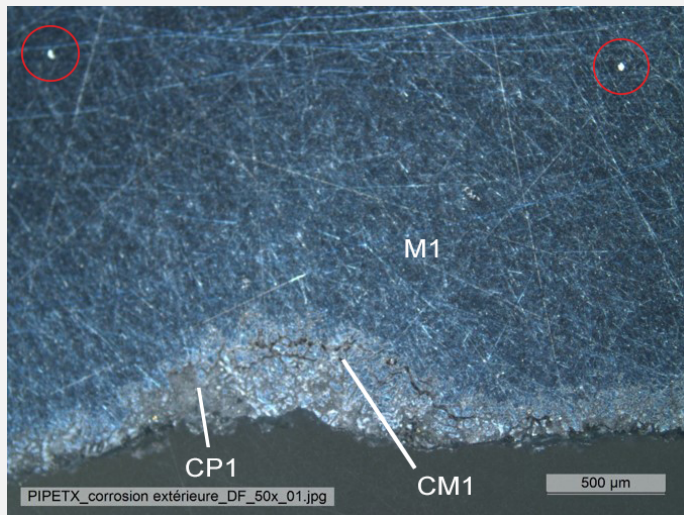
The metal is slightly porous (Fig. 8, red circles). Its dendritic microstructure is revealed by observation in bright field (Fig. 9) and with SEM (Fig. 10).

Fig. 8: Micrograph of the selected area shown on Fig.6 (rotated by 90°), unetched, dark field with indication of pores (red circles),

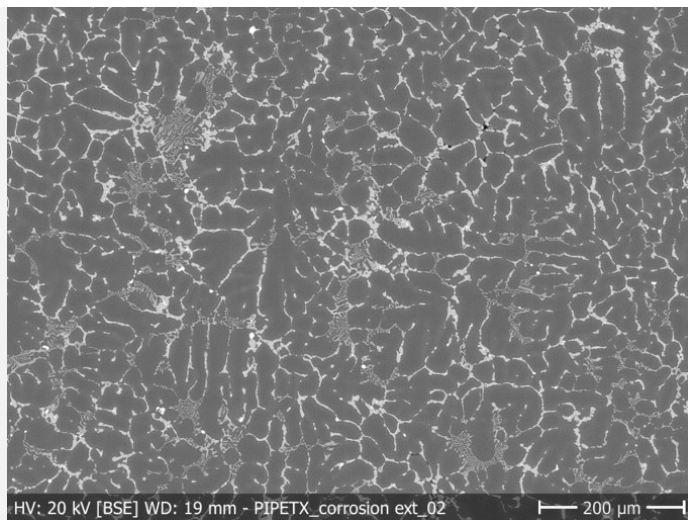
Fig. 10: SEM image (BSE mode) of the metal sample from Fig. 9 showing the microstructure of the pipe. Dark grey = main phase (Al), medium grey = interdendritic phase 1 (eutectic Fe, Cu), light grey = interdendritic phase 2 (Cu) and white = precipitates (Si, Sn),

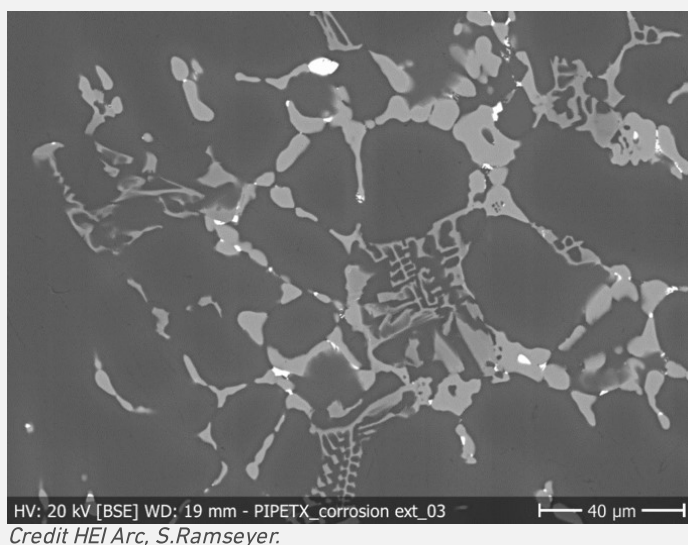
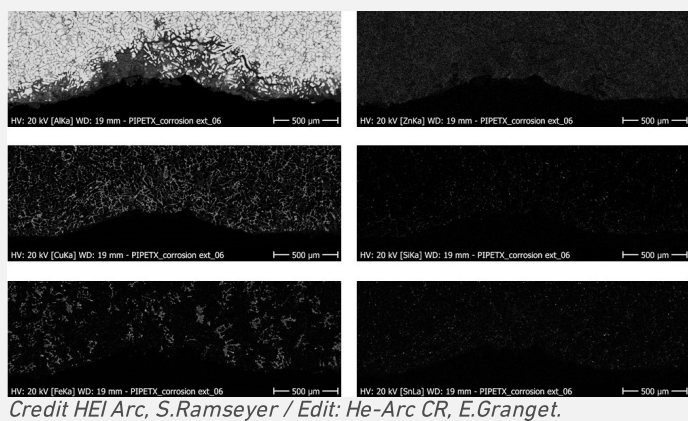
Point analyses of the main dendritic phase showed that it is made of Al, Cu and Zn (Table 1 and Fig. 11). Elemental chemical distribution with EDS allowed to identified the following repartition (Fig. 12): Zn is uniformly present in the alloy. There are two interdendritic phases (Fig. 13): a eutectic phase containing Fe and Cu, and a second phase containing mostly Cu. Additionally Sn and Si precipitates could be identified.

Fig. 12: SEM image and EDS elemental chemical distribution of main and interdendritic phases of the pipe. 20kV,

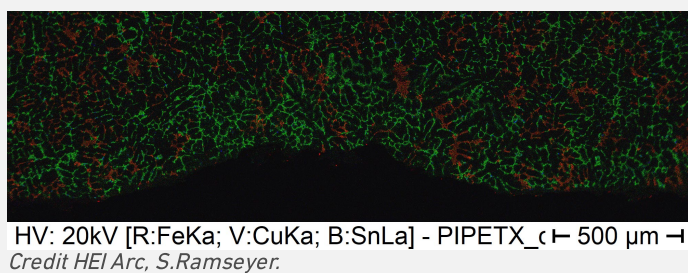
Fig. 13: Fe (red), Cu (green) and Sn (blue) chemical distribution of the area of Fig. 9. Method of analysis: SEM-EDS. Lab. of Electronic Microscopy and Microanalysis, Néode, HEI Arc,
