BUGATTI COOLING SYSTEM PIPE – AL ALLOY – FRANCE

Artefact name Bugatti cooling system pipe

Authors Granget. Elodie (, None) & . (MNAM (Musée National de l'Automobile de Mulhouse), Mulhouse, Alsace, France)

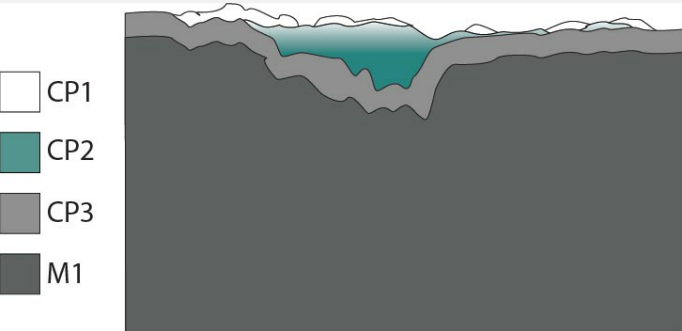
The schematic representation below gives an overview of the corrosion layers encountered on the Bugatti pipe. The stratum M is an aluminium alloy. Three CP strata have been identified. CP3 has a greyish mate color and is covering all of the corroded side of the pipe. Scattered over this uniform layer, blue-green (CP2) and white (CP1) spots of corrosion products can be found.

Fig. 4: Stratigraphic representation of the corrosion structure of the external surface of the water pipe in cross section,

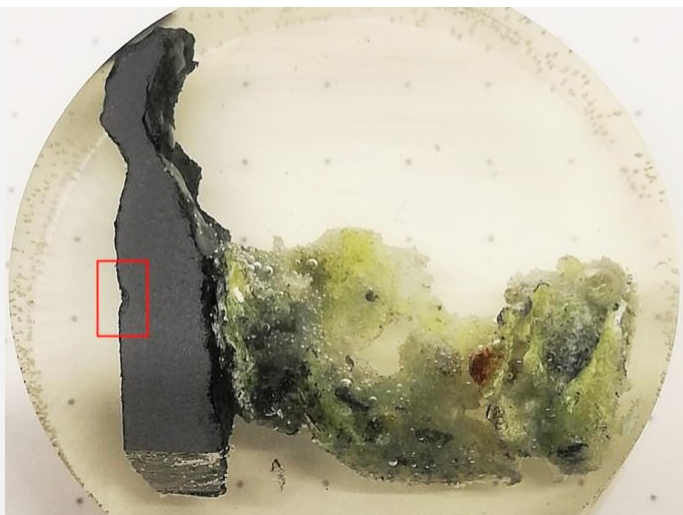
Fig. 6: Micrograph of the sample taken from the corroded exit pipe of the Bugatti water pump (Fig. 3), showing the location of Figs. 8-9

and 12 to 15 in red,

The cross-section shows not only the metal sampled but the accompanying thick yellow deposit that was clogging the pipe. Pitting corrosion develops all along the profile of the sample. A selected area (in red) is further investigated in Figs. 8-9 and 12-15.

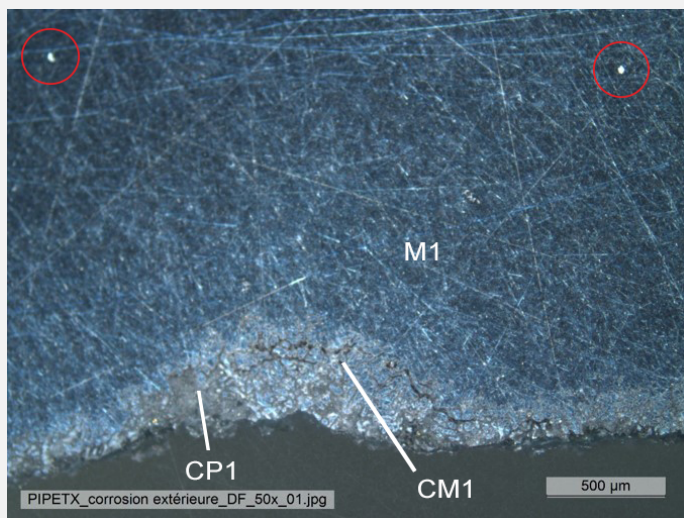
The metal is slightly porous (Fig. 8, red circles). Its dendritic microstructure is revealed by observation in bright field (Fig. 9) and with SEM (Fig. 10).

Fig. 8: Micrograph of the selected area shown on Fig.6 (rotated by 90°), unetched, dark field with indication of pores (red circles),

The BF and DF images (Figs. 8 and 9) show a few big cracks at the interface between CM1 and M1. The SEM image shows that they expand in a network of additional microcracks (Fig. 14). The pipe suffers from a uniform interdendritic corrosion. The Al, Cu and Zn phase is oxidising preferentially, developing then aluminium oxides, versus the interdendritic phases. In some places, pits of corrosion formed. SEM cartography showed a concentration of Cl at the base of the pit (Fig. 14: Green).

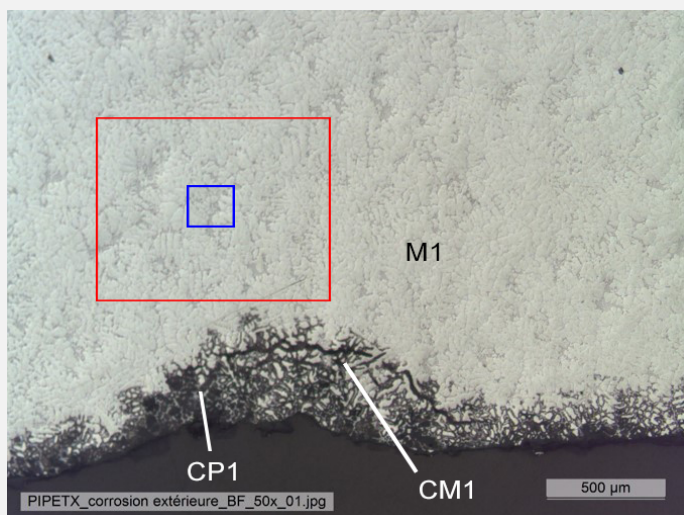
Fig. 9: Micrograph similar to Fig. 8, unetched, bright field showing the locations of Fig. 10 (in red) and Fig. 11 (in blue),

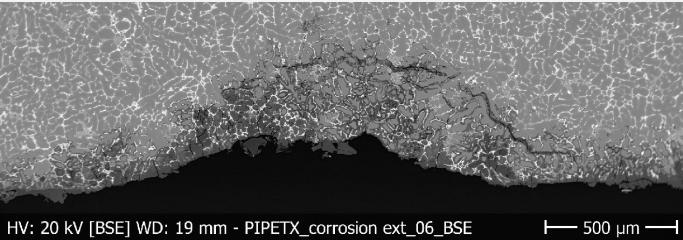
Fig. 14: SEM image of the pitting corrosion of the pipe. BSE, 20kV. Black = Cracks, Dark grey = oxydation, Medium grey = main phase, Light grey = interdendritic phase,

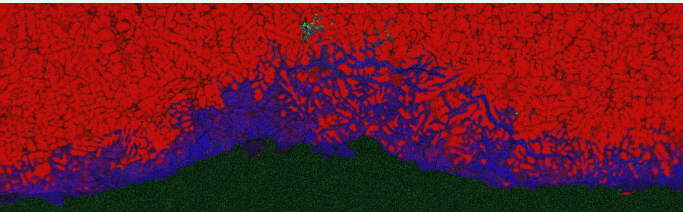
Fig. 15: SEM cartography of a pit of corrosion developing on the pipe. 20kV. Red = Al, Green = Cl, Blue = O,

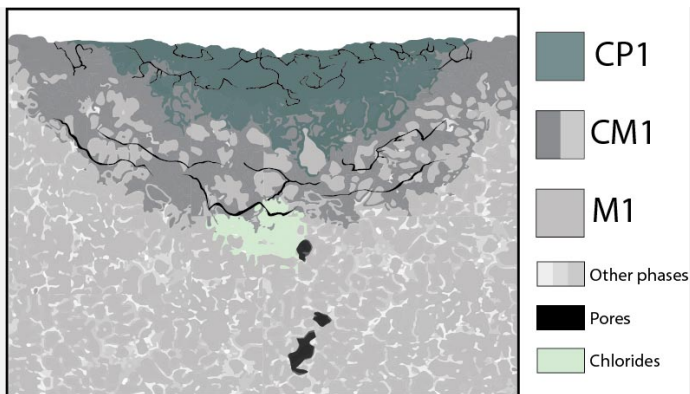
Fig. 16: Improved stratigraphic representation of the exit pipe,

The external surface shows a uniform interdendritic corrosion preferentially consuming the dendritic phase (Al, Cu, Zn). Pitting corrosion has been identified, with Cl pockets at the base of the pit.
