LEAD CAMES OF A STAINED GLASS WINDOW 52583 – AL ALLOY – SWITZERLAND

Artefact name Lead comes of a stained glass window 52583

Authors Alice Gerber. (Haute École Arc Neuchâtel, Neuchâtel, Neuchâtel, Switzerland)

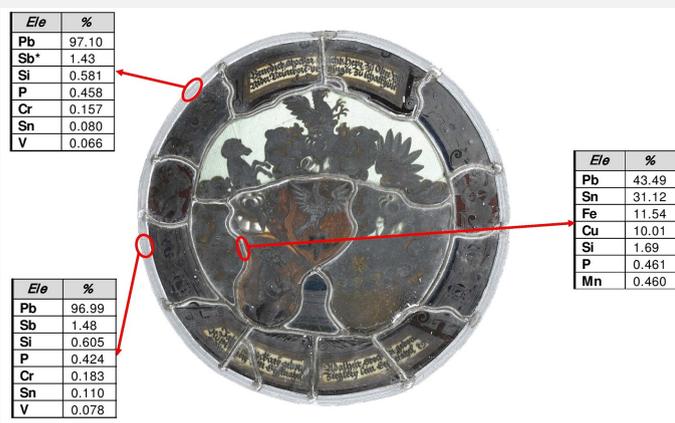
Fig. 2: XRF analysis of the different lead came of the "Stokar" stained glass panel. Tin (Sn) content is very variable from one came to another. Those with a very low Sn but a high Sb (1.4%) contents are much more corroded,

Heterogeneous active corrosion on lead cams. The tin content of the alloy indicates whether or not a cam will corrode ; with a low tin content lead is likely to corrode more. In a lead-antimony alloy, corrosion preferentially attacks the lead.

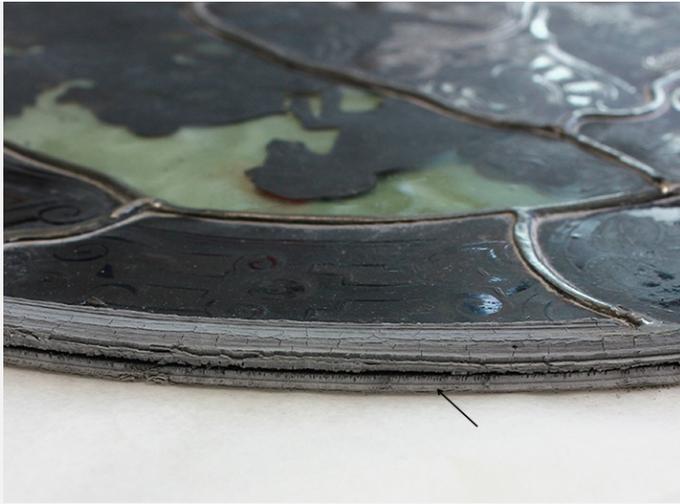
The "stokar" window, which is of interest here, was restored in 2008, just before it was put on display. The restoration consisted of replacing some of the lead cams. Thus, while the object is dated to the 16th century, the replaced cams were new when they entered the display case. In 2018, they were completely corroded. In comparison, the other stained glass panel, with older lead cams, was placed in the same display case at the same time. For this second panel, the cams are slightly corroded in 2018, but not as badly as those of the 'Stokar' panel. The metal chosen by the restorer reacted more strongly with the corrosive environment (the display case) than the historical metal.

Fig. 3: Corroded "modern" lead came on the "Stokar" stained glass panel (sampling area for cross-section indicated by the black arrow),

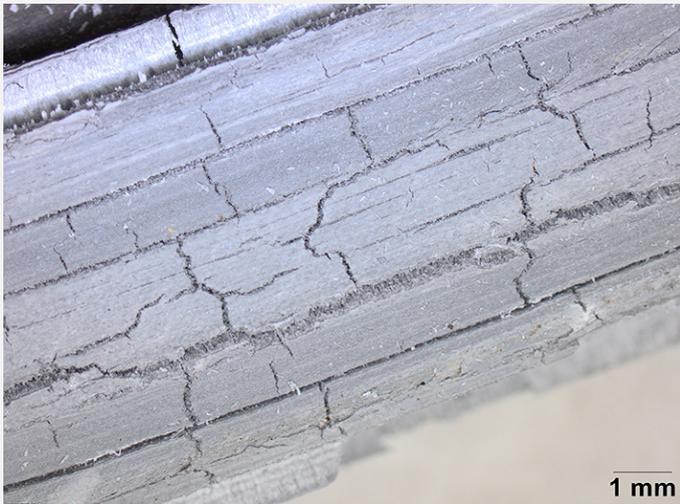
Fig. 4: Detail of the corroded lead came

Visual description of the corrosion: Voluminous forms of corrosion, white powdery efflorescence can be observed. The schematic representation (Fig. 6) gives an overview of the corrosion layers encountered on the object from a first visual macroscopic observation.

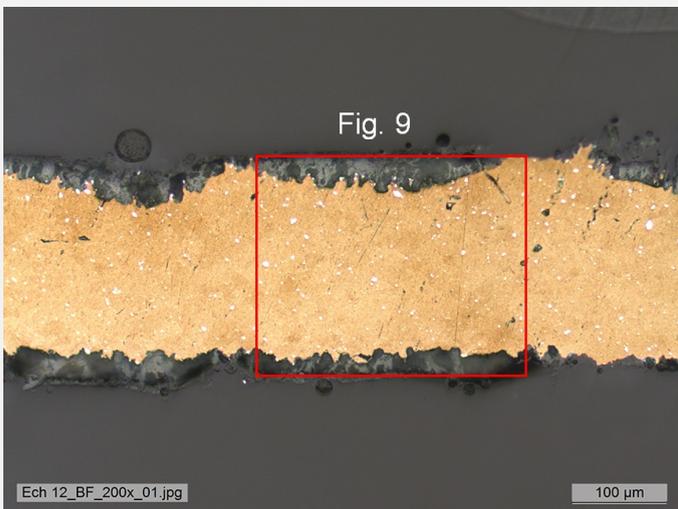
Fig. 7: Micrograph of the cross-section of the corroded lead came with location of Fig. 9, unetched, dark field. The grains of the metal are slightly visible, and the light-coloured dots in the alloy are Sb-rich inclusions,

For this lead cam, the alloy used is a lead alloy with about 1.5% antimony. Under a microscope, the alloy is not homogeneous. The antimony has formed nodules in the alloy, which are visible both under an optical microscope and under SEM. The cross-section shows that corrosion does not attack the antimony nodules in the alloy, it progresses by mineralizing the lead around these nodules.

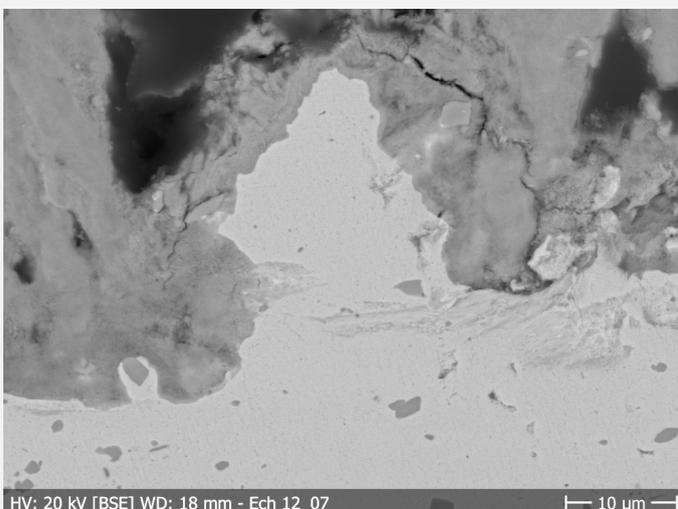
Fig. 8: SEM image (BSE mode) of a detail of the cross-section of the corroded lead came. The area in light grey is the metal, the corrosion is in darker grey with a blurred appearance. Sb-dots are dark grey. Corrosion progresses around them, without mineralising them,

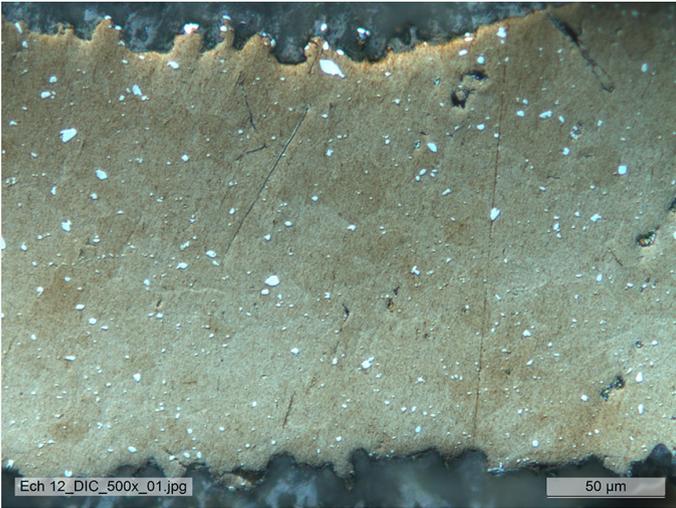
Fig. 10: Micrograph (detail of Fig. 7), unetched, dark field,

CP1 seems to be a heterogeneous compound as indicated on Fig. 10. But EDX analyses do not indicate a significant difference in composition. The attack of lead by organic acids causes the formation of salts, such as lead acetate which are then transformed into basic lead carbonates by the action of CO₂ from the environment as indicated by FTIR analysis of CP1.

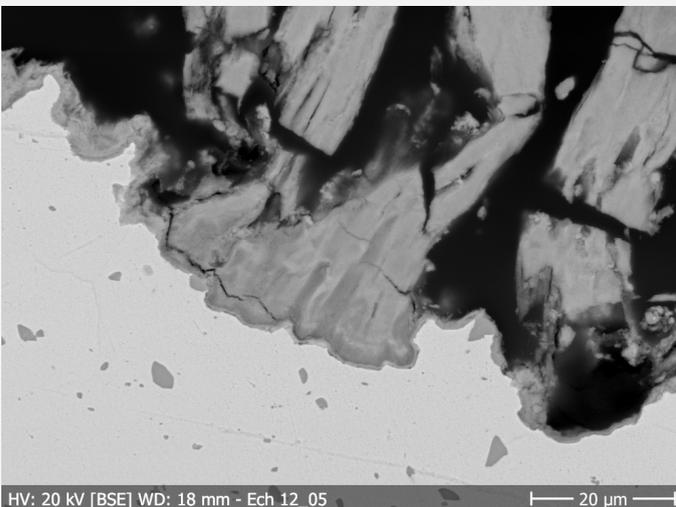
Corrosion develops specifically on cams made of a lead-antimony alloy, where antimony inclusions constitute the cathode (0.150 V/SHE) versus lead (-0.125 V/SHE) which corrodes as an anode in presence of lead acetate (the electrolyte).

The limit of the original surface lies somewhere in the corrosion layers. Antimony nodules are inferior markers of the limit of the original surface.

Fig. 11: SEM image (BSE mode) of the cross-section of the corroded lead cam,
