# LEAD CAMES OF A STAINED GLASS WINDOW 52583 – AL ALLOY – SWITZERLAND

**Artefact name** Lead comes of a stained glass window 52583

**Authors** Alice Gerber. (Haute École Arc Neuchâtel, Neuchâtel, Neuchâtel, Switzerland)

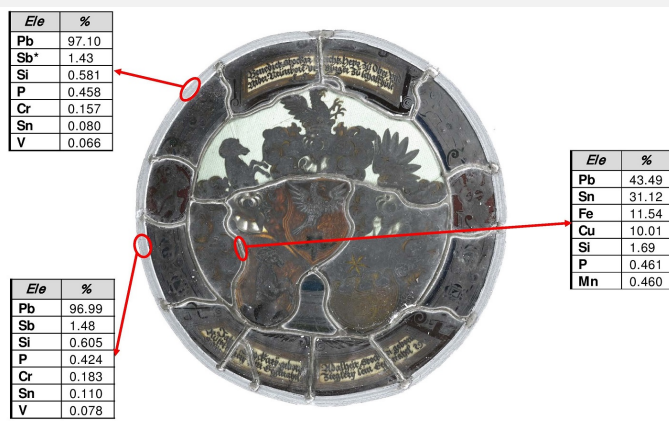
Fig. 2: XRF analysis of the different lead came of the "Stokar" stained glass panel. Tin (Sn) content is very variable from one came to another. Those with a very low Sn but a high Sb (1.4%) contents are much more corroded,

Heterogeneous active corrosion on lead cams. The tin content of the alloy indicates whether or not a cam will corrode ; with a low tin content lead is likely to corrode more. In a lead-antimony alloy, corrosion preferentially attacks the lead.

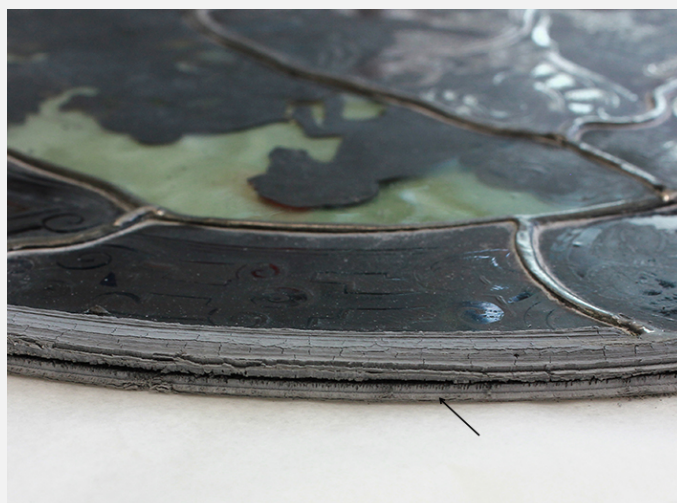
The study of this object is based on a simple problematic: in 2009 two stained glass panels were placed in a showcase for a permanent exhibition, the lead came were then in a good conservation condition. In 2018, the lead showed voluminous efflorescence of white, powdery corrosion products.

The environment of this showcase contained a high level of acetic acid. Lead being sensitive to organic acids, it corroded strongly. This is not new, but what is interesting here is that the two objects corroded in a very heterogeneous way. One lead cam may be deformed and completely covered with bulky white efflorescences, and the one next to it shows no corrosion.

The "stokar" window, which is of interest here, was restored in 2008, just before it was put on display. The restoration consisted of replacing some of the lead cams. Thus, while the object is dated to the 16th century, the replaced cams were new when they entered the display case. In 2018, they were completely corroded. In comparison, the other stained glass panel, with older lead cams, was placed in the same display case at the same time. For this second panel, the cams are slightly corroded in 2018, but not as badly as those of the 'Stokar' panel. The metal chosen by the restorer reacted more strongly with the corrosive environment (the display case) than the historical metal.

Fig. 3: Corroded "modern" lead came on the "Stokar" stained glass panel (sampling area for cross-section indicated by the black arrow),

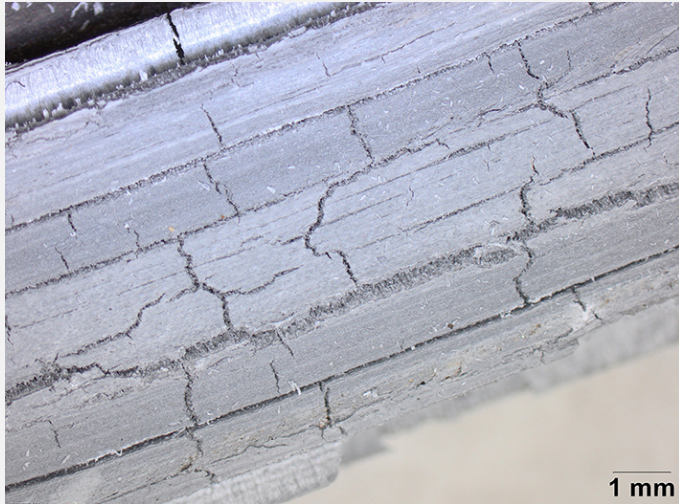
Fig. 4: Detail of the corroded lead came

Visual description of the corrosion: Voluminous forms of corrosion, white powdery efflorescence can be observed. The schematic representation (Fig. 6) gives an overview of the corrosion layers encountered on the object from a first visual macroscopic observation.

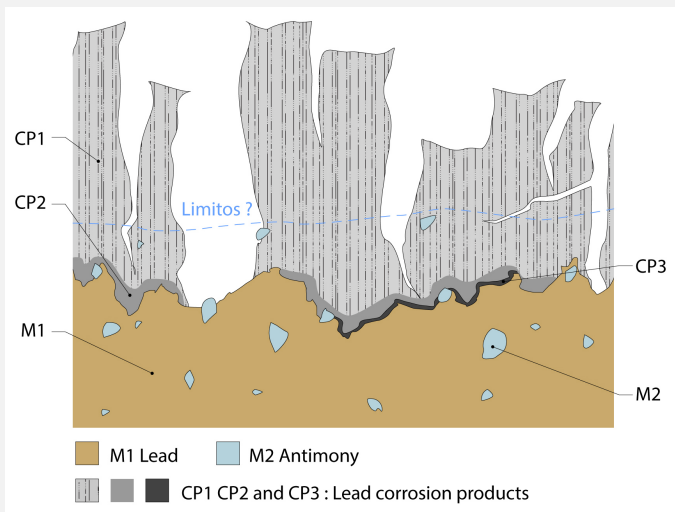
Fig. 5: Stratigraphic representation of a corroded lead came by microscopic observation,

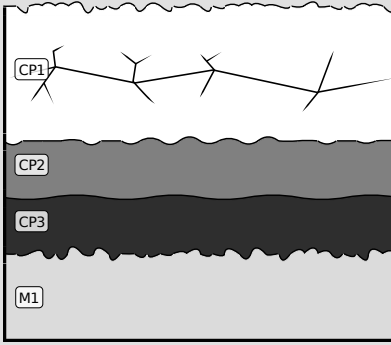
Fig. 6: Stratigraphic representation of the lead came under binocular using the MiCorr application with reference to Fig. 5. The characteristics of the strata are only accessible by clicking on the drawing that redirects you to the search tool by stratigraphy representation, Credit HE-Arc CR, A.Gerber.

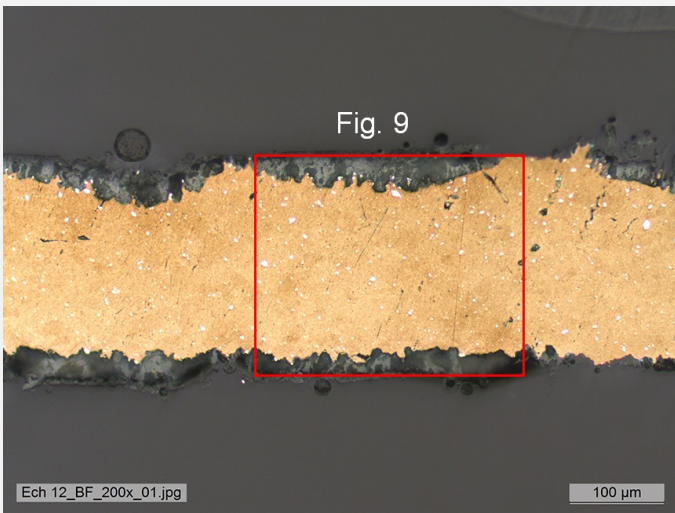
Fig. 7: Micrograph of the cross-section of the corroded lead came with location of Fig. 9, unetched, dark field. The grains of the metal are slightly visible, and the light-coloured dots in the alloy are Sb-rich inclusions,

For this lead cam, the alloy used is a lead alloy with about 1.5% antimony. Under a microscope, the alloy is not homogeneous. The antimony has formed nodules in the alloy, which are visible both under an optical microscope and under SEM.

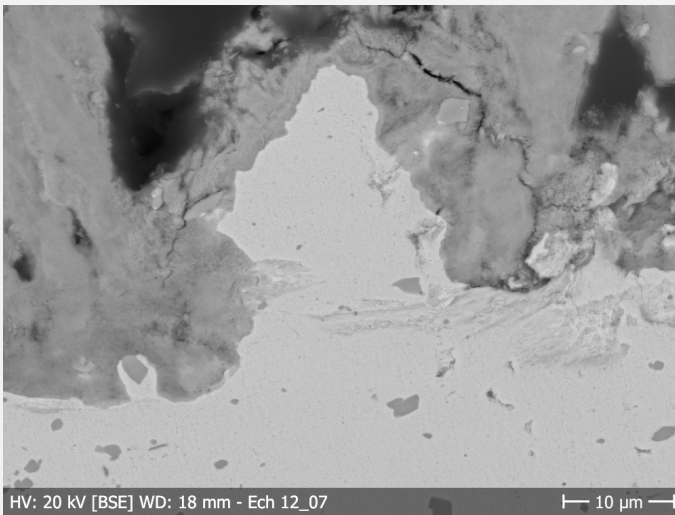
Fig. 8: SEM image (BSE mode) of a detail of the cross-section of the corroded lead came. The area in light grey is the metal, the corrosion is in darker grey with a blurred appearance. Sb-dots are dark grey. Corrosion progresses around them, without mineralising them,

The cross-section shows that corrosion does not attack the antimony nodules in the alloy, it progresses by mineralizing the lead around these nodules.

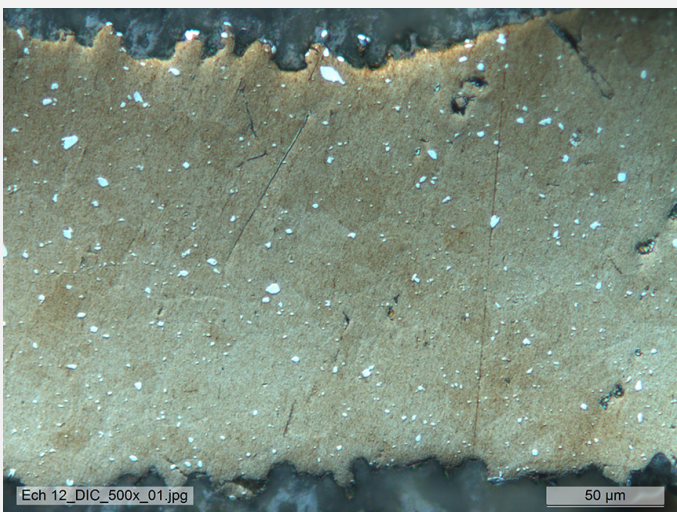
Fig. 10: Micrograph (detail of Fig. 7), unetched, dark field,

CP1 seems to be an heterogeneous compound as indicated on Fig. 10. But EDX analyses do not indicate a significant difference in composition. The attack of lead by organic acids causes the formation of salts, such as lead acetate which are then transformed into basic lead carbonates by the action of CO<sub>2</sub> from the environment as indicated by FTIR analysis of CP1.

Corrosion develops specifically on cams made of a lead-antimony alloy, where antimony inclusions constitute the cathode (0.150 V/SHE) versus lead (-0.125 V/SHE) which corrodes as an anode in presence of lead acetate (the electrolyte).

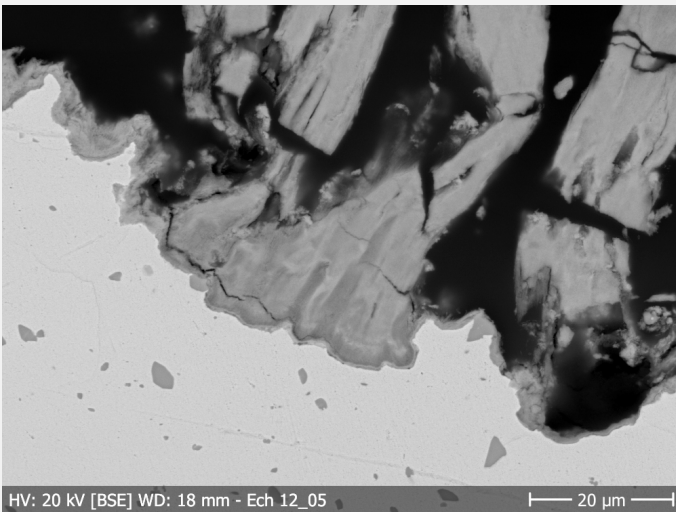
Fig. 11: SEM image (BSE mode) of the cross-section of the corroded lead came,

<b>Corrosion form</b>	Uniform - transgranular
<b>Corrosion type</b>	Active corrosion of lead

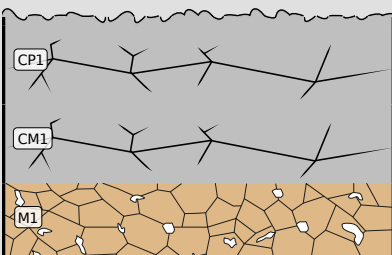
Fig. 9: Stratigraphic representation of the lead came in cross-section (dark field) using the MiCorr application with reference to Figs. 7 and 10. The characteristics of the strata are only accessible by clicking on the drawing that redirects you to the search tool by stratigraphy representation, Credit HE-Arc CR, A.Gerber
