LEAD CAMES OF A STAINED GLASS WINDOW 52583 – AL ALLOY – SWITZERLAND

Artefact name Lead comes of a stained glass window 52583

Authors Alice Gerber. (Haute École Arc Neuchâtel, Neuchâtel, Neuchâtel, Switzerland)

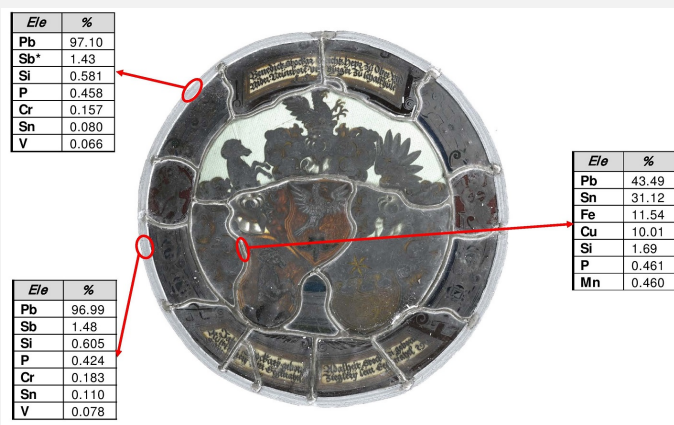
Fig. 2: XRF analysis of the different lead came of the "Stokar" stained glass panel. Tin (Sn) content is very variable from one came to another. Those with a very low Sn but a high Sb (1.4%) contents are much more corroded,

Heterogeneous active corrosion on lead cams. The tin content of the alloy indicates whether or not a cam will corrode ; with a low tin content lead is likely to corrode more. In a lead-antimony alloy, corrosion preferentially attacks the lead.

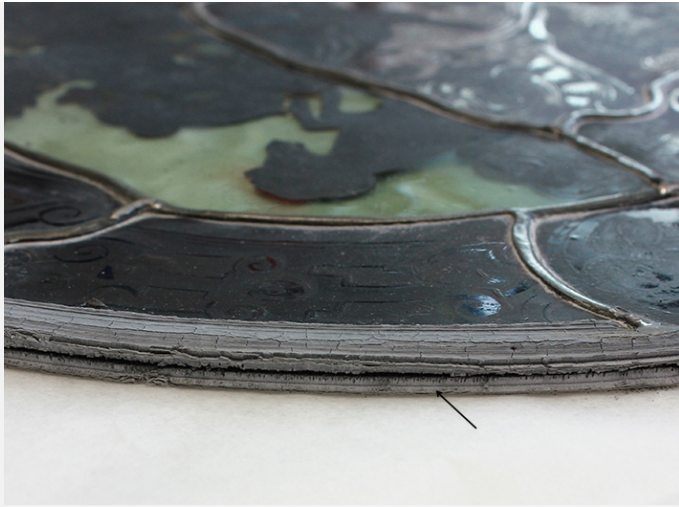
The study of this object is based on a simple problematic: in 2009 two stained glass panels were placed in a showcase for a permanent exhibition, the lead came were then in a good conservation condition. In 2018, the lead showed voluminous efflorescence of white, powdery corrosion products.

The environment of this showcase contained a high level of acetic acid. Lead being sensitive to organic acids, it corroded strongly. This is not new, but what is interesting here is that the two objects corroded in a very heterogeneous way. One lead cam may be deformed and completely covered with bulky white efflorescences, and the one next to it shows no corrosion.

The "stokar" window, which is of interest here, was restored in 2008, just before it was put on display. The restoration consisted of replacing some of the lead cams. Thus, while the object is dated to the 16th century, the replaced cams were new when they entered the display case. In 2018, they were completely corroded. In comparison, the other stained glass panel, with older lead cams, was placed in the same display case at the same time. For this second panel, the cams are slightly corroded in 2018, but not as badly as those of the 'Stokar' panel. The metal chosen by the restorer reacted more strongly with the corrosive environment (the display case) than the historical metal.

Fig. 3: Corroded "modern" lead came on the "Stokar" stained glass panel (sampling area for cross-section indicated by the black arrow),

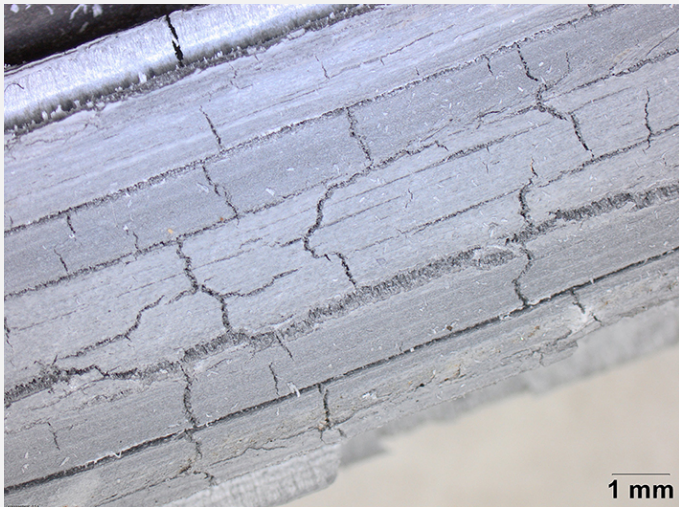
Fig. 4: Detail of the corroded lead came

Visual description of the corrosion: Voluminous forms of corrosion, white powdery efflorescence can be observed. The schematic representation (Fig. 6) gives an overview of the corrosion layers encountered on the object from a first visual macroscopic observation.

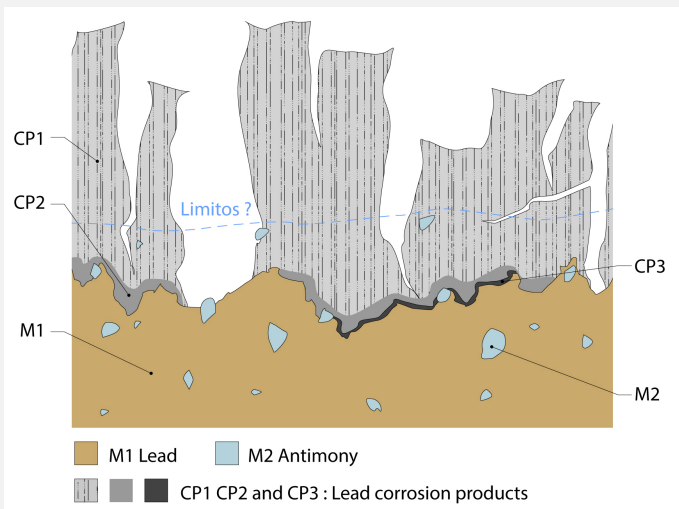
Fig. 5: Stratigraphic representation of a corroded lead came by microscopic observation,

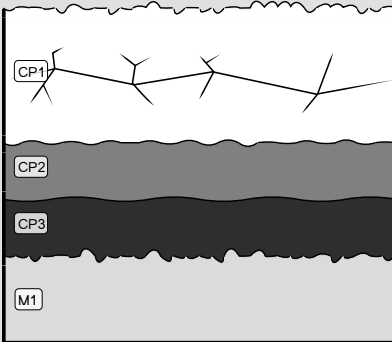
Fig. 6: Stratigraphic representation of the lead came under binocular using the MiCorr application with reference to Fig. 5. The characteristics of the strata are only accessible by clicking on the drawing that redirects you to the search tool by stratigraphy representation, Credit HE-Arc CR, A.Gerber.

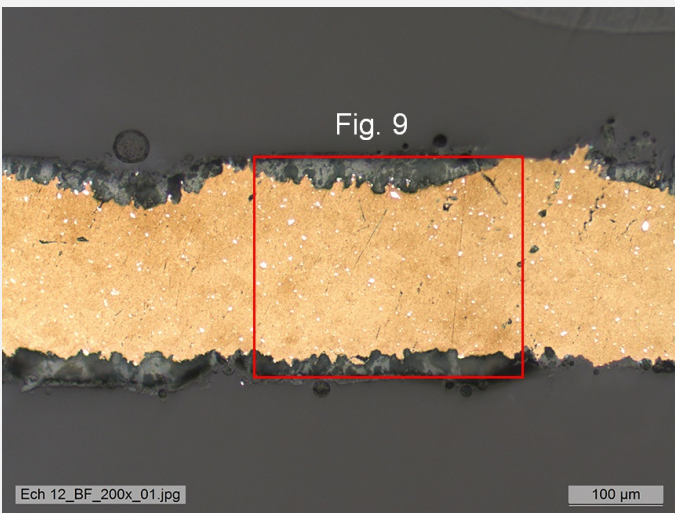
Fig. 7: Micrograph of the cross-section of the corroded lead came with location of Fig. 9, unetched, dark field. The grains of the metal are slightly visible, and the light-coloured dots in the alloy are Sb-rich inclusions,

For this lead cam, the alloy used is a lead alloy with about 1.5% antimony. Under a microscope, the alloy is not homogeneous. The antimony has formed nodules in the alloy, which are visible both under an optical microscope and under SEM. The cross-section shows that corrosion does not attack the antimony nodules in the alloy, it progresses by mineralizing the lead around these nodules.

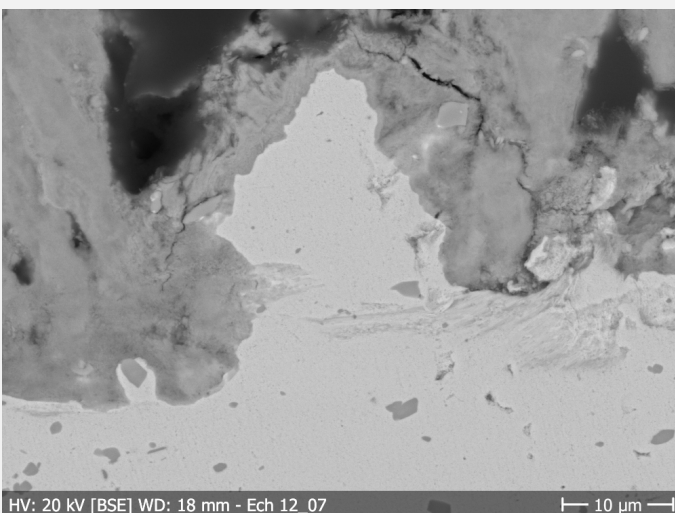
Fig. 8: SEM image (BSE mode) of a detail of the cross-section of the corroded lead came. The area in light grey is the metal, the corrosion is in darker grey with a blurred appearance. Sb-dots are dark grey. Corrosion progresses around them, without mineralising them,

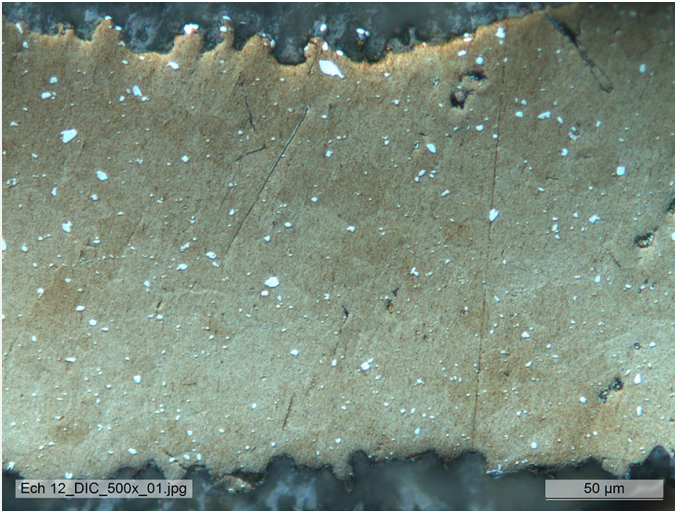
Fig. 10: Micrograph (detail of Fig. 7), unetched, dark field,

CP1 seems to be a heterogeneous compound as indicated on Fig. 10. But EDX analyses do not indicate a significant difference in composition. The attack of lead by organic acids causes the formation of salts, such as lead acetate which are then transformed into basic lead carbonates by the action of CO₂ from the environment as indicated by FTIR analysis of CP1.

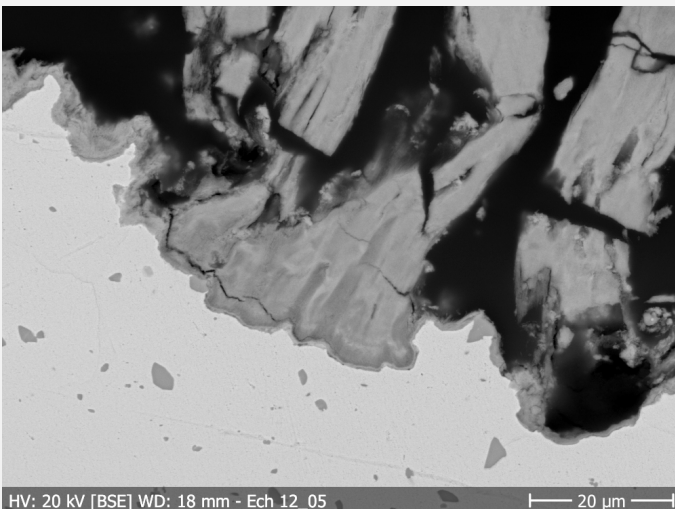
Corrosion develops specifically on cams made of a lead-antimony alloy, where antimony inclusions constitute the cathode (0.150 V/SHE) versus lead (-0.125 V/SHE) which corrodes as an anode in presence of lead acetate (the electrolyte).

The limit of the original surface lies somewhere in the corrosion layers. Antimony nodules are inferior markers of the limit of the original surface.

Fig. 11: SEM image (BSE mode) of the cross-section of the corroded lead cam,

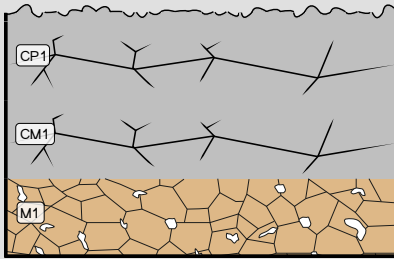
Fig. 9: Stratigraphic representation of the lead came in cross-section (dark field) using the MiCorr application with reference to Figs. 7 and 10. The characteristics of the strata are only accessible by clicking on the drawing that redirects you to the search tool by stratigraphy representation, Credit HE-Arc CR, A.Gerber
