LEAD CAMES OF A STAINED GLASS WINDOW 52583 – AL ALLOY – SWITZERLAND

Artefact name Lead comes of a stained glass window 52583

Authors Alice Gerber. (Haute École Arc Neuchâtel, Neuchâtel, Neuchâtel, Switzerland)

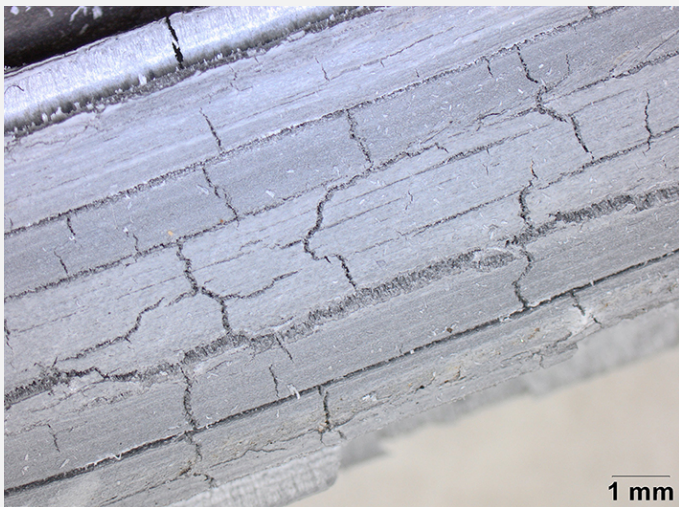
Fig. 4: Detail of the corroded lead came

Visual description of the corrosion: Voluminous forms of corrosion, white powdery efflorescence can be observed. The schematic representation (Fig. 6) gives an overview of the corrosion layers encountered on the object from a first visual macroscopic observation.

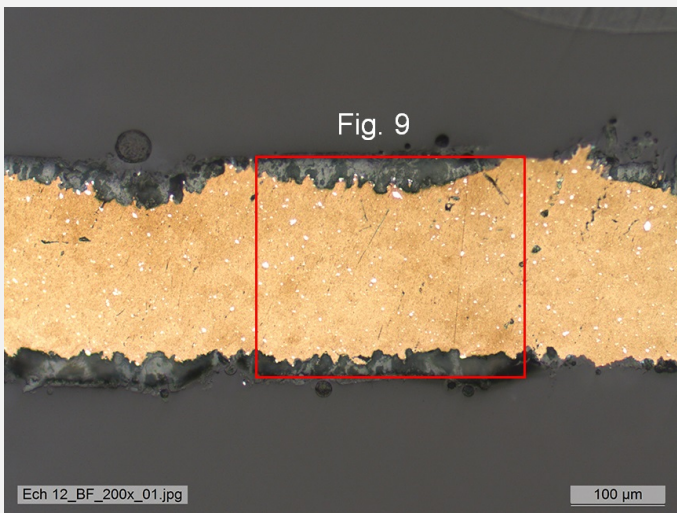
Fig. 7: Micrograph of the cross-section of the corroded lead came with location of Fig. 9, unetched, dark field. The grains of the metal are slightly visible, and the light-coloured dots in the alloy are Sb-rich inclusions,

For this lead cam, the alloy used is a lead alloy with about 1.5% antimony. Under a microscope, the alloy is not homogeneous. The antimony has formed nodules in the alloy, which are visible both under an optical microscope and under SEM. The cross-section shows that corrosion does not attack the antimony nodules in the alloy, it progresses by mineralizing the lead around these nodules.

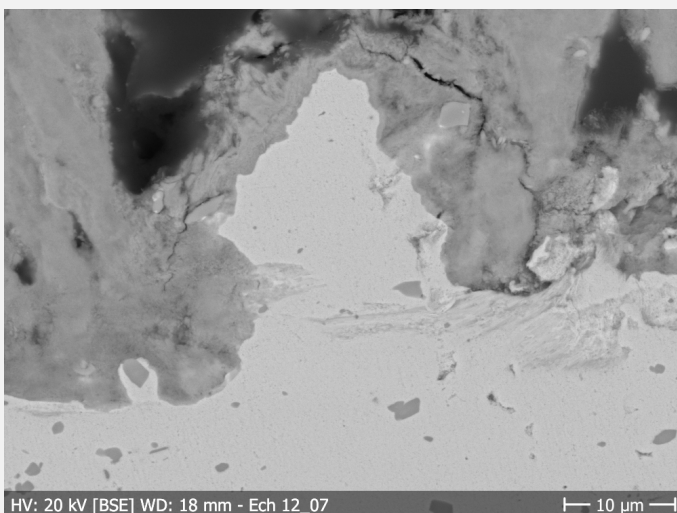
Fig. 8: SEM image (BSE mode) of a detail of the cross-section of the corroded lead came. The area in light grey is the metal, the corrosion is in darker grey with a blurred appearance. Sb-dots are dark grey. Corrosion progresses around them, without mineralising them,

Corrosion develops specifically on cams made of a lead-antimony alloy, where antimony inclusions constitute the cathode (0.150 V/SHE) versus lead (-0.125 V/SHE) which corrodes as an anode in presence of lead acetate (the electrolyte).
