LEAD CAMES OF A STAINED GLASS WINDOW 52583 – AL ALLOY – SWITZERLAND

Artefact name Lead comes of a stained glass window 52583

Authors Alice Gerber. (Haute École Arc Neuchâtel, Neuchâtel, Neuchâtel, Switzerland)

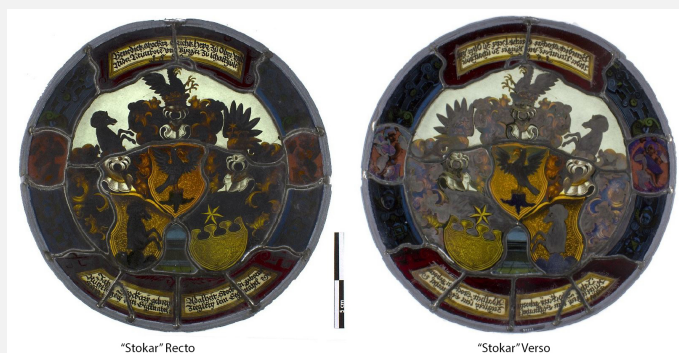
Fig. 1: Stained glass panel "Stokar" both sides,

The study of this object is based on a simple problematic: in 2009 two stained glass panels were placed in a showcase for a permanent exhibition, the lead came were then in a good conservation condition. In 2018, the lead showed voluminous efflorescence of white, powdery corrosion products.

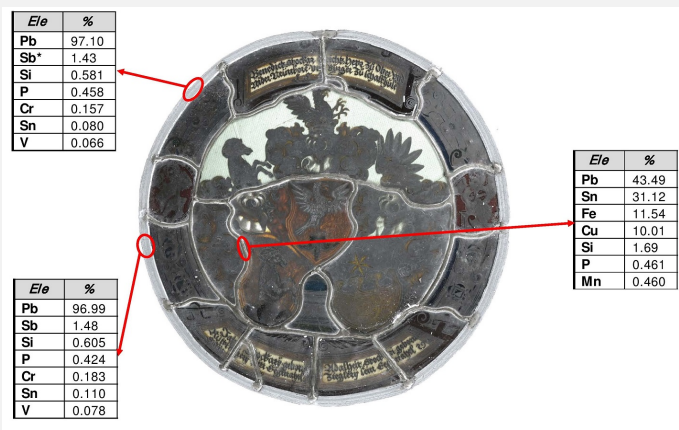
Fig. 2: XRF analysis of the different lead comes of the "Stokar" stained glass panel. Tin (Sn) content is very variable from one came to another. Those with a very low Sn but a high Sb (1.4%) contents are much more corroded,

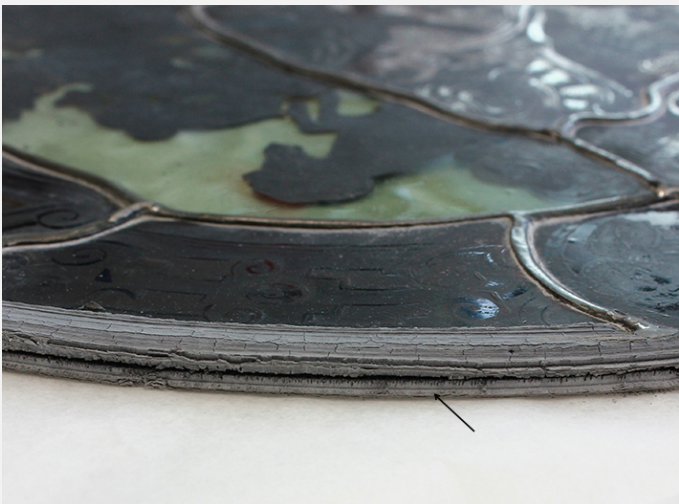
The "stokar" window, which is of interest here, was restored in 2008, just before it was put on display. The restoration consisted of replacing some of the lead cams. Thus, while the object is dated to the 16th century, the replaced cams were new when they entered the display case. In 2018, they were completely corroded. In comparison, the other stained glass panel, with older lead cams, was placed in the same display case at the same time. For this second panel, the cams are slightly corroded in 2018, but not as badly as those of the 'Stokar' panel. The metal chosen by the restorer reacted more strongly with the corrosive environment (the display case) than the historical metal.

Fig. 3: Corroded "modern" lead came on the "Stokar" stained glass panel (sampling area for cross-section indicated by the black arrow),

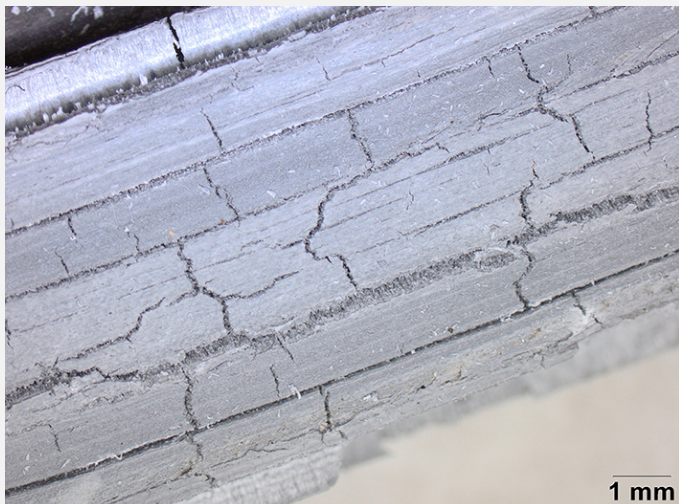
Fig. 4: Detail of the corroded lead came

Visual description of the corrosion: Voluminous forms of corrosion, white powdery efflorescence can be observed.

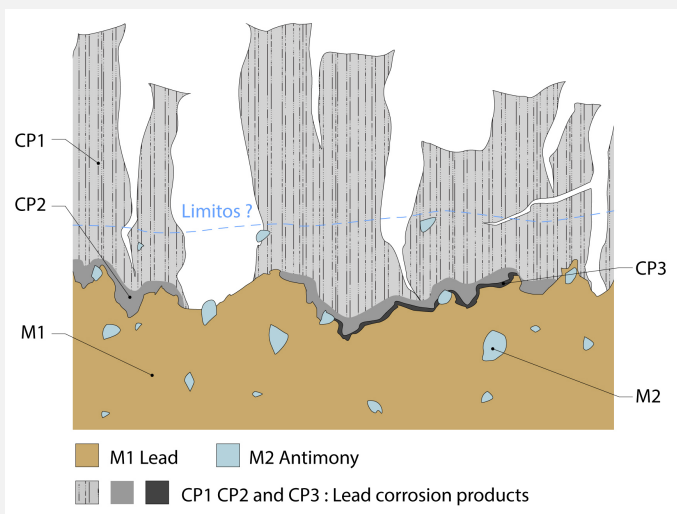
Fig. 5: Stratigraphic representation of a corroded lead came by microscopic observation,

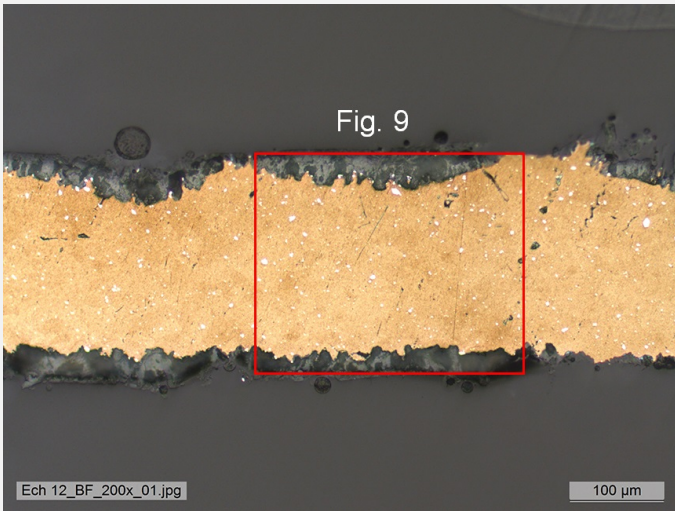
Fig. 7: Micrograph of the cross-section of the corroded lead came with location of Fig. 9, unetched, dark field. The grains of the metal are slightly visible, and the light-coloured dots in the alloy are Sb-rich inclusions,

For this lead cam, the alloy used is a lead alloy with about 1.5% antimony. Under a microscope, the alloy is not homogeneous. The antimony has formed nodules in the alloy, which are visible both under an optical microscope and under SEM.

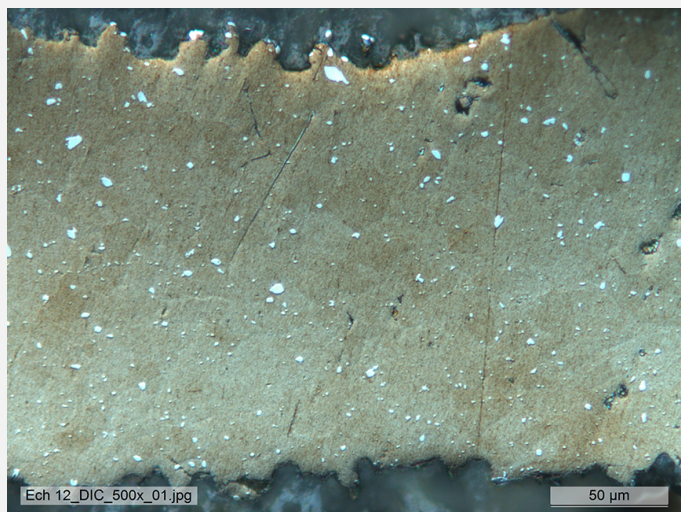
Fig. 10: Micrograph (detail of Fig. 7), unetched, dark field,

CP1 seems to be an heterogeneous compound as indicated on Fig. 10. But EDX analyses do not indicate a significant difference in composition. The attack of lead by organic acids causes the formation of salts, such as lead acetate which are then transformed into basic lead carbonates by the action of CO2 from the environment as indicated by FTIR analysis of CP1.

Corrosion develops specifically on cams made of a lead-antimony alloy, where antimony inclusions constitute the cathode (0.150 V/SHE) versus lead (-0.125 V/SHE) which corrodes as an anode in presence of lead acetate (the electrolyte).

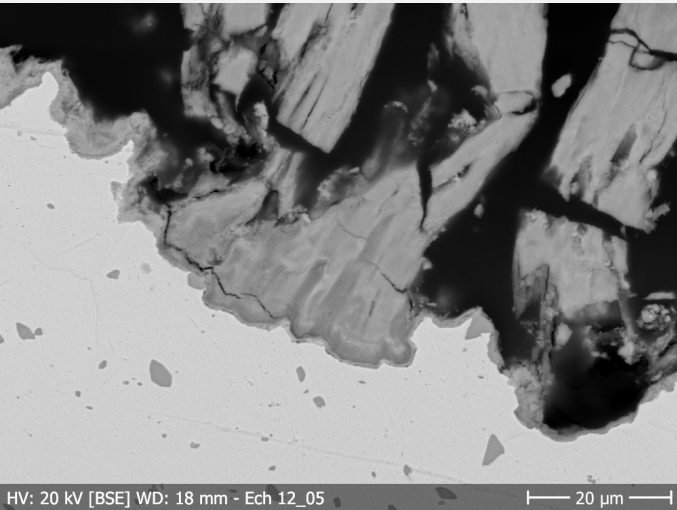
Fig. 11: SEM image (BSE mode) of the cross-section of the corroded lead came,
