# LEAD CAMES OF A STAINED GLASS WINDOW 52583 – AL ALLOY – SWITZERLAND

**Artefact name** Lead comes of a stained glass window 52583

**Authors** Alice Gerber. (Haute École Arc Neuchâtel, Neuchâtel, Neuchâtel, Switzerland)

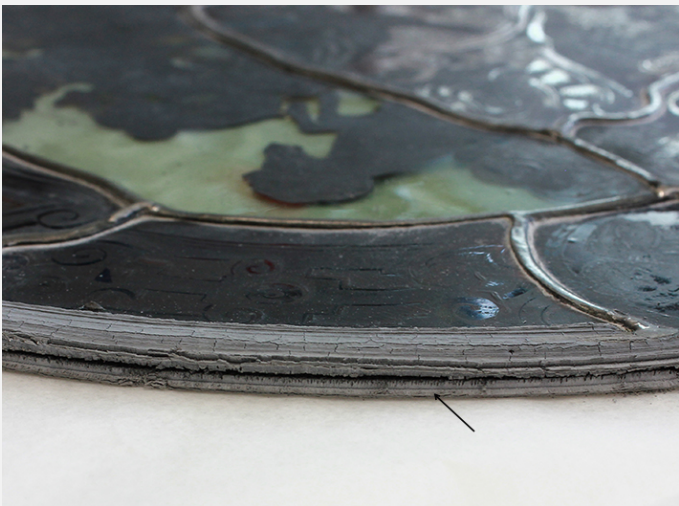
The "stokar" window, which is of interest here, was restored in 2008, just before it was put on display. The restoration consisted of replacing some of the lead cams. Thus, while the object is dated to the 16th century, the replaced cams were new when they entered the display case. In 2018, they were completely corroded. In comparison, the other stained glass panel, with older lead cams, was placed in the same display case at the same time. For this second panel, the cams are slightly corroded in 2018, but not as badly as those of the 'Stokar' panel. The metal chosen by the restorer reacted more strongly with the corrosive environment (the display case) than the historical metal.

Fig. 3: Corroded "modern" lead came on the "Stokar" stained glass panel (sampling area for cross-section indicated by the black arrow),

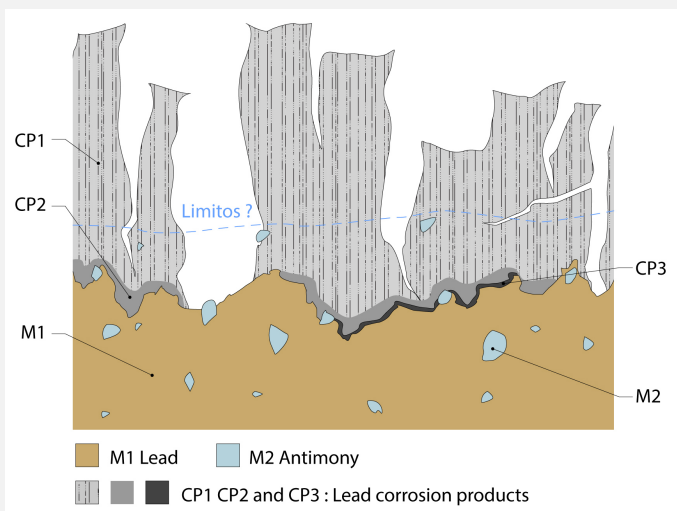
Fig. 5: Stratigraphic representation of a corroded lead came by microscopic observation,

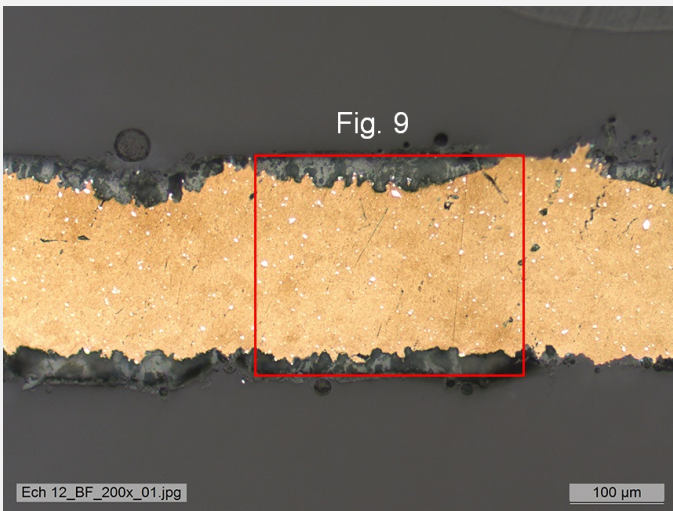
Fig. 7: Micrograph of the cross-section of the corroded lead came with location of Fig. 9, unetched, dark field. The grains of the metal are slightly visible, and the light-coloured dots in the alloy are Sb-rich inclusions,

For this lead cam, the alloy used is a lead alloy with about 1.5% antimony. Under a microscope, the alloy is not homogeneous. The antimony has formed nodules in the alloy, which are visible both under an optical microscope and under SEM.

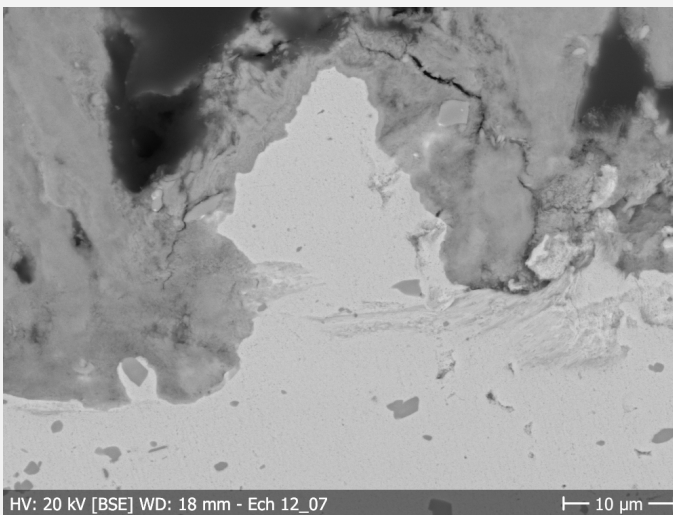
Fig. 8: SEM image (BSE mode) of a detail of the cross-section of the corroded lead came. The area in light grey is the metal, the corrosion is in darker grey with a blurred appearance. Sb-dots are dark grey. Corrosion progresses around them, without mineralising them,

The cross-section shows that corrosion does not attack the antimony nodules in the alloy, it progresses by mineralizing the lead around these nodules.

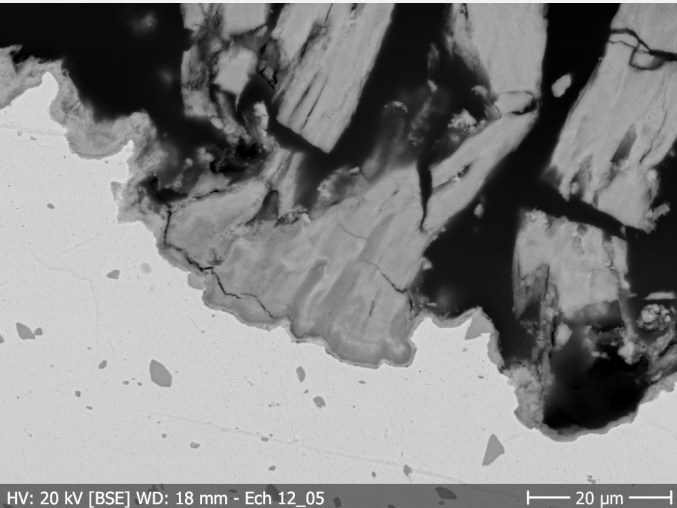
Fig. 11: SEM image (BSE mode) of the cross-section of the corroded lead came,

Corrosion form	Uniform - transgranular
Corrosion type	Active corrosion of lead
