FRAGMENT OF AN AEGIS OF NEÏTH 1886.305.0096 – LEADED BRONZE

Artefact name	Fragment of an Aegis of Neïth 1886.305.0096
Authors	Line. Pedersen (HE-Arc, Neuchâtel, Neuchâtel, Switzerland) & Christian. Degrigny (HE-Arc CR, Neuchâtel, Neuchâtel, Switzerland) & Valentin. Boissonnas (HE-Arc CR, Neuchâtel, Neuchâtel, Switzerland)
Url	/artefacts/675/

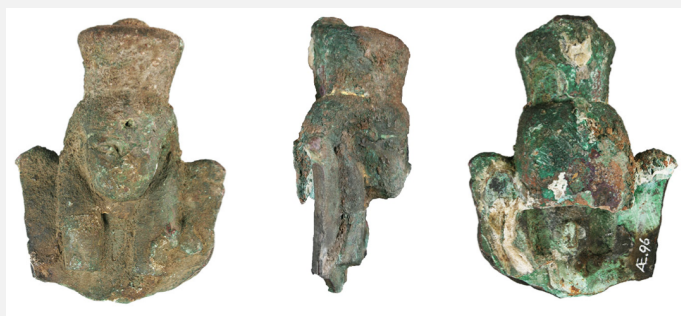
Fig. 1: Fragment of an Aegis of Neïth. From left to right: front, side view and back respectively,

Description of the artefact Fragment of an aegis surmounted by the head of Neïth, the Egyptian goddess of war (Fig. 1). Traces of leaf gilding is still present in certain areas (Fig. 3). The lower part of the collar and the upper part of the crown are broken (Fig. 2 and 4). The surface is covered with a thick and hard, green-brown corrosion crust (Fig. 2, 3 and 4). A cross-section was studied on the lower edge that was broken after excavation. Dimensions: L = 96mm; W = 72mm; T = 40mm; WT = 216g.

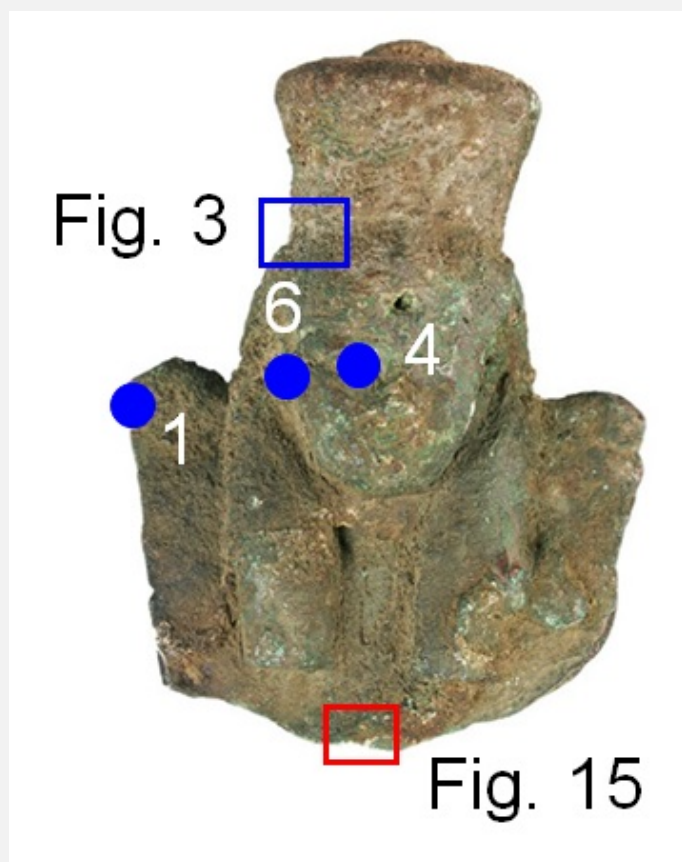
Fig. 2: Front face of the aegis with location of XRF measurements (blue spots), powder sample (red square) and gilding remains on the surface (blue square),

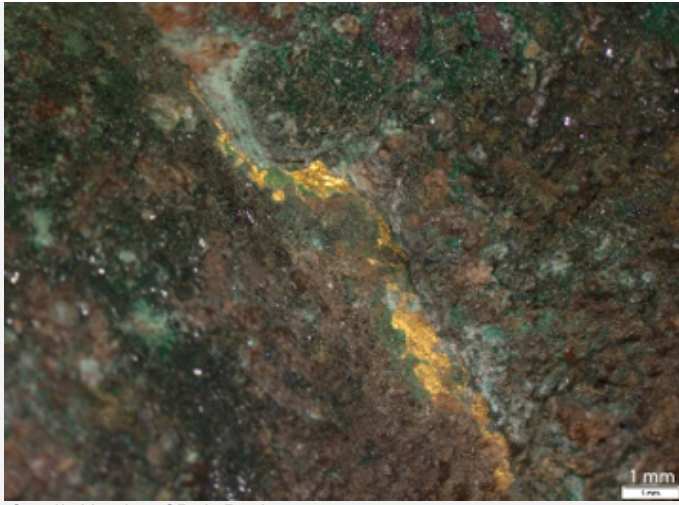
Fig. 3: Remains of foil-gilding on the corroded surface,

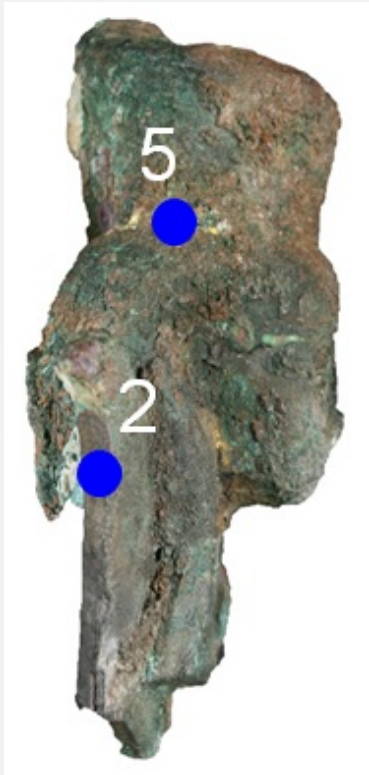
Fig. 4: Side view of the aegis with location of XRF measurements (blue spots),

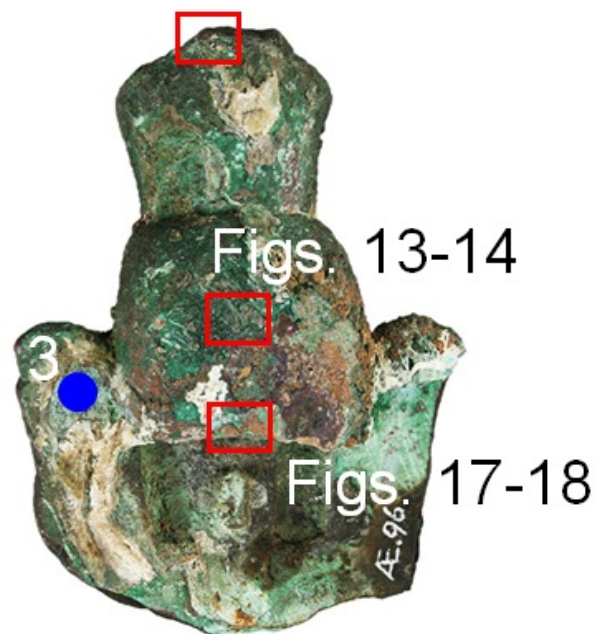
Fig. 5: Back face of the aegis with location of XRF measurement (blue spot) and powder samples (red squares),

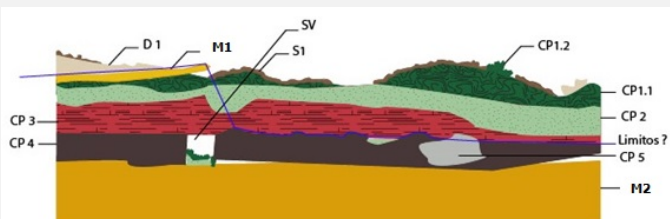
Fig. 6: Preliminary stratigraphy 1, corresponding to the front face of the aegis. S = soil, D = deposit, M = metal, CP = corrosion products, SV = structural void,

Captions	Colour, aspect, hardness and cohesion
S1	Brown, matte, can be scratched with scalpel blade but remains cohesive.
D1	White deposit: shiny, powdery when shaved with scalpel.
M1	Thin gold leaf trapped in corrosion products, brittle, yellow and not adherent.
CP1.1	Dark green corrosion layer, lumpy and matte, thick, hardly scratched by a scalpel blade, cohesive and compact.
CP1.2	Minor stratum of CP1.1. Dark green crystals appearing on the surface of the artefact. Easily scratched under the action a scalpel blade.
CP2	Light green corrosion layer, matte, thick in some places, powdery under the action of a scalpel blade. In some areas it is located directly on CP4.
CP3	Red corrosion layer, lumpy and matte, thick, sometimes hard and sometimes powdery under the action of a scalpel blade.
Limitos	Interface of the limit of the original surface. Shiny, straight and black with manufacturing traces.
CP4	Dark grey with red or green reflection. Shiny, hard, straight, dense and with traces of engraving and possible inlays.

CP5	Isolated white corrosion products: waxy and very soft.
SV	Void in CP4 resulting in loss of the limitos.
M2	Yellow stratum with metallic sheen, dense and hardly scratched by scalpel blade.

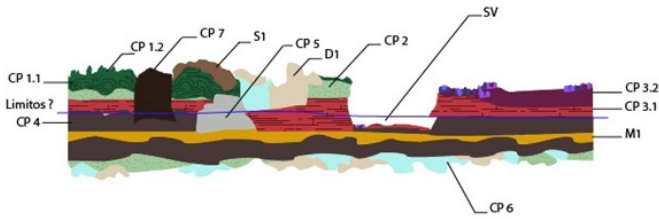
Fig. 7: Preliminary stratigraphy 2, corresponding to the back face of the aegis and interior (below part). S = soil, D = deposit, M = metal, CP = corrosion products, SV = structural void,

Captions	Colour, aspect, hardness and cohesion
S1	Brown, matte, can be scratched with scalpel blade but remains cohesive.
D1	White shiny deposit, powdery when shaved with scalpel.
CP1.1	Dark green corrosion layer, lumpy and matte, thick, hardly scratched by a scalpel blade, cohesive and compact.
CP1.2	Minor stratum of CP1.1. Dark green crystals appearing on the surface of the artefact. Easily scratched by a scalpel blade.
CP2	Light green corrosion layer, matte and thick in some places, powdery under the action of a scalpel blade. Sometimes located directly on CP4.
CP3.1	Red corrosion layer, lumpy and matte, thick, sometimes hard and sometimes powdery under the action of a scalpel blade.
CP3.2	Minor stratum of CP3.1. Purple with blue-purple crystals, hard and cohesive.
Limitos	Interface of the limit of the original surface. Shiny, straight, black, manufacturing traces.
CP4	Dark grey with red or green reflection. Shiny, hard, straight, dense and with traces of engraving and possible inlays.

CP5	Isolated white stratum: waxy and very soft.
CP6	Light blue stratum, chalky. Isolated on the exterior surface and extends on the interior surface.
CP7	Isolated black stratum, very hard, straight and shiny.
SV: Structural Void	Void in CP4, resulting in loss of the limitos. Presence of CP1.2 crystals inside the void.
M1	Yellow stratum with metallic sheen, dense and hardly scratched by scalpel blade.

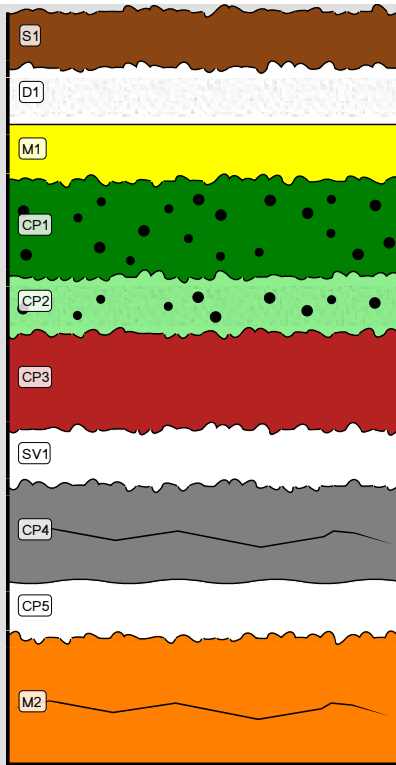
Fig.9: Schematic representation combining stratigraphies 1 and 2 under binocular and using the MiCorr application. The characteristics of the strata are only accessible by clicking on the drawing that redirects you to the search tool by stratigraphy representation, Credit He-Arc CR, L.Pedersen.

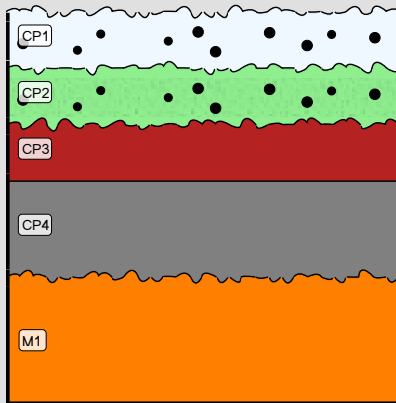
Fig.10: Schematic representation of stratigraphy 3 under binocular and using the MiCorr application. CP1 is CP6 in Fig. 8. The characteristics of the strata are only accessible by clicking on the drawing that redirects you to the search tool by stratigraphy representation, Credit He-Arc CR, L. Pedersen.

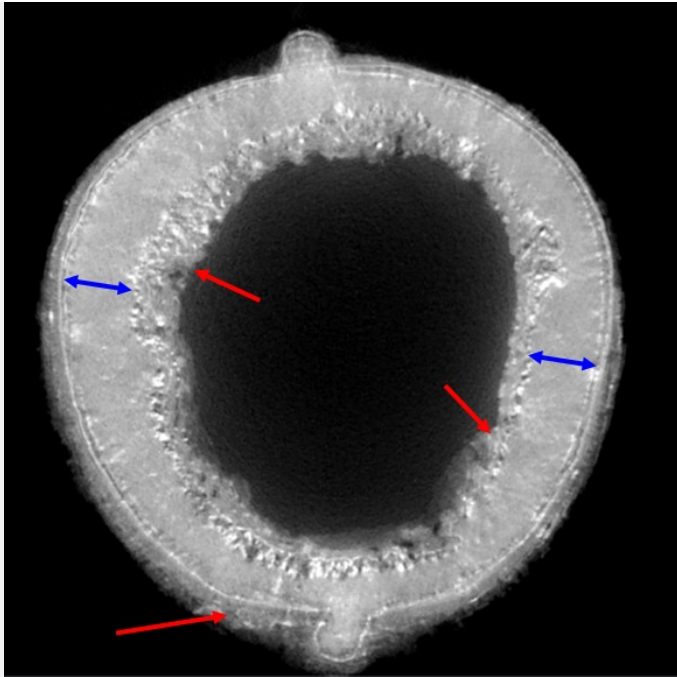
As indicated by the X-ray tomography, the metal of the aegis seems to be well preserved (Figs. 11-12). The metal (M2 in Fig.9 and M1 in Fig. 10) was analysed on the broken edge of the bottom of the artefact where despite a highly corroded surface, the metal seems to be the best preserved. The XRF analyses revealed that the metal is a leaded bronze with remains of gold leaf on the surface (Table 1, Au was detected in the measurement spots 4,5 and 6) (Scott 2002; Gouda 2012; Mohammed 2012).

Fig. 11: X-ray tomography by cross section of the crown showing a dense and non-porous metal core (blue arrows). The corrosion products however are porous (red arrows). The external limit is visible as a fine line preserved under corrosion layers,

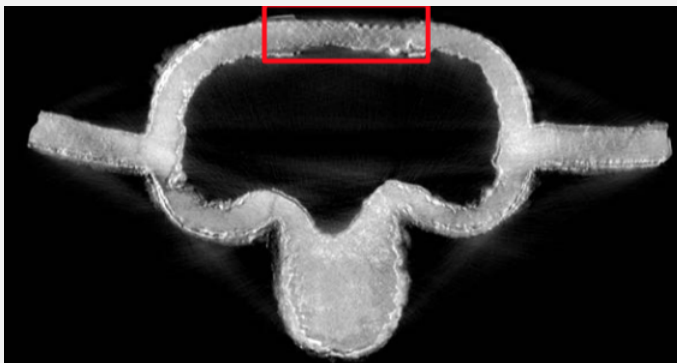
Fig. 12: X-ray tomography by cross section of the lower part showing that there are losses of the original surface (red square),

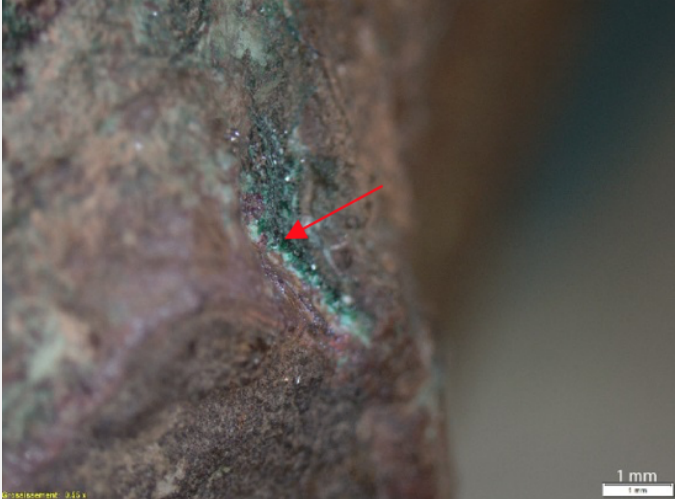
Fig. 13: Observation of the dark green corrosion product,

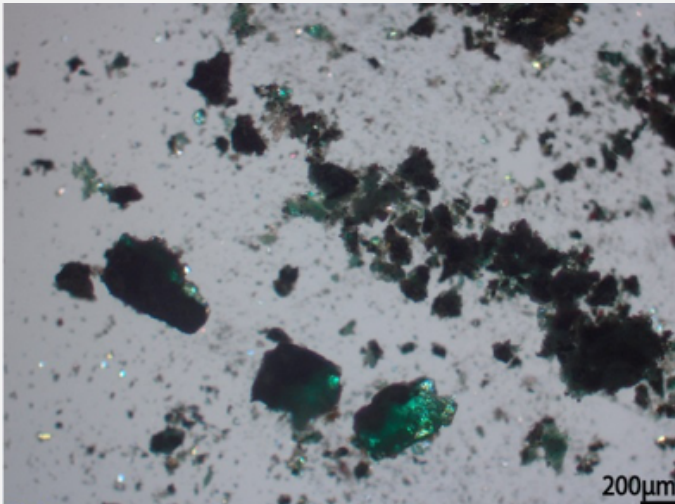
Fig. 14: Dark green corrosion product identified as paratacamite, atacamite $\text{Cu}_2\text{Cl}(\text{OH})_3$ by XRD. Microscopic examination under polarized light,

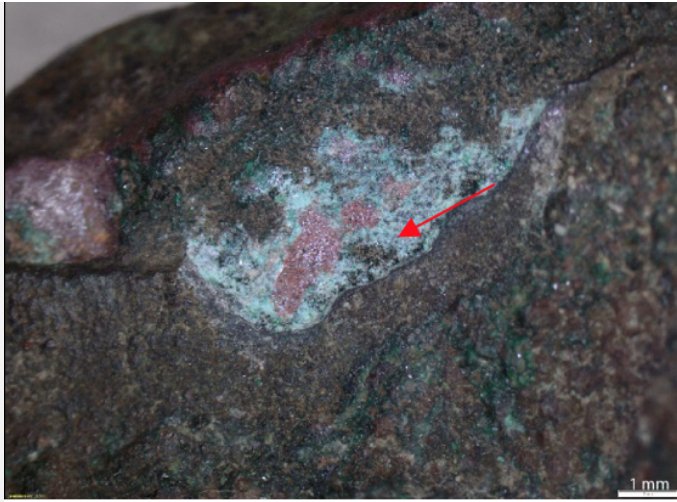
Fig. 15: Observation of the light green corrosion product,

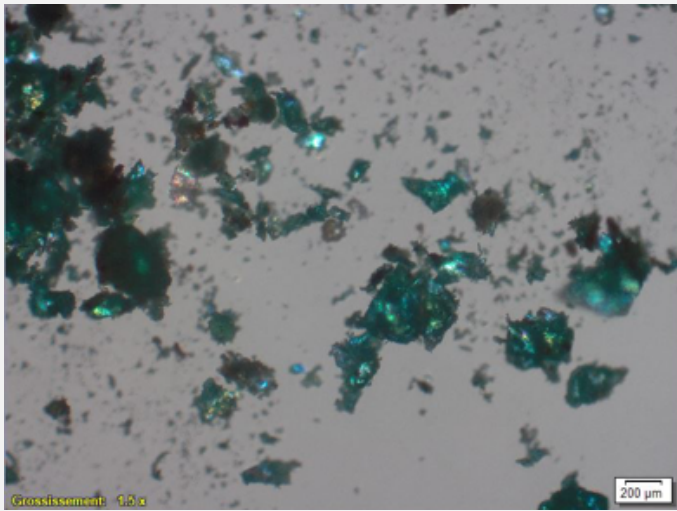
Fig. 16: Light green corrosion product identified as paratacamite, atacamite ($\text{Cu}_2\text{Cl}(\text{OH})_3$) by XRD. Microscopic examination under polarized light,

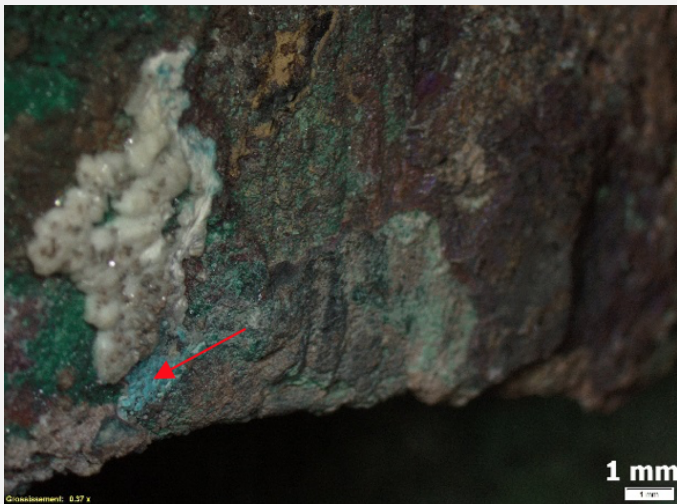
Fig. 17: Observation of the light blue corrosion product,

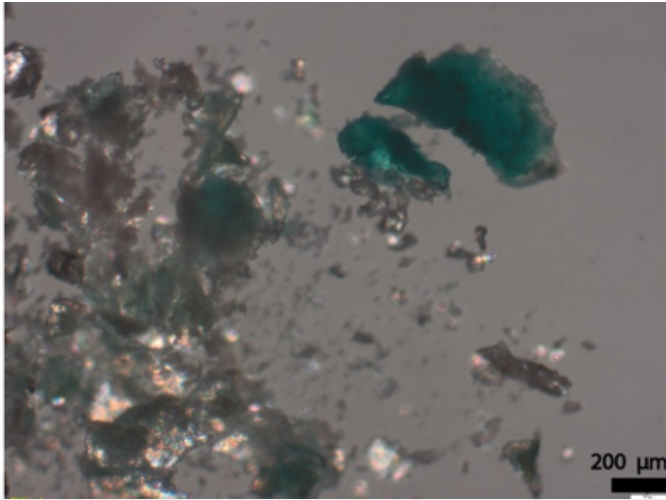
Fig. 18: Light blue corrosion product identified as chalconatronite $\text{Na}_2\text{Cu}(\text{CO}_3)_2 \cdot 3\text{H}_2\text{O}$ by XRD. Microscopic examination under polarized light,

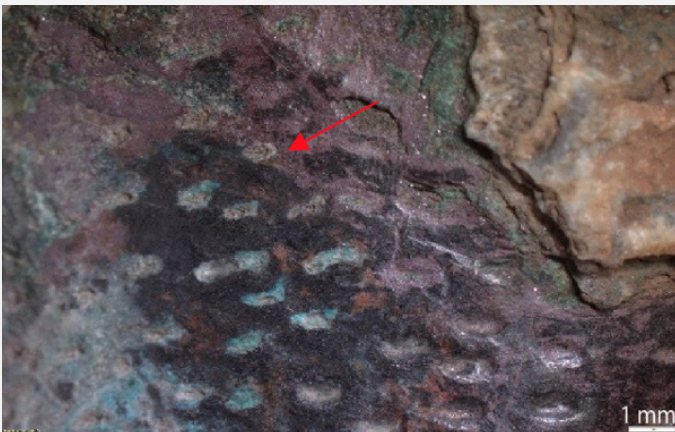
Fig. 19: Observation of the red corrosion product above the black original surface containing corresponding markers such as engravings,

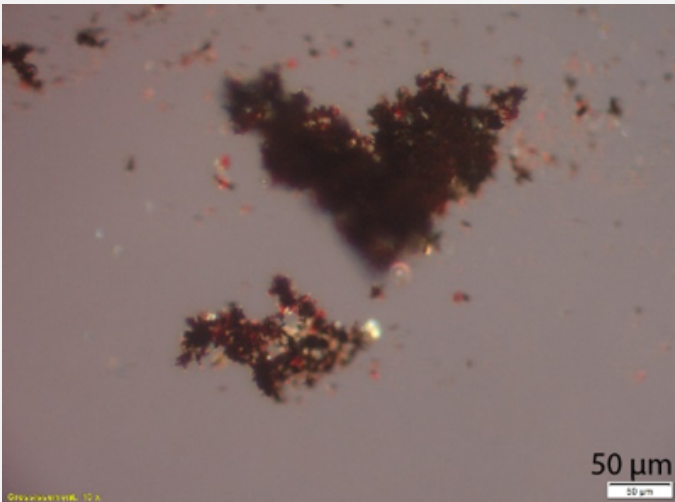
Fig. 20: Dark red corrosion product identified as cuprite Cu_2O as major component and tenorite CuO as minor component. Microscopic examination under polarized light,

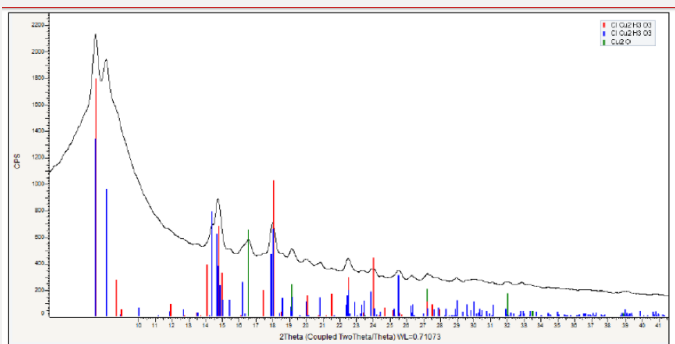
Fig. 21: XRD spectrum of the sample of the dark green corrosion product showing the presence of atacamite and paratacamite ($\text{Cu}_2\text{Cl}(\text{OH})_3$) as major compound and cuprite (Cu_2O) as minor compound,

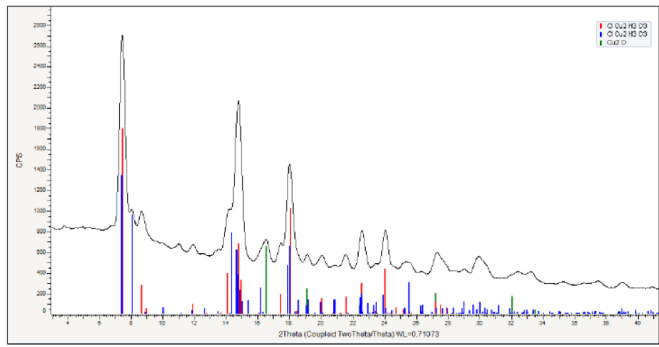
Fig. 22: XRD spectrum of the sample from the light green corrosion product showing the presence of atacamite and paratacamite ($\text{Cu}_2\text{Cl}(\text{OH})_3$) as major compound and cuprite (Cu_2O) as minor compound,

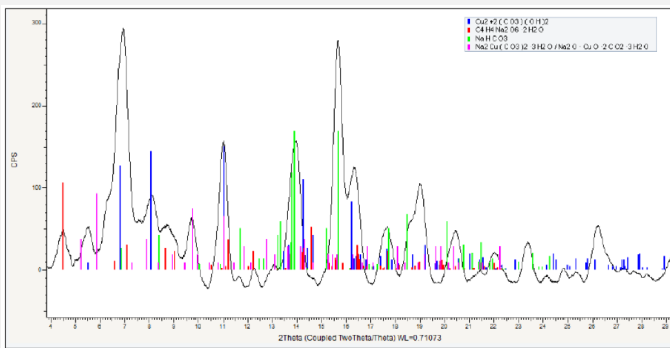
Fig. 23: XRD spectrum of the sample from the light blue corrosion product showing the presence of chalconatronite ($\text{Na}_2\text{Cu}(\text{CO}_3)_2 \cdot 3\text{H}_2\text{O}$). The other compounds are analysis supposition, but are not relevant,

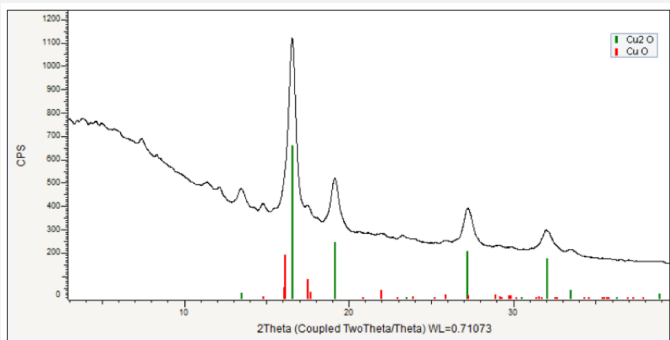
Fig. 24: XRD spectrum of the sample from the dark red corrosion product showing the presence of cuprite (Cu_2O) as major compound and tenorite (CuO) as minor compound,
