CIRCULAR DOOR KNOCKER STRIKING PLATE – CU ALLOY – MODERN TIMES – SWITZERLAND

Artefact name	Circular door knocker striking plate
Authors	Marianne. Senn (EMPA, Dübendorf, Zurich, Switzerland) & Christian. Degryny (HE-Arc CR, Neuchâtel, Neuchâtel, Switzerland)
Url	/artefacts/682/

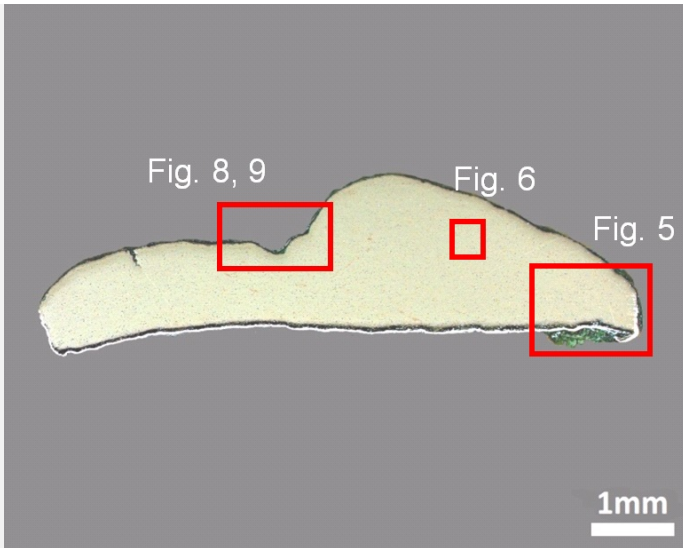
Fig. 3: Micrograph of the cross-section of the sample taken from the circular base showing the location of Figs. 5 to 6 and 8 to 9,

Description of sample	No information is given on where the sample has been taken. A supposed location is however illustrated in Fig. 2. The polished sample shows a well preserved metal surface with some cracks covered by a thin corrosion crust (Fig. 3).
Alloy	Cu Alloy
Technology	Rolled, annealed after cold working
Lab number of sample	MAH 94-156-001
Sample location	Musées d'art et d'histoire, Genève, Geneva
Responsible institution	Musées d'art et d'histoire, Genève, Geneva
Date and aim of sampling	1994, metallography and presence or not of a gilding treatment

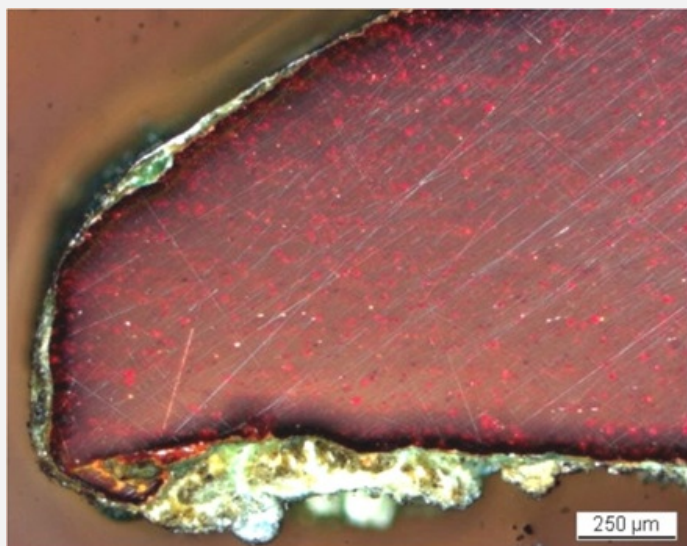
mode, Fig. 9). Due to the rolling process the copper oxide inclusions are parallel to the longitudinal orientation of the sample (Figs. 5 and 6). They were identified as cuprite by Raman spectroscopy (Fig. 7). The etched alloy shows a structure of polygonal grains with annealing twins (Fig. 6). The grain size is variable. The average hardness of the alloy is HV1 80, which is quite high compared to the average hardness of a pure annealed copper of around HV1 40-50 (Schumann 1991, 627).

Fig. 5: Micrograph of the metal sample from Fig. 3 (reversed picture), unetched, polarised light. The red copper oxide inclusions form rows in the copper alloy matrix.,

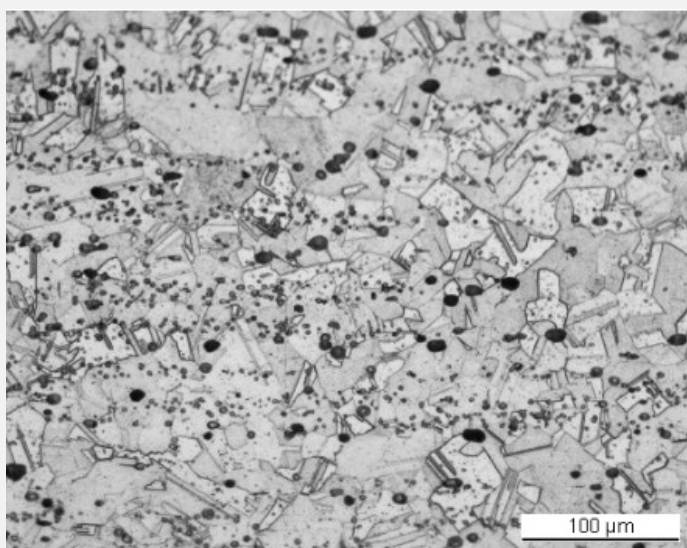
Fig. 6: Micrograph of the metal sample from Fig. 3 (detail), etched, bright field. The metal shows a structure of polygonal and twinned grains. Copper oxide inclusions are visible as dark spots,

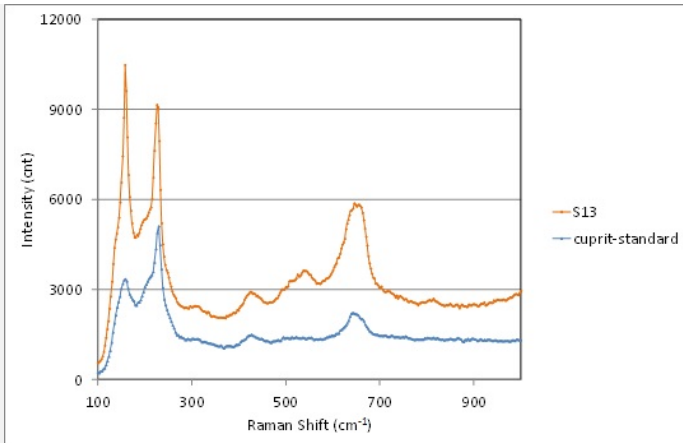
Fig. 7: Raman spectrum of a red inclusion (S13) of Fig. 5 compared to a cuprite standard spectrum. Settings: laser wavelength 532nm, acquisition time 100s, one accumulation, filter D2 (0.75-0.8mW), hole

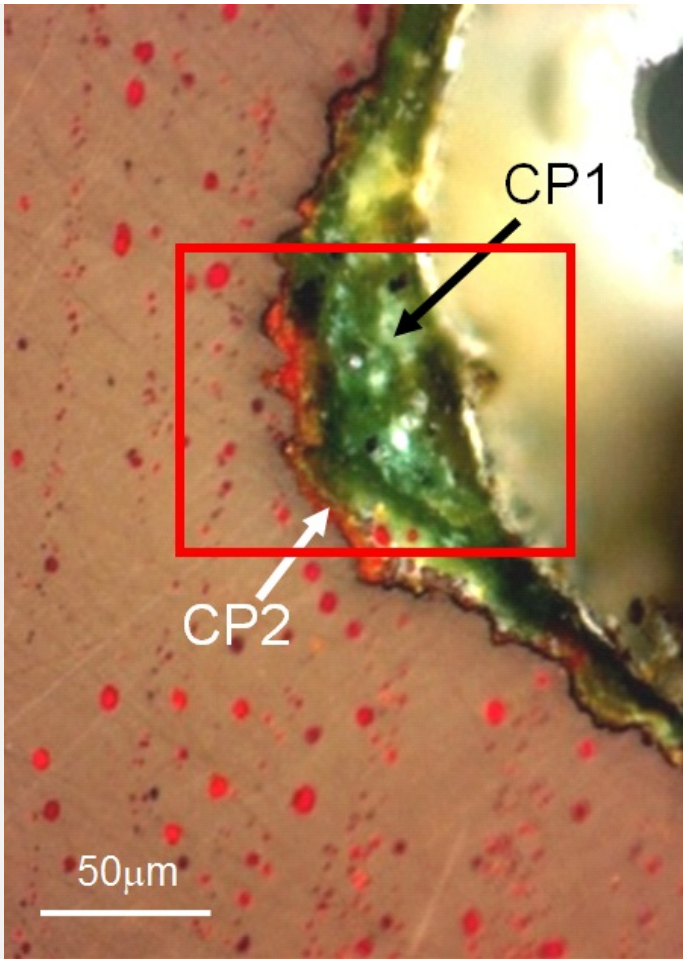
The average thickness of the corrosion crust is about 90µm, but may be thinner or thicker depending on the area of origin (Fig. 5). Under polarized light, we observe a multilayer system with a dense and thin inner red corrosion layer (CP2, probably cuprite/Cu₂O) on the metal (Fig. 8) containing chlorides (Fig. 9 and Table 3). This is followed by bands of heterogeneous green corrosion products (CP1, possibly copper chloride / sulphate / carbonate). This outer corrosion layer is contaminated with atmospheric components (Si, Al, Cl, C and O and perhaps gypsum particles (CaSO₄)) (Fig. 9).

Fig. 8: Micrograph of the metal sample from Fig. 3 (rotated by 90°) and corresponding to the stratigraphy of Fig. 4, polarised light. Metal with red copper oxide inclusions. The black particles in the green corrosion layer are quartz inclusions. The area selected for elemental chemical distribution (Fig. 9) is marked by a red rectangle.

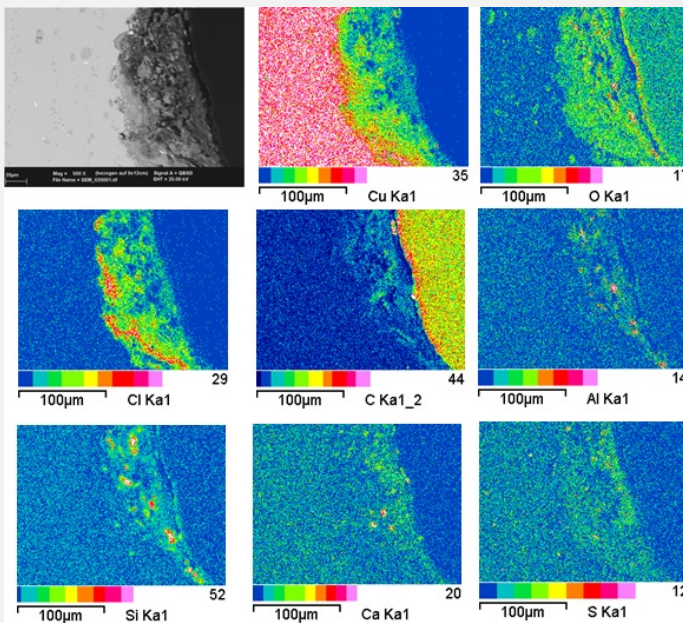
Table 2: Chemical composition (mass %) of the inclusions (light-grey and white in Fig. 9) in the metal. Method of analysis: SEM/EDS, Laboratory of Analytical Chemistry, Empa.

Fig. 9: SEM image, BSE-mode, and elemental chemical distribution of the selected area of Fig. 8. Method of examination: SEM/EDS, Laboratory of Analytical Chemistry, Empa,
